John R. Kasich, Governor
Mary Taylor, Lt. Governor
Scott J. Nally, Director
October 31, 2012

RE: SUM-SEIBERLING PHS 2
3GC05686*AG
STORMWATER
SUMMIT COUNTY

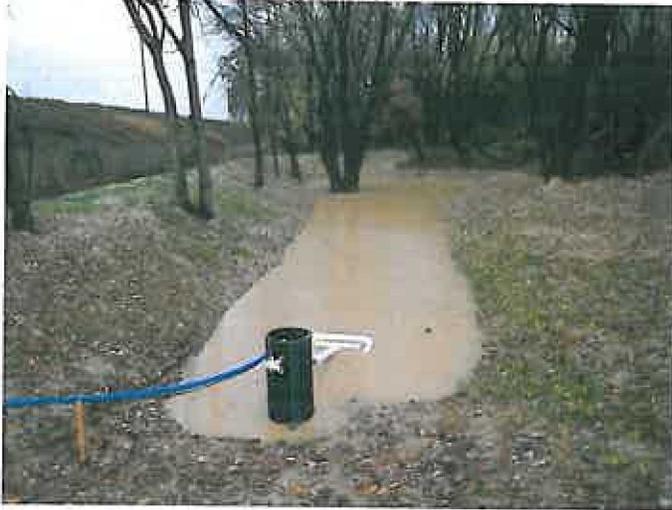
- 1) It had rained during the past 24 hours. The low points and berms have been collecting storm water runoff in sufficient quantities to where the final sedimentation basin now contains collected water. At the time of my inspection, the water level in the basin was at least a foot below the orifice attached to the floating skimmer/pump system. Therefore, there was no discharge.

10/29/2012 Sedimentation Pond

- 1) To date, the water collected in detention area 3 and the sedimentation pond is considered to be leachate. It will need to be pumped and hauled to a properly licensed treatment facility. Please state when this will occur and to what treatment facility it is disposed. Also, state whether or not leachate or leachate contaminated storm water has been discharged from the site to date.
- 2) State whether or not detention area 1 is located over solid waste and if it was constructed in accordance with the approved SWPPP.
- 3) Water collected behind the pilings isolating Haley's Ditch must be pumped thru the filter bag. Please acknowledge.

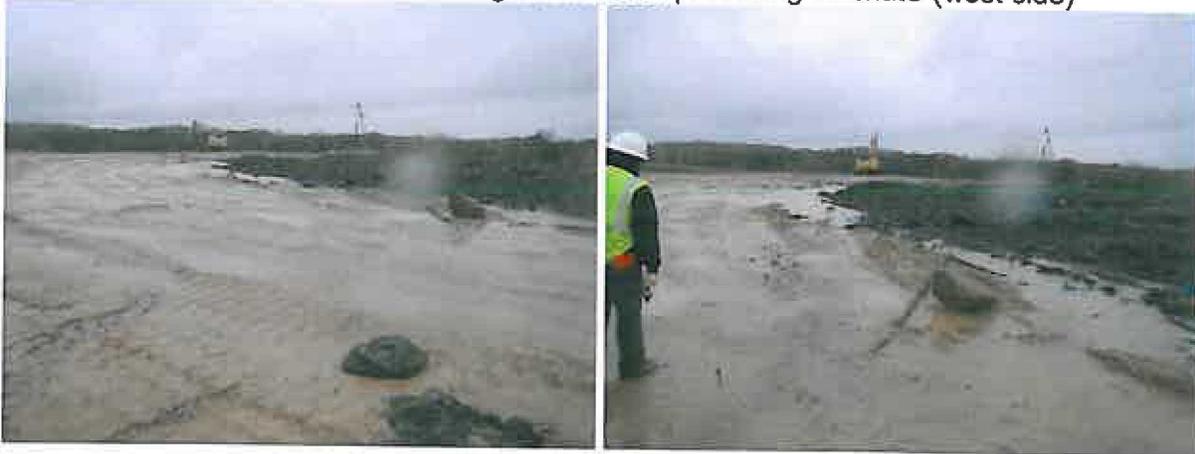
- 2) There is exposed relocated waste on top of the landfill. At several points on the east, south and west side of the landfill, storm water that has contacted solid waste was running down the cover material and entering the storm drainage system. This is leachate. The City of Akron representatives, their consultants, your consultants and yourself were all informed that any water contacting solid waste is considered to be leachate. Leachate entering the storm water system, causes all water it mixes with to be leachate. The General Construction Stormwater NPDES Permit 3GC05686*AG does not authorize the discharge of leachate to waters of the state. **Discharging leachate and/or leachate contaminated storm water would be a violation of the permit and a violation of Ohio Revised Code 6111.04 and 6111.07.** All leachate must be collected and hauled to a properly licensed treatment facility.

10/29/2012: Exposed waste contacting storm water producing leachate (west side)

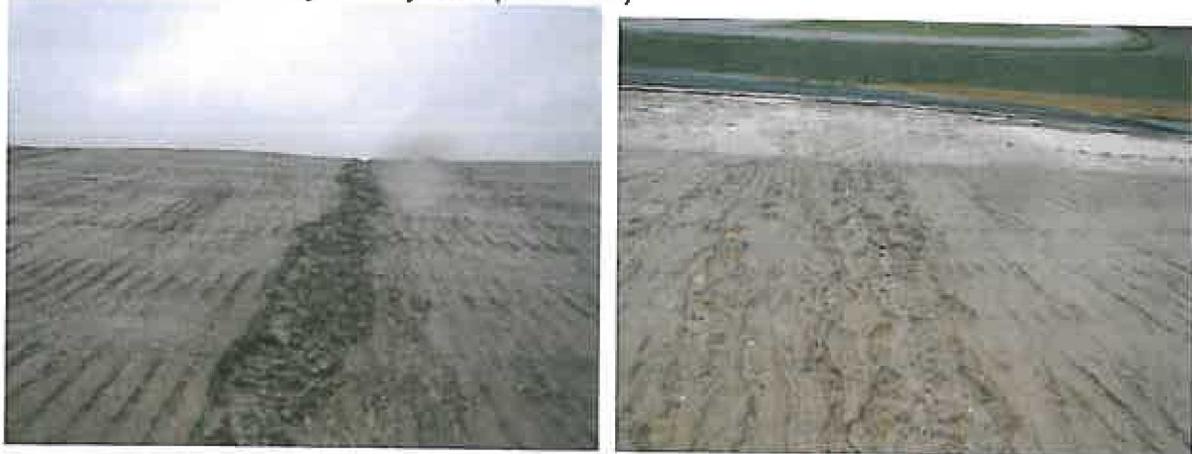
10/29/2012: Leachate/storm water eroding cover and entering
The storm water conveyance system (west side)

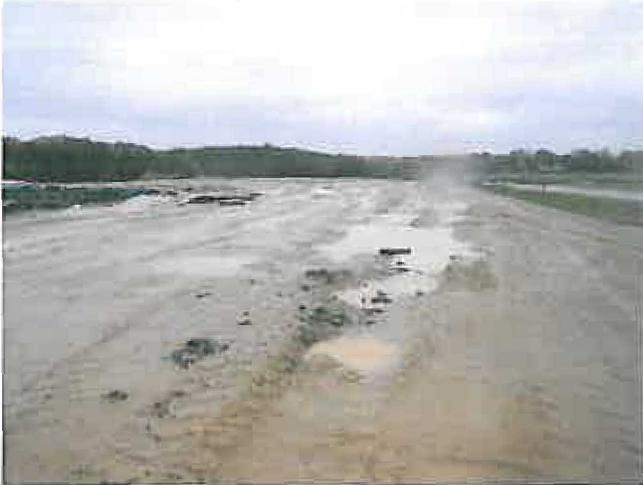
10/29/2012: No berm present to prevent leachate from running off into the storm water conveyance system (west side)

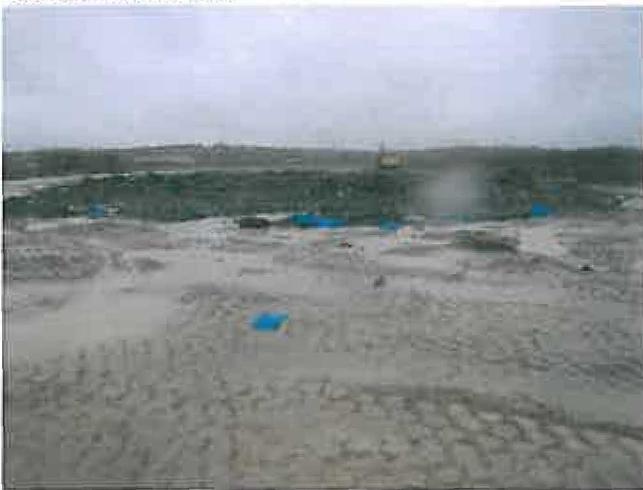
10/29/2012: View from the south. Storm water in contact with solid waste

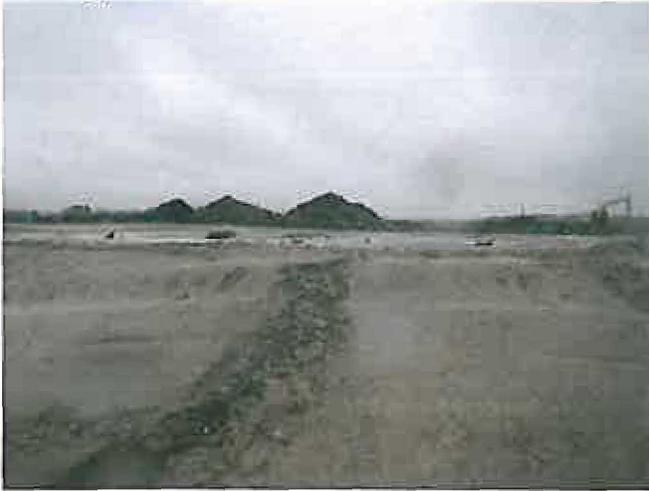
10/29/2012: View from south. Storm water/leachate
Eroding cover.

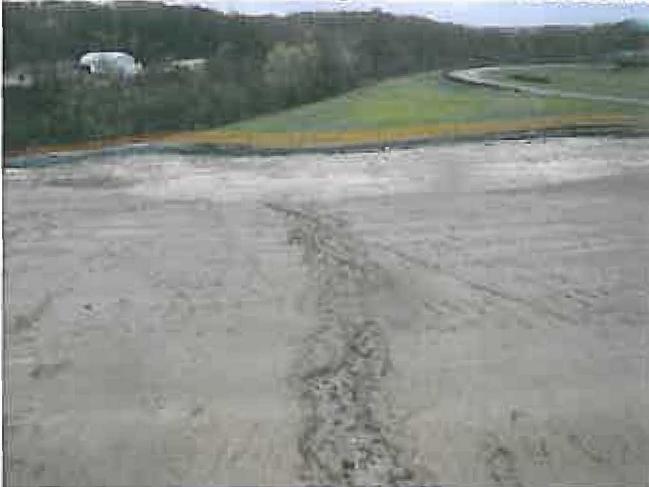
10/29/2012: View from south. Storm water/leachate
Eroding cover and entering storm water conveyance system

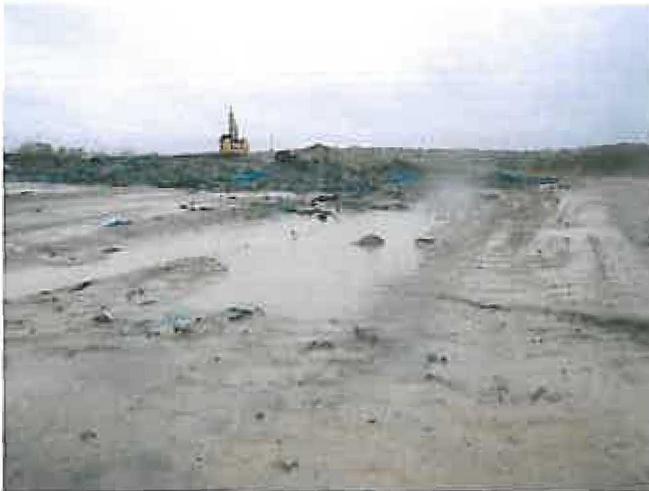
2/29/2012: East side. Storm water in contact with solid waste.

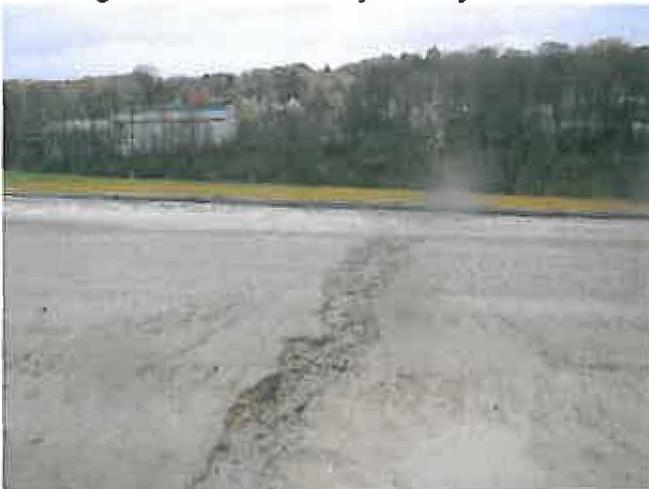
2/29/2012: Storm water/leachate eroding cover and entering storm water conveyance system
