November 9, 2012

RE: MAHONING COUNTY  
PILOT TRAVEL CENTERS LLC  
SITE NO. 011  
NPDES PERMIT NO. 3IG00066

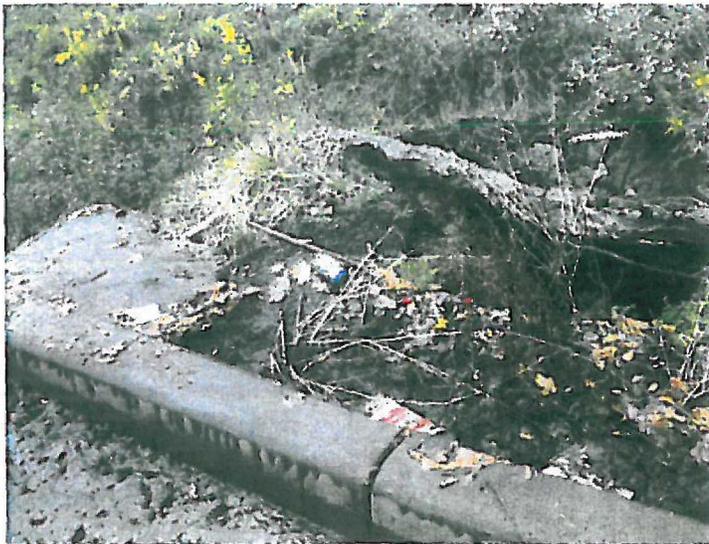
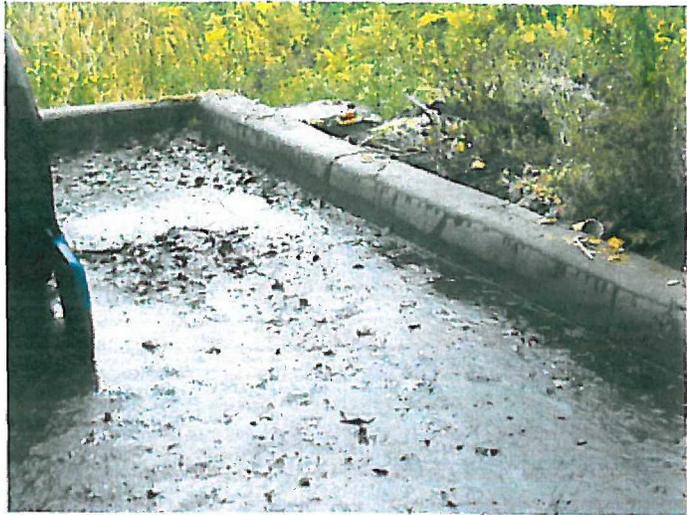
1. An inspection of the pond identified a slight oil sheen on the surface of the water. The sheen could originate from an area located on the southwest corner of the diesel lot. The southwest corner appears to receive significant runoff from the diesel area as evidenced by a heavy deposition of black sludge and oil on the paved area. Following are pictures of the area.

Standard Operating Procedures (SOP) must be developed to address this area of the site. Increased maintenance in this area may address the problem. Action must be taken to prevent this area from accumulating heavy deposits of sediment and petroleum products. In addition, the erosion of the basin banks in this area must be repaired. A response to this inspection report addressing this concern must be provided no later than December 7, 2012.
