November 21, 2012

RE: CUYAHOGA COUNTY
CITY OF MIDDLEBURG HEIGHTS
CONSTRUCTION STORM WATER
MIDDLEBURG HEIGHTS MEDICAL CENTER
PERMIT NO: 3GC05904

NOTICE OF VIOLATION

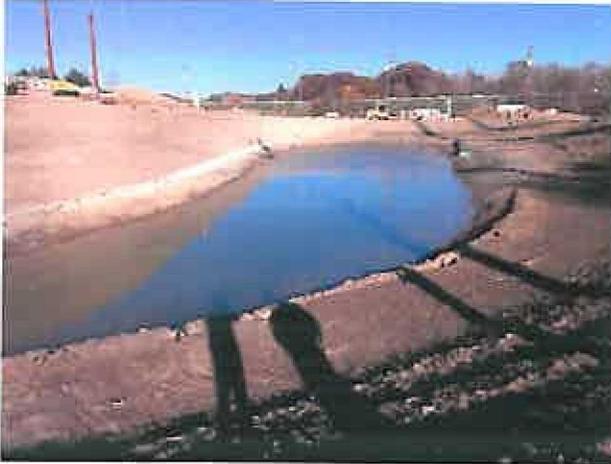
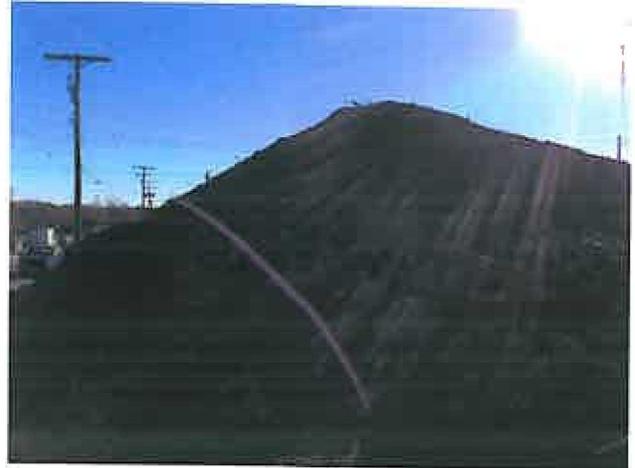
- **Stabilization, i.e., seeding and mulching, has not been initiated as required by the NPDES permit.** Temporary stabilization must be initiated within 7 days of last disturbance on any disturbed area of the site if it will not be further disturbed within 21 days of last disturbance. Permanent stabilization must be initiated within 7 days of reaching final grade. No temporary or permanent stabilization was evident on this site. Areas that should have been temporarily or permanently stabilized include: the soil stockpile near the construction trailers, the embankments and slopes near the sediment basin, and perimeter areas of the site. As we are now past the growing season, stabilization can be achieved either through mulching or dormant seeding. Specifications can be found in the SWP3 or the *Rainwater* manual.

Fig 1 & 2. Embankments around the sediment basin and soil stockpiles have not been stabilized.

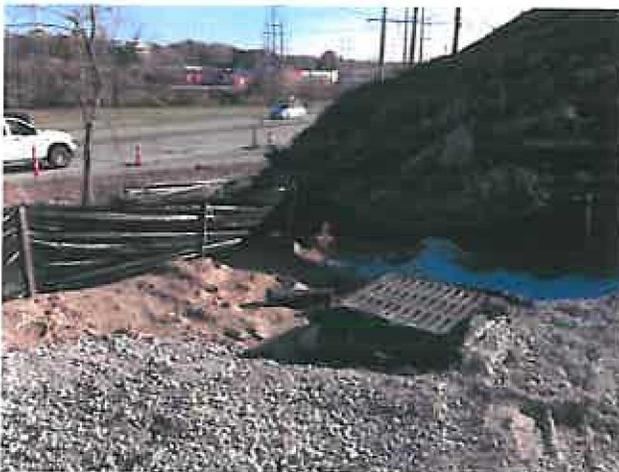
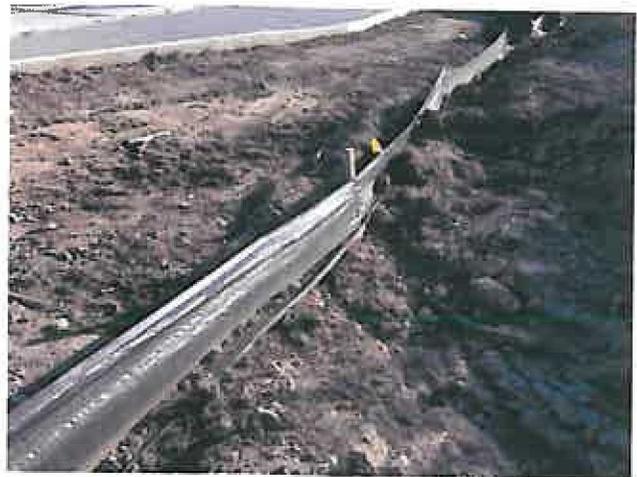
- **Silt fence has not been installed in a functional manner or has not been maintained.** All sediment controls, including silt fence, must be capable of ponding runoff in order to settle sediment. Several stretches of silt fence, particularly along Pearl Road, were not been trenched or backfilled and thus, were not capable of ponding runoff. Please install/repair silt fence so that it is functional. It must remain in place until the upslope contributing drainage area has reached final stabilization, i.e., a vegetative growth density of 70% or greater has been achieved.

Fig 3 & 4. Silt fence has not been trenched and backfilled so as to allow runoff to pond behind it.

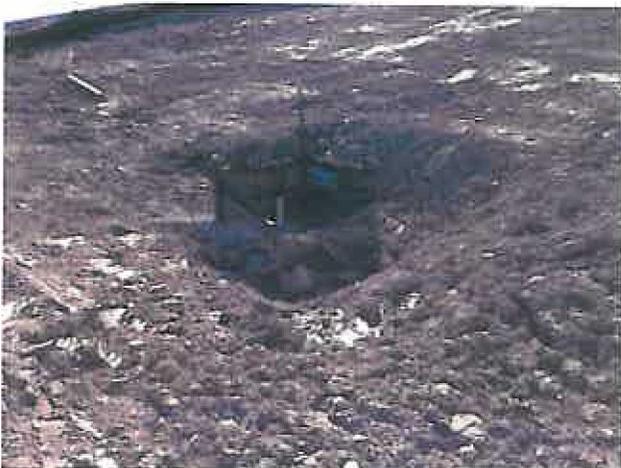
- **Storm drain inlet protection has not been constructed per specifications contained in the SWP3.** Inlet protection was constructed simply by encircling drains with silt fence. This has resulted in failed storm drain inlet protection (see photos). Please note that geotextile is to be supported by a wooden frame and cross braces constructed of 2"x4"s as well as wire mesh. Please review the specifications contained in the SWP3 and in the enclosure titled Storm Drain Inlet Protection from *Rainwater and Land Development, Ohio's Standards for Stormwater Management, Land Development*

Fig 5 (LEFT). Storm drain inlet protection along Pearl Rd has not been constructed as required.
Fig 6 (RIGHT). There is no containment around or cover over the mortar mixer.

and *Urban Stream Protection* (Ohio Department of Natural Resources, 2006), and install/repair inlet protection to meet these standards.

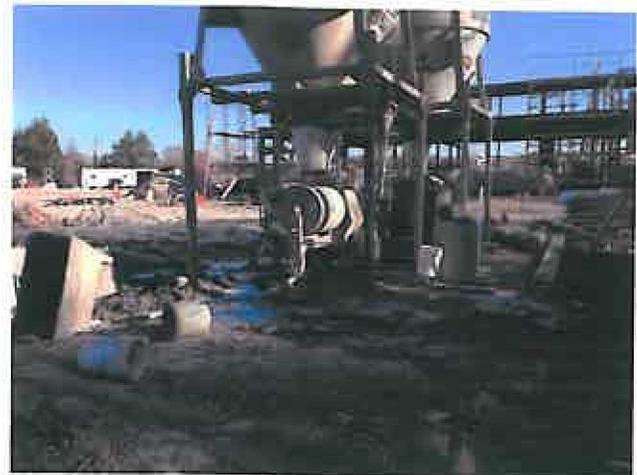
- **There is no berm or other such containment structure to prevent storm water discharges from the mortar mix operations.** Runoff from cement and cement-based products is typically alkaline. Sediment and erosion controls do not address this pollutant of concern. Other measures such as berms to prevent discharge or cover to prevent storm water from contacting materials of concern must be implemented.
