December 27, 2012

RE: GEAUGA COUNTY
THOMPSON TWP
INDUSTRIAL STORM WATER
RW SIDLEY THOMPSON PLANT

Site Inspection

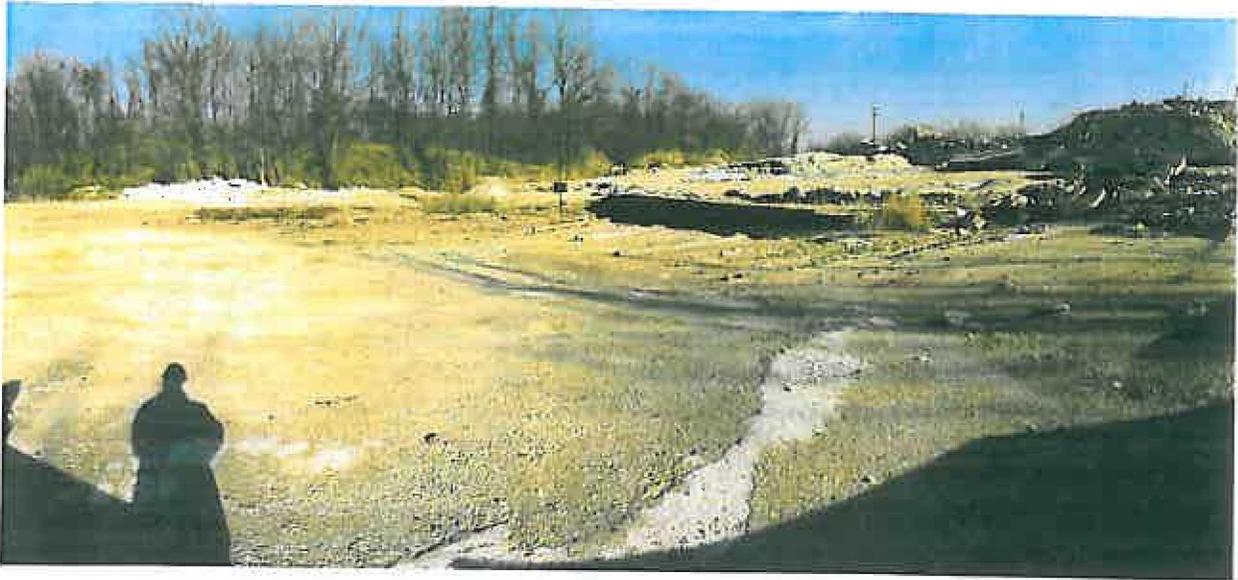
- We observed evidence of pollutants discharging from the Concrete Burial Yard. Excess batches of concrete are brought to this area to harden and then recycled through the concrete crusher. However, before the batch hardens, washwater or seepage from the concrete drains into an unnamed tributary of Mill Creek. We observed colorants and particulates associated with concrete flowing from the Concrete Burial Yard into the stream. Measures such as berming or placing batches within excavated pits can be implemented to prevent these discharges. This outfall is one of the unidentified outfalls from the facility.

Fig 1. Concrete Burial Yard. Storm water runoff flows toward the tree line.

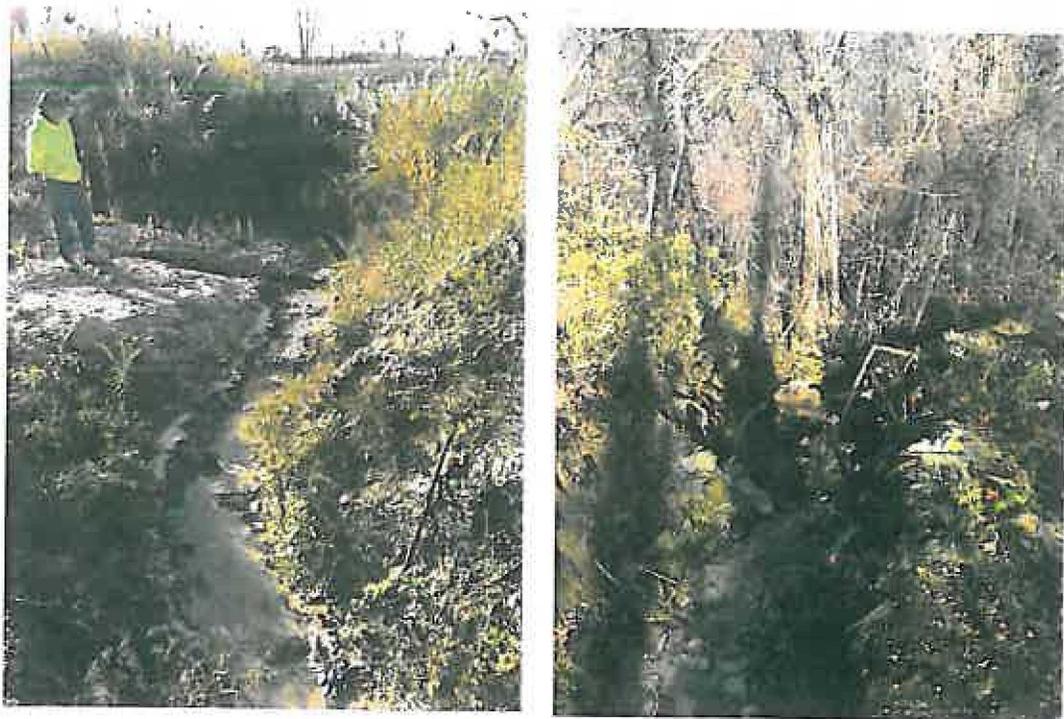
Fig 2 & 3. The Concrete Burial Yard discharges into this swale and then down a slope to the east. This outfall of storm water is not identified in the SWPPP and must be added to the plan and sampled for quarterly visual and benchmark monitoring. Note colorant discharge in photo on left.

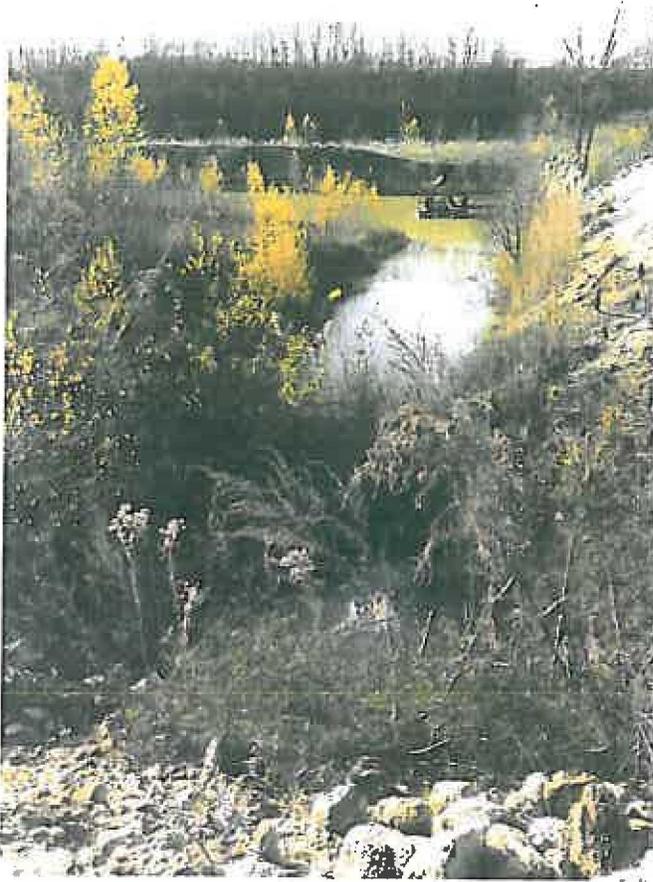
We noted that this facility generates process wastewater which collects within the Concrete Batch Plant Pond, Sand Wash Plant Pond and Pro Angle Wet Plant Pond. Please be aware that your existing NPDES permit does not authorize the discharge of process wastewater. As such, RW Sidley must take measures to ensure that no process wastewater is discharged from the facility or seek additional NPDES permit coverage for these discharges. Our observation of the Sand Wash Plant Pond indicated that there may be occasional discharges due to overflow in the NE corner of the pond. Erosion rills were observed from the pond down the slope above Ledge Road. Measures such as raising the berm or increasing recycling of washwater back to the wash plant are steps that can be taken to prevent future discharges. In addition, the Pro Angle Wet Plant Pond was discharging when we observed it on November 15, 2012. You indicated that this water is to be recycled back to the Pro Angle Wet Plant. Again, increasing recycling or the holding capacity of the pond may prevent future unauthorized discharges of process water.

Fig 4 (LEFT). The Pro Angle Wet Plant pond was discharging on the date of inspection. Storm water and process water are co-mingled in this pond.

If you determine that future discharges of process water cannot be prevented, please be aware that you must obtain an individual NPDES permit to authorize those discharges or arrange for proper off-site disposal of the wastewater. Please contact Laura Weber at (330) 963-1299 to determine application requirements to obtain the appropriate permit. Further, be aware that additional best management practices may be required to address storm water pollutants within the drainage areas served by these ponds if you cannot prevent them from discharging, e.g., storage of admixtures within secondary containment, establishment of washout pits to contain washout in Concrete Burial Yard, etc.

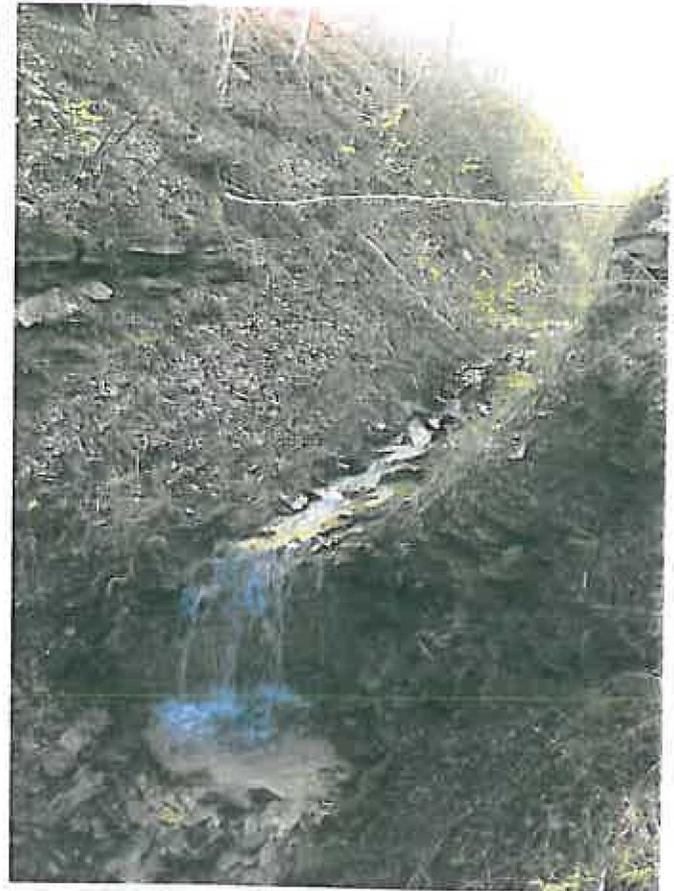
Fig 5 (RIGHT). Outfall 001. The Pro Angle Wet Plant pond is tributary to this outfall. Note the discharge despite no rainfall.

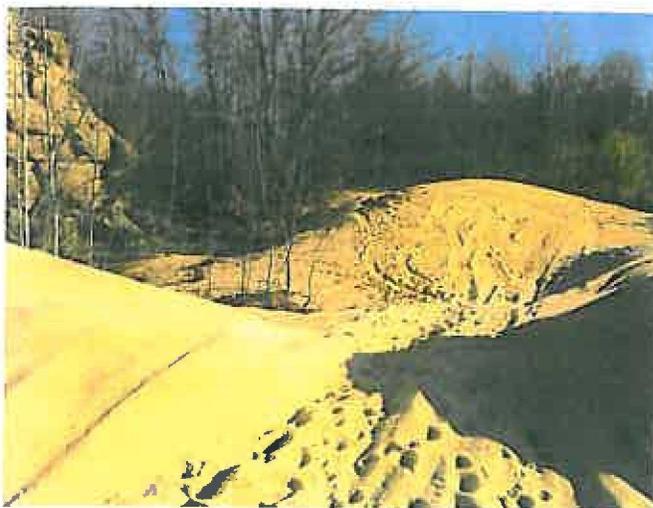
- There is a large stockpile of sand on the north end of the site on the east side of SR 528. Sand can be mobilized by storm water runoff and measures must be taken to prevent erosion into adjacent drainage ways. Measures such as berming or sediment controls such as sediment ponds and silt fence can be used to address this concern.

Fig 6. Sand is stockpiled on the north end of the site east of SR 528. Note erosion of sand along the eastern perimeter. No silt fence or other appropriate sediment control is in place to prevent the migration of sand into drainage ways.

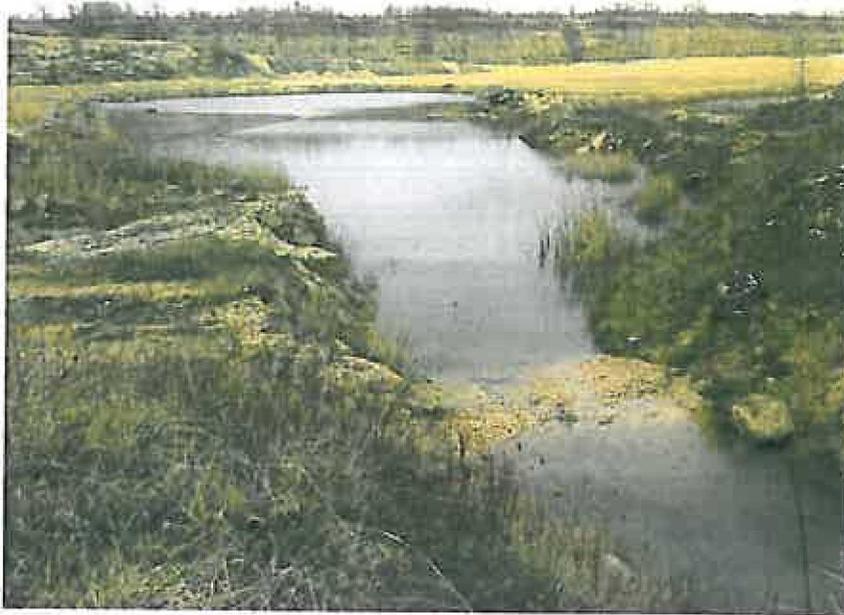
- Drainage from the mining operations on the west side of the SR 528 collects in a poorly-defined "pond" and discharges through a rock check dam into a drainage channel. As indicated previously, sediment ponds should be designed per the standards contained in *Rainwater and Land Development*. Sediment ponds should provide a sediment storage volume below the invert of discharge of at least 1,000 cubic feet per acre of disturbed area draining into the pond. Sediment ponds should further provide a dewatering volume above the invert of discharge of at least 1,800 cubic feet (67 cubic yards) per acre of total contributing drainage area. Discharges from sediment basins should be controlled to provide a drain time of 48 hours to seven days. The preferred dewatering device is a skimmer.

Fig 7. This pond on the west side of SR 528 collects runoff from the mining operations. The outlet is a simple gravel dam and provides no storage volume above the invert of discharge. The basin outlet should be designed per specifications for sediment basins contained in the *Rainwater and Land Development*.

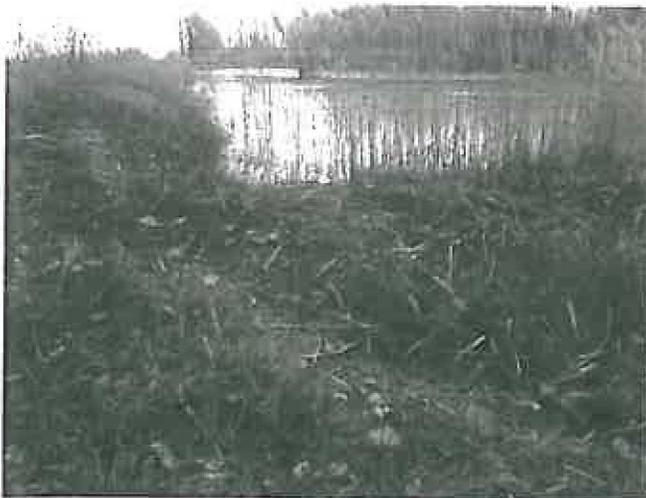
Fig 8 & 9. Erosion rill in the NE corner of the Sand Plant Wash pond and concrete flumes below the pond indicate that there are occasional overflows. This results in an unauthorized discharge of process water.

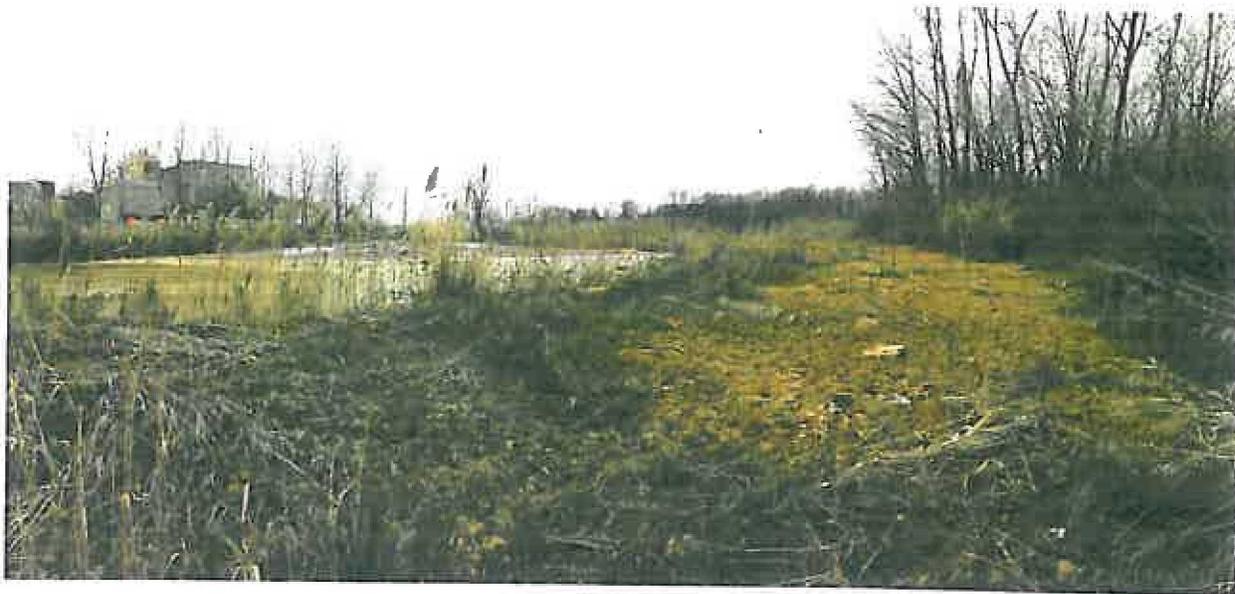
Fig 10. The Concrete Batch Plant pond (left side of photo) was recently dredged, but spoils were not properly disposed. They were placed on the downslope side of the pond, allowing wastewater to leach off site as the dredgings dewatered and sediment to be conveyed off site when it rains.
