January 4, 2013

RE: CUYAHOGA COUNTY
CITY OF BEACHWOOD
CONSTRUCTION STORM WATER
EATON WORLD HEADQUARTERS

NOTICE OF VIOLATION

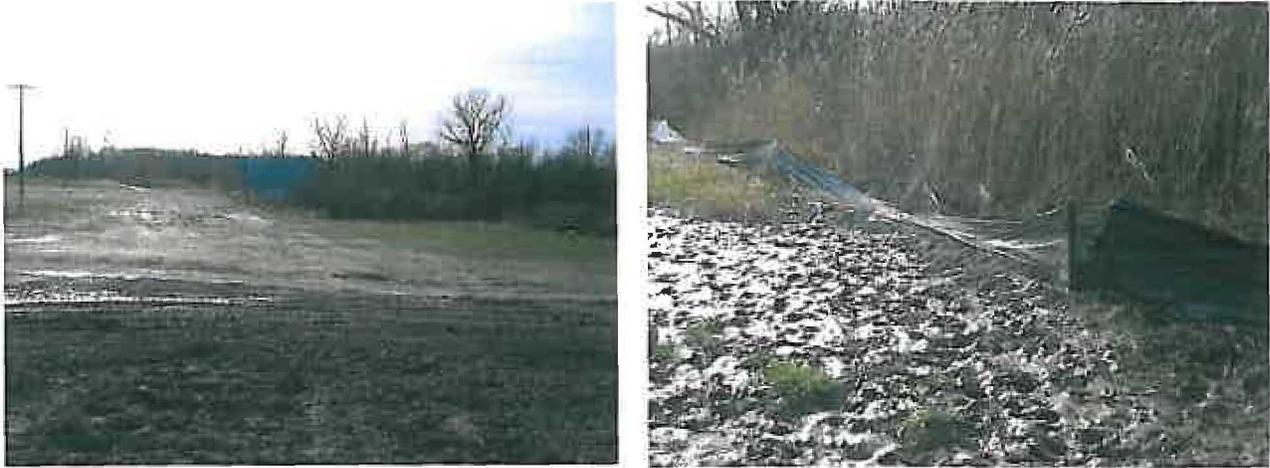
- **Sediment controls implemented for the south side of the property are inadequate.** Although silt fence has been installed along most of the western perimeter of the disturbed area, the allowable drainage area directed to the silt fence has exceeded the limits contained in Part III.G.2.d.iii of the NPDES permit. Sections of the silt fence were knocked over as a result, allowing sediment to discharge into waters of the state. Silt fence was missing along some stretches of disturbed area and must be installed (see photos). Although the disturbed area has been hydroseeded, vegetation has not germinated to an extent sufficient to control erosion. This is not expected to occur until Spring 2013. Mr. Pierce was instructed to mulch the disturbed area with straw and repair the silt fence. If you expect to re-disturb this area in the future, please amend the SWP3 to provide a sediment pond.

Fig 1 (LEFT). South side of the site has been hydroseeded, but vegetation sufficient to control erosion has not established. Note the size of the drainage area exceeds the area allowed for silt fence in the NPDES permit.

Fig 2 (RIGHT). Sediment concentrates along a point of the silt fence shown in Fig 1. Note the fence has a gap and partially knocked over. Sediment was observed downslope of the silt fence.

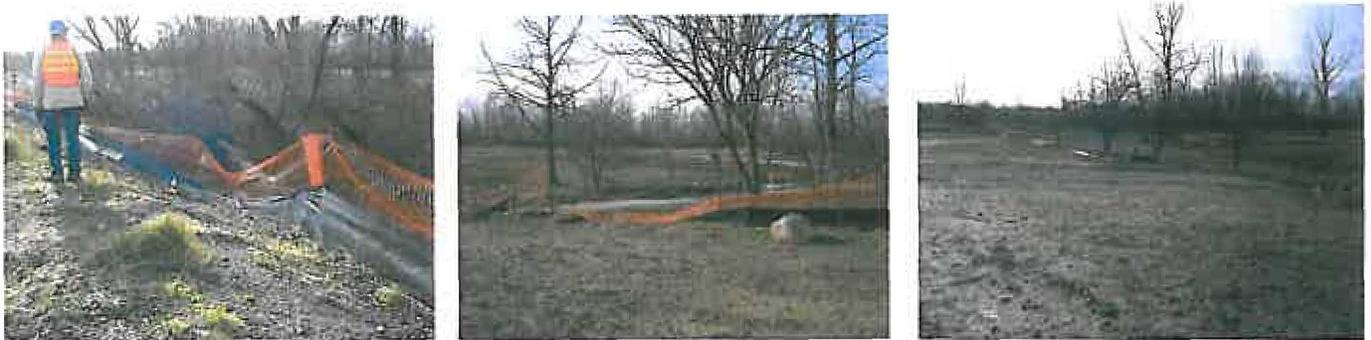
Fig 3 – 5. Sections of the silt fence shown in Fig 1 that have either been knocked over, improperly repaired or where silt fence is missing.

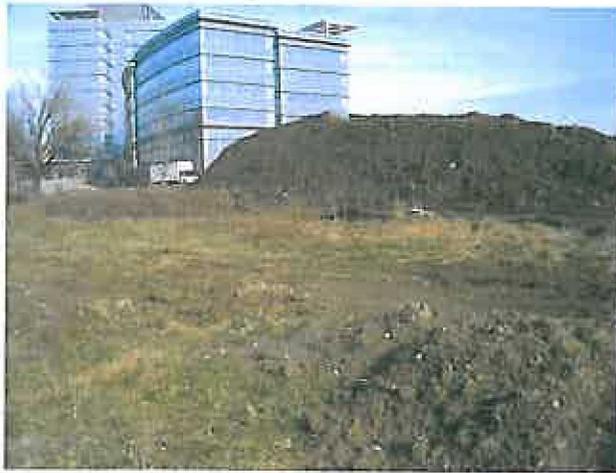
Fig 6 (LEFT). The stockpile on the west side of the site was not temporarily stabilized. It must be mulched or otherwise temporarily stabilized if it is to remain in place undisturbed for 21 days or longer.

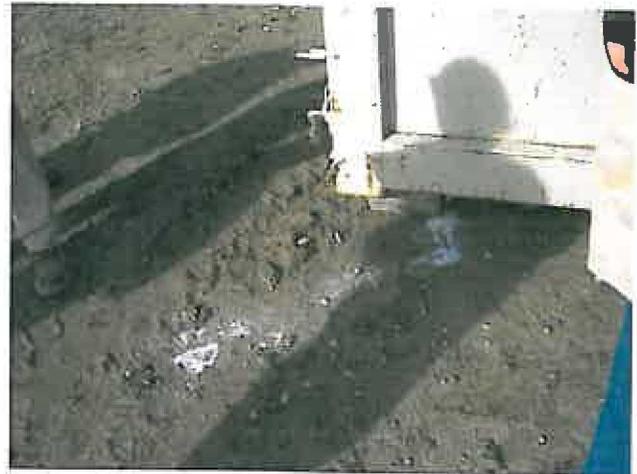
Fig 7 (RIGHT). Pollutants were observed leaking from the trash dumpster onto the ground.

- **Non-sediment pollution controls require repair and maintenance.** The concrete washout pit was full. Please remove hardened concrete and restore the washout pit to its original design capacity to prevent an unauthorized discharge of wastewater to the environment. The trash dumpster is uncovered and leaking allowing pollutants to spill onto the ground. Please clean up spilled pollutants and replace the dumpster with one in good condition that will not allow spills to occur. Trash dumpsters must be covered with a lid or tarp to prevent the generation of leachate.

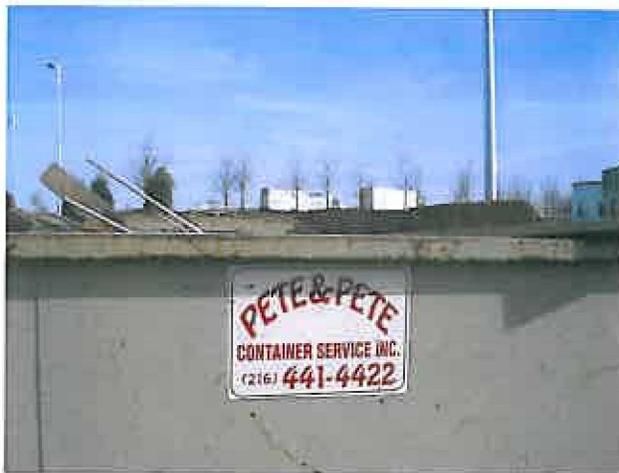
Fig 8 (LEFT). The trash dumpster is not lidded or tarped to prevent storm water from contacting waste and creating leachate.

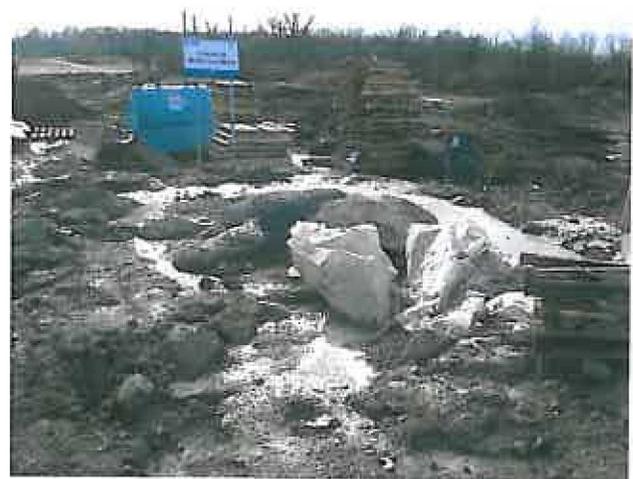
Fig 9 (RIGHT). The concrete washout pit is full and spilling over.

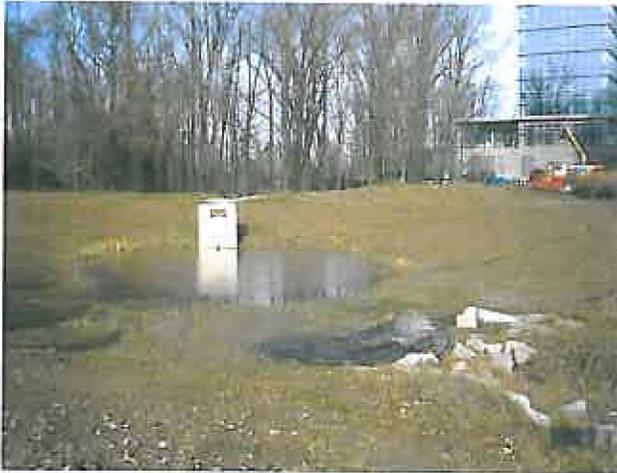
- **Sediment Pond T-1 is not being maintained as a sediment trap as indicated in the SWP3.** Sediment controls must be maintained until their contributing drainage area has been re-stabilized. The drainage area to T-1 remains disturbed. The SWP3 calls for T-1 to be a sediment trap with rock dam outlet and a sediment storage volume below and dewatering volume above the base of the dam. Instead, it appears that you have installed the permanent outlet structure for T-1 and have not modified it so that T-1 can act as a sediment basin. Please consult with your project engineer and the enclosed specifications for sediment basins found in *Rainwater and Land Development, Ohio's Standards for Stormwater Management, Land Development and Urban Stream Protection* (Ohio Department of Natural Resources, 2006) to determine how to amend the permanent outlet structure of T-1 to mimic a sediment basin.

Fig 10 (ABOVE). Sediment pond T-1. Note that the permanent outlet is in place rather than the trap outlet shown in the SWP3.

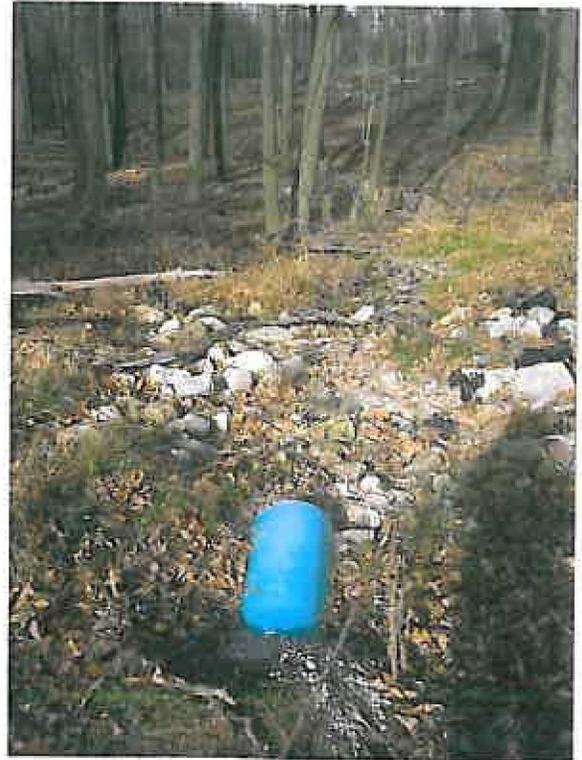
Fig 11 (RIGHT). Sediment was observed at the discharge of Sediment Pond T-1.

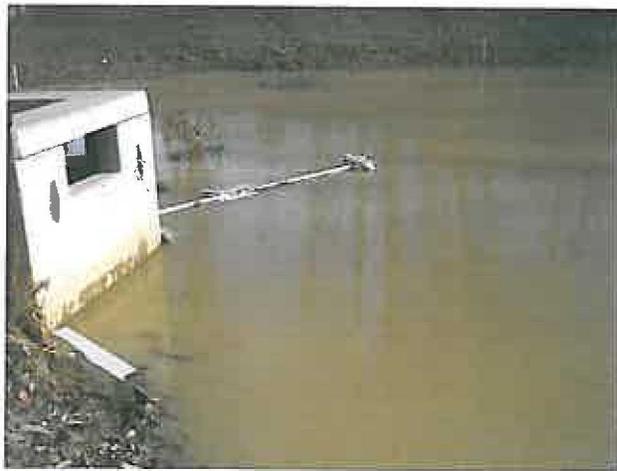
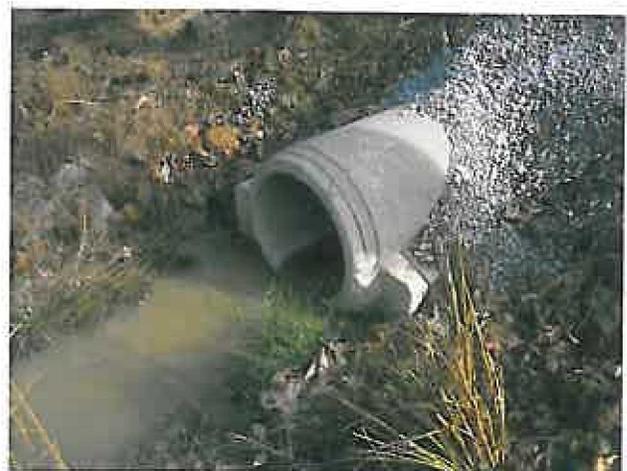
- **Sediment Pond S-2 requires maintenance.** It appears that there is a leak around the skimmer where it attaches to the basin outlet structure. Please repair to ensure that runoff discharges only through the skimmer head.

Fig 12 & 13. The skimmer is in place for Sediment Pond S-2, but there appears to be a leak in the outlet structure. Note that the discharge from S-2 (RIGHT) is almost as sediment-laden as the pond.

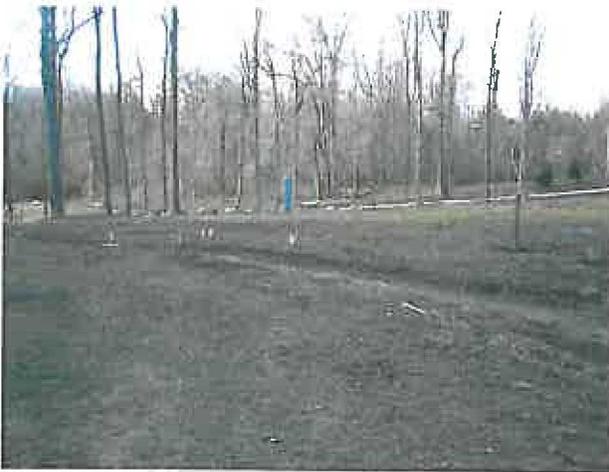
- **The diversion swale between T-1 and S-2 requires maintenance.** Please ensure that the diversion has a depth/height of at least 18 inches and is compacted to prevent breaching. The diversion acts to collect surface runoff and convey it to S-2.

Fig 14 (LEFT). Diversion swale directs runoff to S-2, but note that the swale has not been stabilized and rock check dams have not been provided.

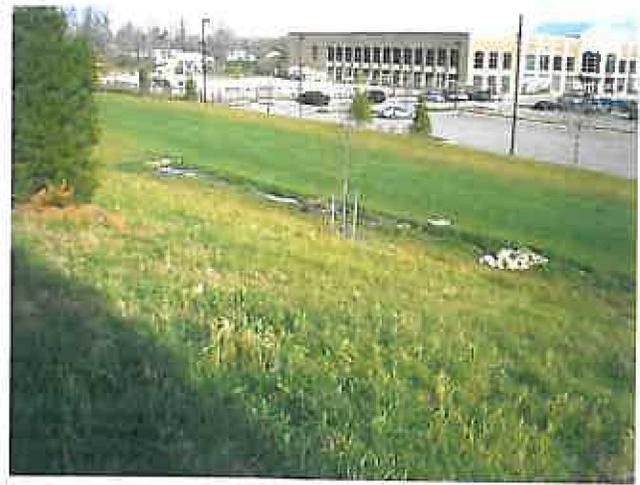
- **The check dams in the swale to Sediment Pond S-1 have not been constructed per proper specifications.** Please refer to the enclosed specifications contained in *Rainwater and Land Development*. Note that check dams must stretch across the entire width of the channel such that the ends of the dam are at a higher elevation than the middle. Please re-construct the check dams in accordance with the enclosed specification.

Fig 15 (RIGHT). Drainage channel directs runoff to S-1. Note that the rock check dams are not built across the entire width, allowing runoff to flow around the ends and cause erosion.

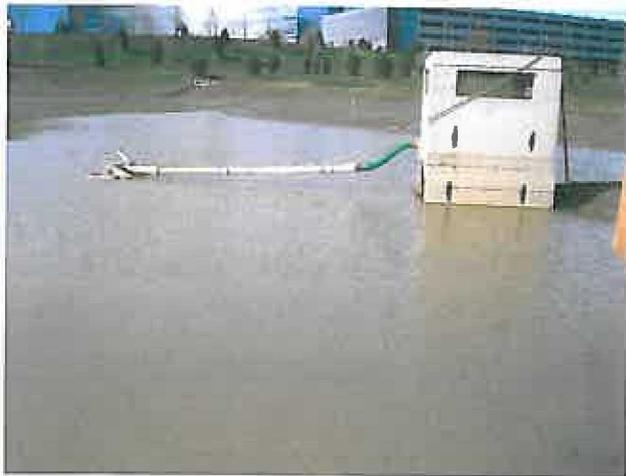
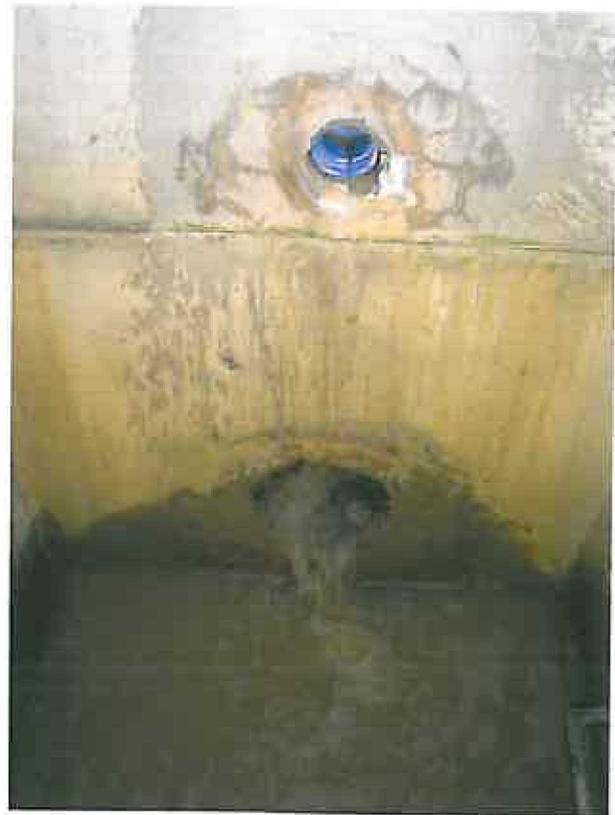
- **Sediment Pond S-1 is not operating as intended.** The pond must still function as a sediment basin. As such, runoff up to the top of the Dewatering Volume must discharge only through the skimmer head. We observed runoff discharging from the lower, permanent water quality orifice, resulting in sediment in the receiving stream. The water quality orifice must be temporarily blocked to prevent discharge from that orifice as long as Sediment Pond S-1 must function as a sediment basin.

Fig 16 & 17. Sediment Pond S-1 is not functioning as intended. Note that the water level is below the invert of the skimmer. A look inside the outlet structure (RIGHT) shows that runoff is charging from a lower orifice. This orifice should not be active at this time.
