RE: PORTAGE COUNTY  
BRIMFIELD TWP.  
PERMIT NO: 3GC05847  
CONSTRUCTION STORM WATER  
DISTRIBUTION FACILITY WAREHOUSE

NOTICE OF VIOLATION

**RE:** Distribution Facility Warehouse Site Inspection on January 31, 2013

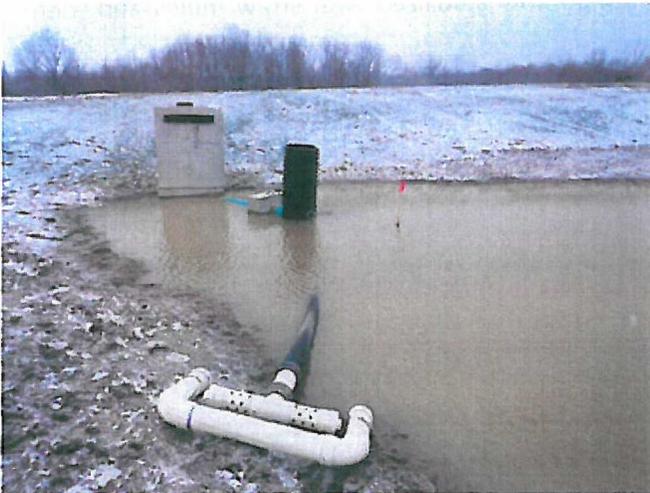
- The temporary skimmer has become disconnected from the West Basin and the Crystal Parkway Basin outlet structures. The skimmers must be reconnected to the basin outlet structure. We recommended stone be placed under the skimmer head to prevent it from becoming stuck to the bottom of the basin and guide posts installed to keep the skimmer in place.

West Basin skimmer must be reconnected

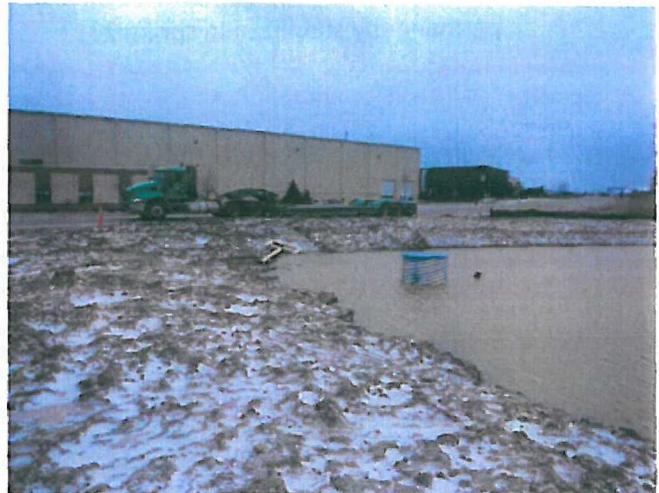
Crystal Parkway skimmer must be reconnected

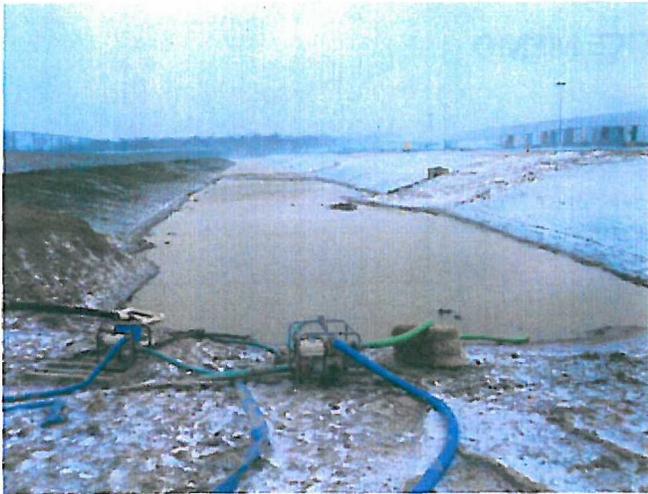
- The East Basin is currently being dewatered and being discharged onto dirt, resulting in sediment laden waters. This would be fine if the Crystal Parkway Basin was working properly. However, the skimmer in the Crystal Parkway Basin has also become detached from the outlet structure and must be reattached in order to properly function as a sediment basin.

East Basin looking south from outlet

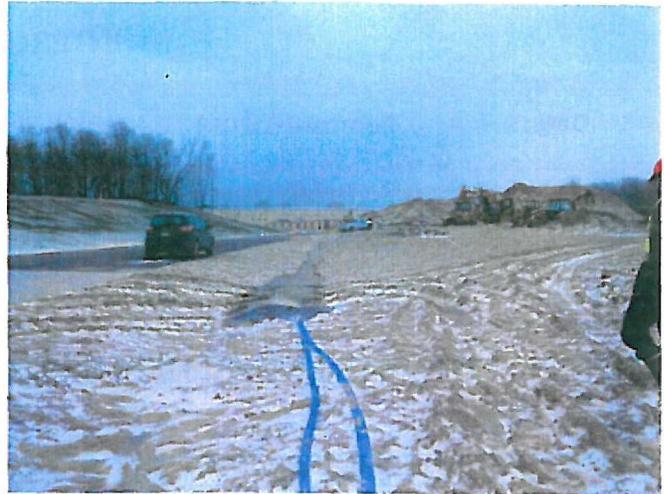
East Basin is being dewatered into Edge Dr swale

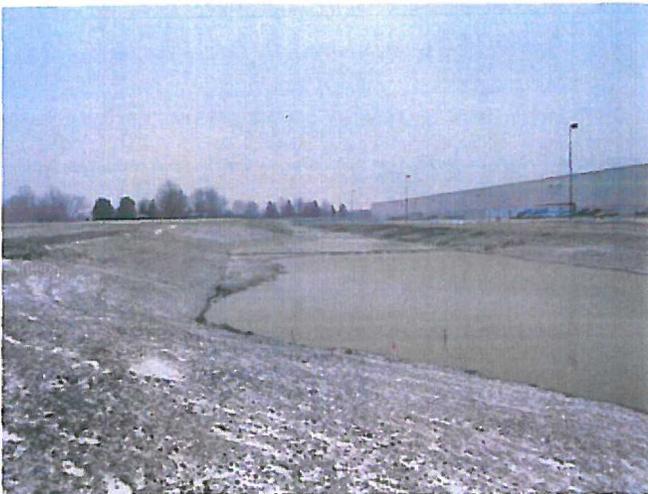
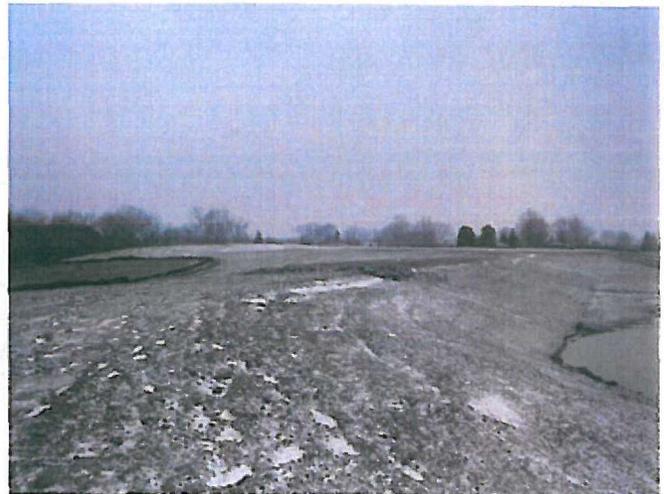
- The West Basin and areas around it were regraded in conjunction with the construction of the clay liner. Temporary or permanent stabilization of these areas has not been initiated in the timeframes required by the NPDES permit. Stabilization must be initiated within 7 days of last disturbance or final grade. Stabilization has also not been initiated on Lot 2 and in the soil stockpile area. These areas must be stabilized.

Areas recently disturbed must be stabilized, especially around the West Basin and the regraded area(s)

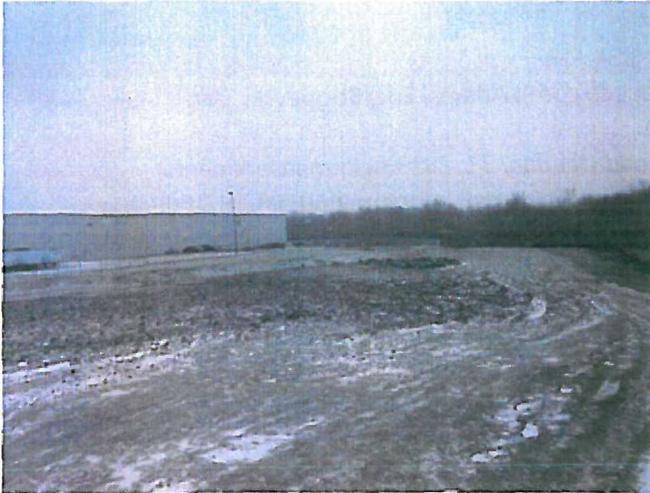
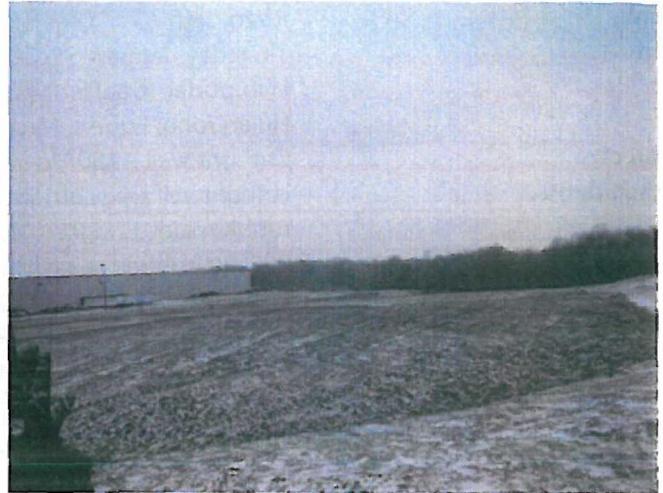
- Other areas of the site disturbed by construction have been seeded, hydromulched and/or matted. However, vegetation has not yet established to a growth density of 70% or greater over much of the site. Areas where only seed and/or hydromulch were used were not mulched with straw before the onset of winter weather to ensure cover over the winter season. These areas still need to be (a) dormant seeded or (b) temporarily stabilized with straw mulch and then permanently stabilized in spring 2013.

Areas recently graded on the west side of the site must be stabilized

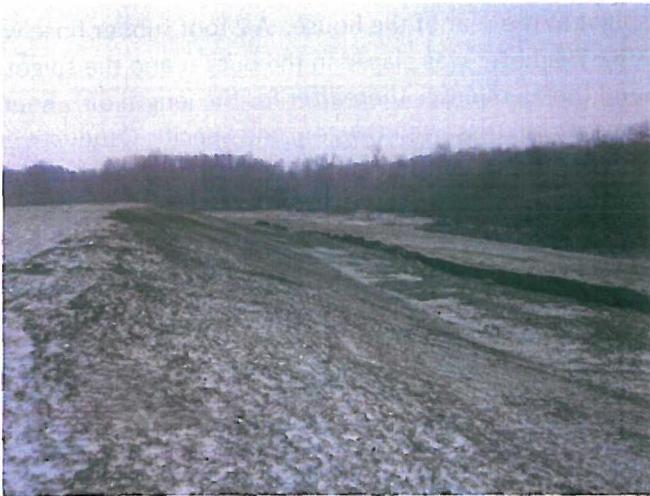
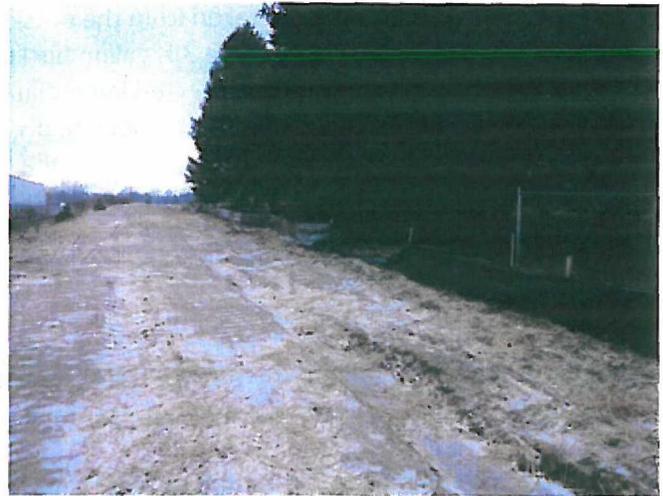
- Silt fence has not been installed in a functional manner or has not been maintained. All sediment controls, including silt fence, must be capable of ponding runoff in order to settle sediment. Silt fence must be trenched or backfilled and the joint stakes of the silt fence must be connected by twisting the stakes together prior to staking them into the ground. Please repair silt fence, particularly along the west and north sides of the site so that it is functional. Silt fence must remain in place until the upslope contributing drainage area has reached final stabilization, i.e., a vegetative growth density of 70% or greater has been achieved (spring of 2013).

Silt fence must be repaired and disturbed areas must be stabilized
