December 28, 2012

RE: SUM-SEIBERLING PHS 2
3GC05686*AG
STORMWATER
SUMMIT COUNTY

On December 19, 2012, this writer inspected the above referenced construction site for the purpose of determining compliance with General Construction National Pollutant Discharge Elimination System (NPDES) Permit No. 3GC05686*AG. Below is a summary of my observations:

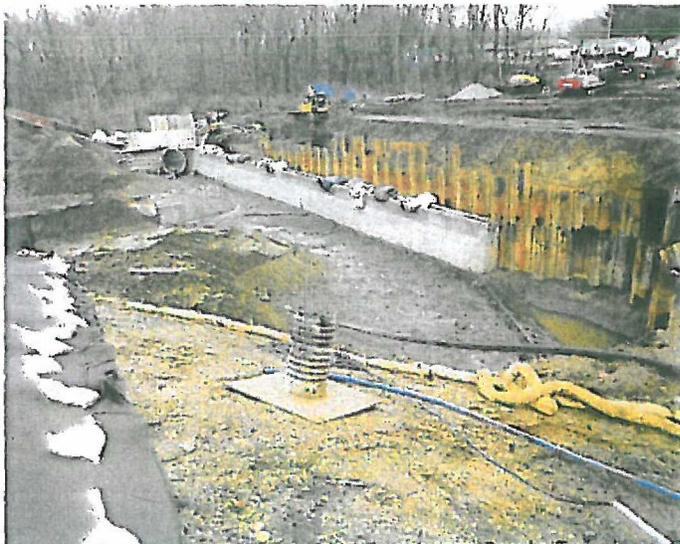
- 1) A review of the most current Storm Water Pollution Prevention Plan (SWPPP) in the construction trailer was done. The most current SWPPP did not contain any updates that reflect the changes that have been made to the handling of storm water on the east side of the site. As noted in previous site inspection letters, Detention Area 1 was not present. On this day, any storm water generated would collect behind the concrete pier as depicted in the following picture:

Concrete Pier on east side of site, isolating Haley's Ditch.

Reportedly during small storm events, the collected water infiltrates west to east under the concrete pier due the sandy soils and the rock base of the pier. Accumulated water it is then pumped directly to Haley's Ditch on the downstream side of the work area. During extended heavy rainfall this system can be overwhelmed backing up on the west side of the pier where it is then pumped directly to Haley's Ditch. This water is not receiving any treatment as it is not being pumped to the berm and subsequently to Detention Area 2, Detention Area 3 and finally to the storm water detention basin on the west side of the site. This BMP system is required by your currently approved SWPPP. As stated in this writers previous letters, **failure to implement sediment controls in compliance with the SWPPP is violation of Part III.G.2.d of NPDES Permit 3GC05686*AG and Ohio Revised Code (ORC) 6111.04 and 6111.07.**

Alterations or modifications to the BMP system must be formally documented by amending the SWPPP drawings and any associated verbiage. Please be advised that any changes to the SWPPP erosion and sediment controls for the site must be designed in accordance with Part III.G.2.d of the General Permit. The current practice does not appear to meet the aforementioned specifications. Should the specifications be met with the current practice it is still not acceptable as the discharge has been observed by this writer to discharge turbid waters that discolor the downstream waters of the state. **This is a violation of the general water quality criteria specified in Ohio Administrative Code 3745-1-04.**

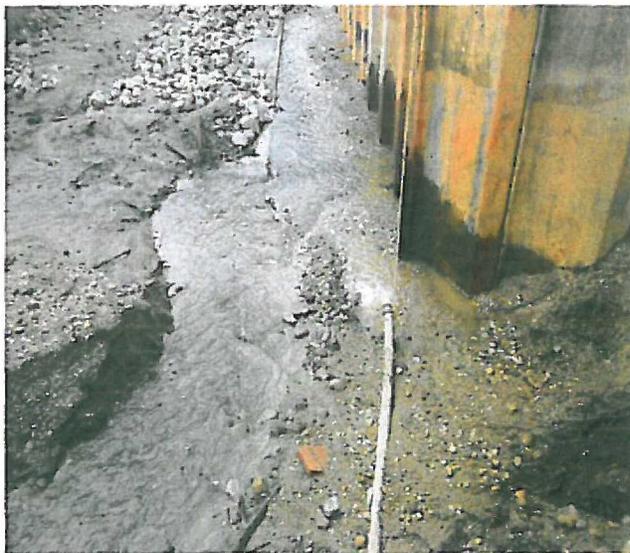
Redirected Haley's Ditch water east of concrete pier and west of sheet piling. South side.

Also seen in the above photo is the discharge end of a hose pumping water from the adjacent excavation east of the sheet piling. The water was visually turbid. **This dewatering practice is a violation of Part III.G.2.g.iv of the NPDES Permit 3GC05686*AG and ORC 6111.04 and 6111.07.**

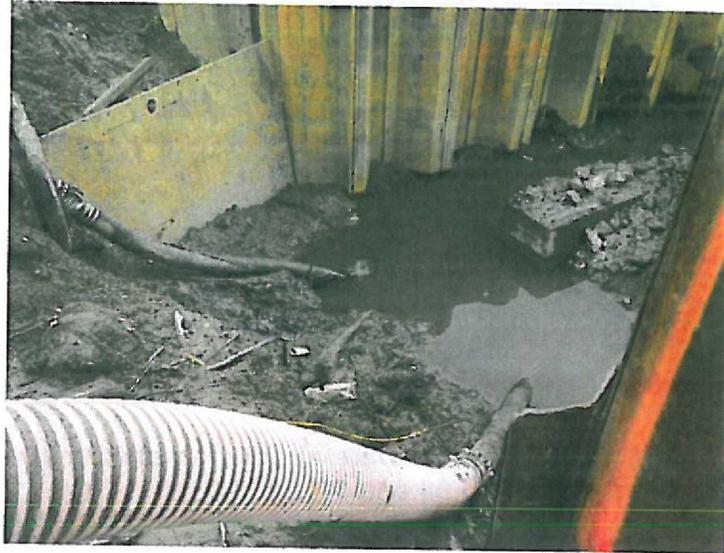
- 3) The excavation area east of the redirected Haley's Ditch was also being pumped at the time of the inspection. The water is allowed to travel thru the work area where it is being pumped from the north end and into Haley's Ditch downstream of the site. At the time of the inspection, the pump inlets were located at the bottom of the excavation. No well point/filter was being used on the north end.

North end of redirected Haley's Ditch

The above listed and depicted practices are a violation of Part III.G.2.g.iv of the NPDES Permit 3GC05686*AG and ORC 6111.04 and 6111.07.

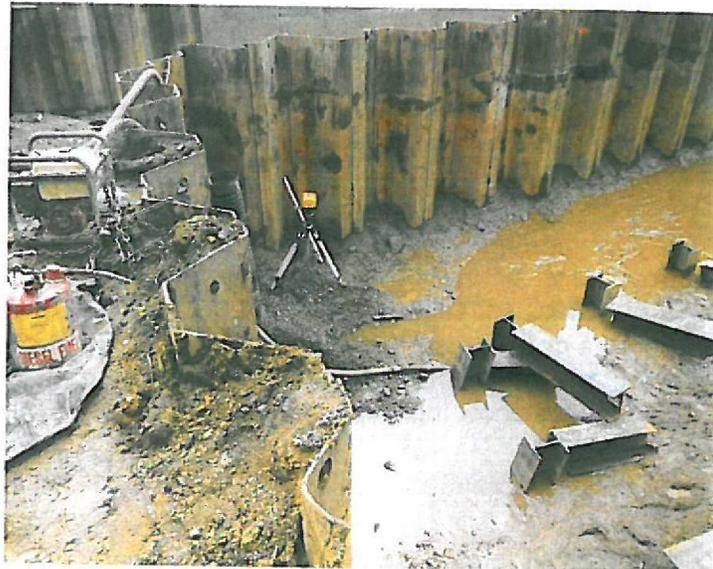
South end of area east of the redirected Haley's Ditch

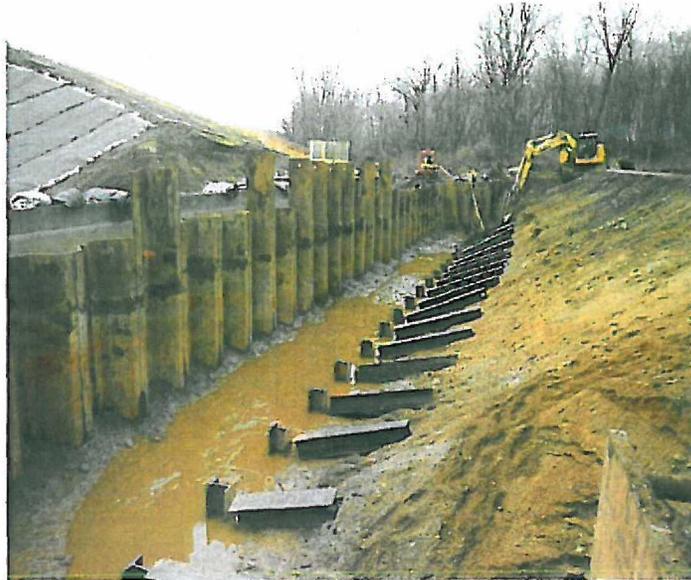
Area east of the redirected Haley's Ditch.
Note extremely turbid water.

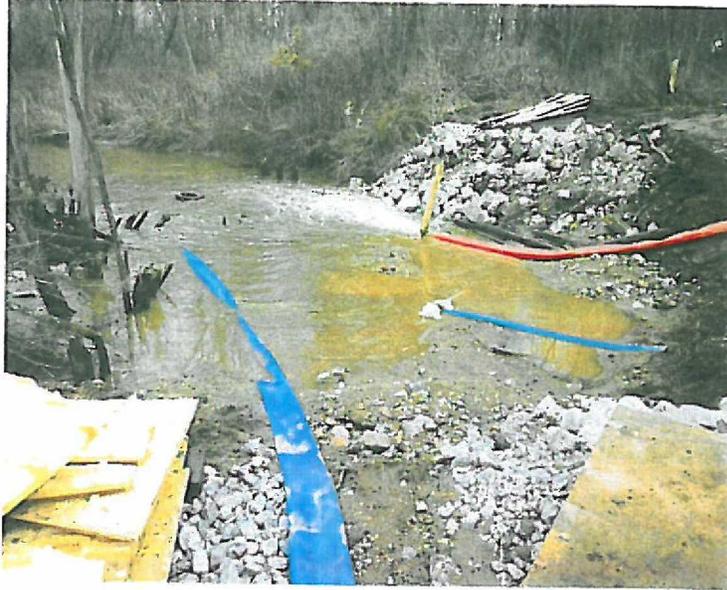
- 4) Haley's Ditch is being discolored downstream of the site by the water being pumped between the above excavations. While well points and gravel filtration have been observed in past inspections they were not being used at the time of this inspection. Additionally, it has been common practice to lay the inlet hose at the bottom of the excavations where solids are then pumped to Haley's Ditch. This writer has previously discussed this with site personnel and recommended that the intake be at least floated just below the surface of the water. Do not assume that the aforementioned recommendations as an approval of how storm water is being handled. Compounding the problem is the absence of any velocity reduction methods on the discharge ends of the piping, causing scouring of Haley's Ditch. Any previously deposited sediment is being flushed downstream. **Again, the dewatering and discharge methods described above are a violation of Part III.G.2.g.iv of the NPDES Permit 3GC05686*AG and ORC 6111.04 and 6111.07. Discharging highly sediment laden water and causing a color change downstream of the discharge point is a violation of the general water quality criteria specified in Ohio Administrative Code 3745-1-04.** The following photos show this impact on Haley's Ditch and Springfield Lake Outlet.

Haley's Ditch just downstream of bridge construction area

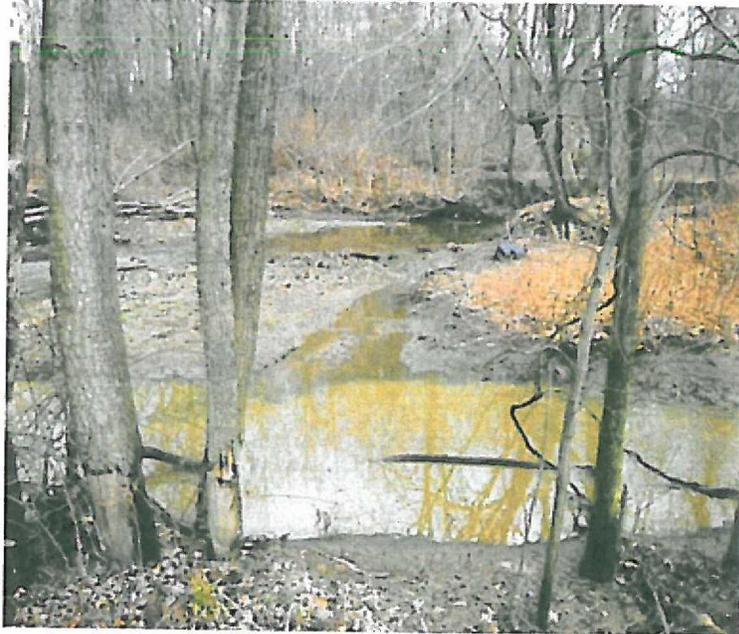
Haley's Ditch intersecting Springfield Lake Outlet

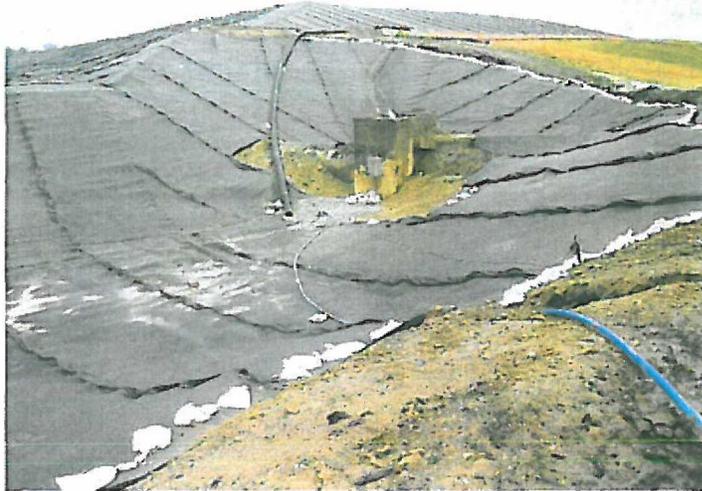
- 6) It was noted that Detention Area 3 has been reinstated since this writers November 30, 2012 inspection.

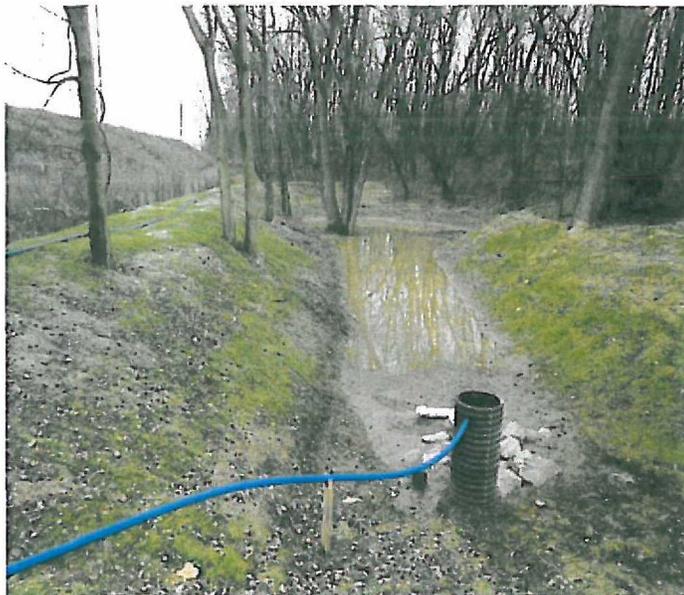
- 7) The final sedimentation basin is acting as an infiltration basin. The pump has been removed from the dewatering standpipe as there has been no need to pump any collected water. Reportedly, the basin water level has never risen high enough to flow into the standpipe due to infiltration into sandy soils below the basin.
