April 19, 2013

RE: HOLMES COUNTY  
HOLMES CO AIRPORT RUNWAY 9-27  
RELOCATION & EXTENSION  
NPDES PERMIT NO. OHC000003  
OHIO EPA PERMIT NO. 3GC06131\*AG  
CONSTRUCTION STORM WATER

**NOTICE OF VIOLATION**

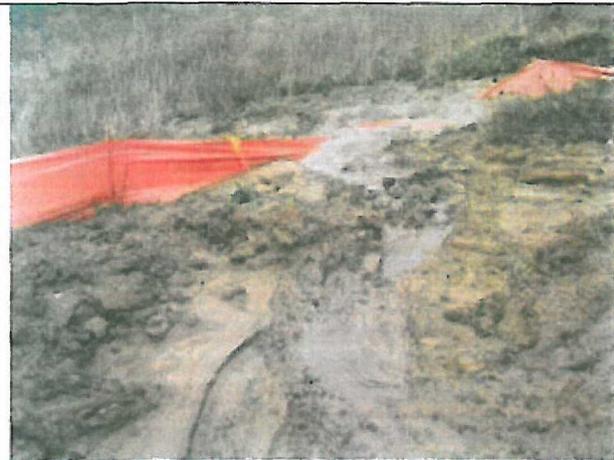
- The majority of the site had failing best management practices (BMP) that were allowing sediment-laden storm water runoff to discharge directly into "waters of the State." The erosion gullies present throughout the site indicate that the BMPs (i.e. silt fence) have been failing for an extended period of time. At a minimum, sediment traps and diversion channels must be installed within the following locations:
  - a. West of the construction entrance and north of County Road 292 as concentrated storm water runoff had caused the silt fence to fail (Figure 1);
  - b. South of "Proposed Runway 9-27" at approximately Station 23+00 as silt fence was not properly installed and concentrated storm water runoff was discharging directly into a culvert to "waters of the State" (Figures 2 to 3);

**Figure 1** – Concentrated runoff was causing silt fence to fail.

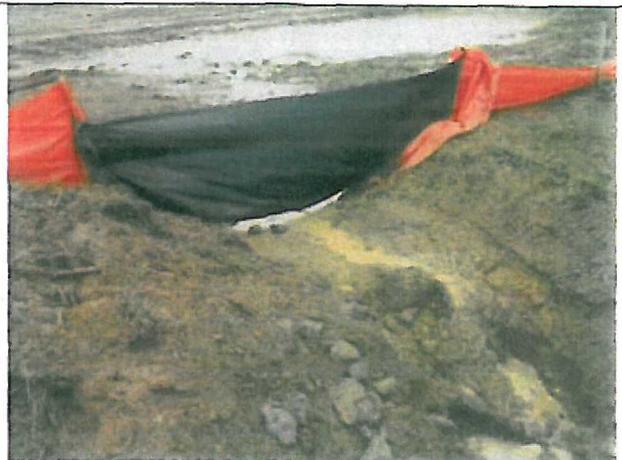
**Figure 2** – Silt fence was not properly installed and concentrated storm water runoff is discharging into a culvert.

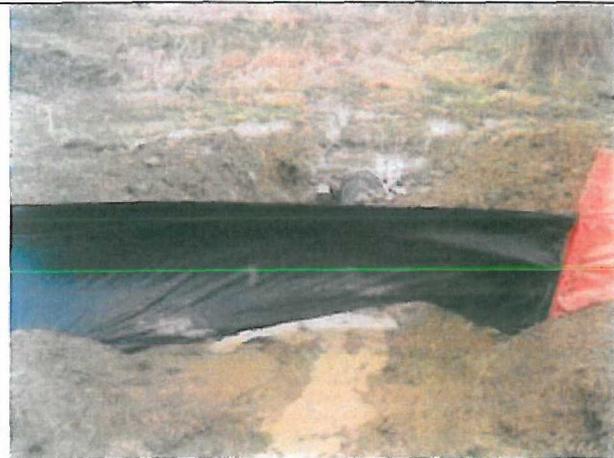
**Figure 3** – Silt fence was not properly installed and concentrated storm water runoff is discharging into a culvert.

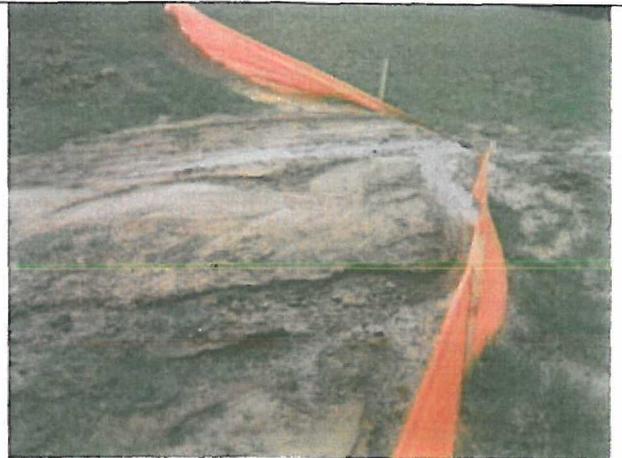
- c. South of "Proposed Runway 9-27" at approximately Station 20+00 as concentrated storm water runoff had caused the silt fence to fail (Figure 4);
- d. Southwest of the culvert located at approximately Station 26+00 as concentrated storm water runoff had caused silt fence to fail (Figure 5). Sediment was observed discharging to "waters of the State" and had caused a significant amount of sediment to be deposited within the unnamed tributary of Newton's Run (Figures 6 to 8);

**Figure 4** – Concentrated storm water runoff has caused the installed silt fence to fail.

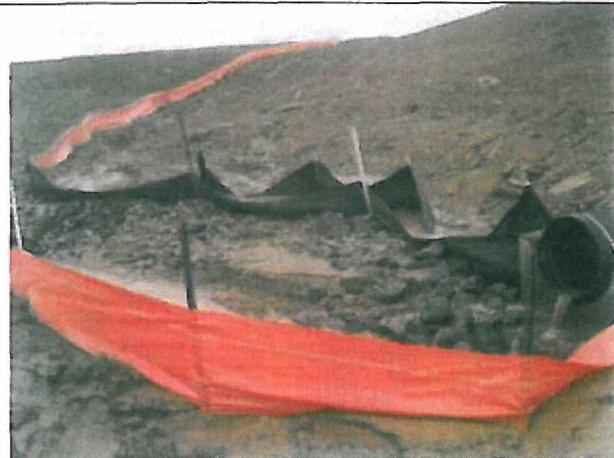
**Figure 5** – Concentrated storm water runoff had caused the installed silt fence to fail.

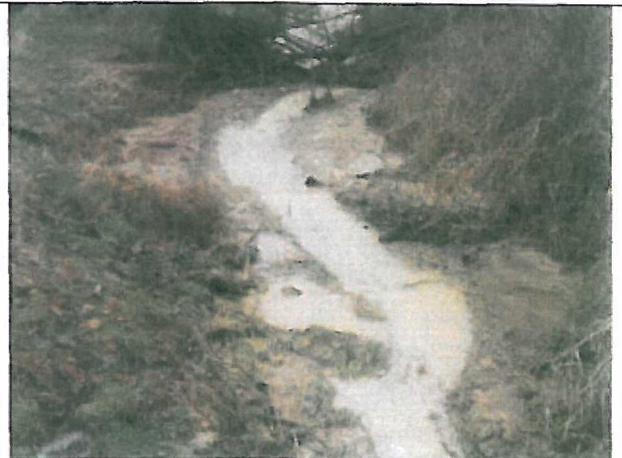
**Figure 6** – Sediment was observed discharging to “waters of the State” and had caused significant amounts of sediment to be deposited.

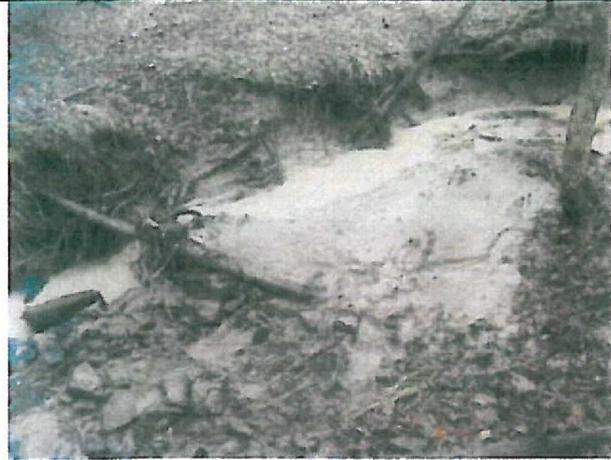
**Figure 7** – Sediment was observed discharging to “waters of the State” and had caused significant amounts of sediment to be deposited.

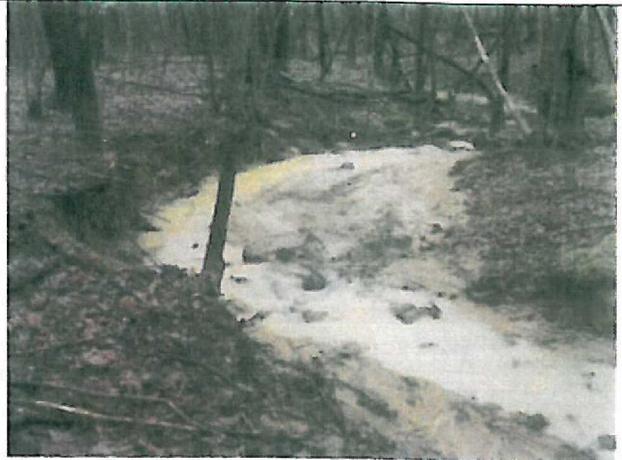
**Figure 8** – Sediment was observed discharging to “waters of the State” and had caused significant amounts of sediment to be deposited.

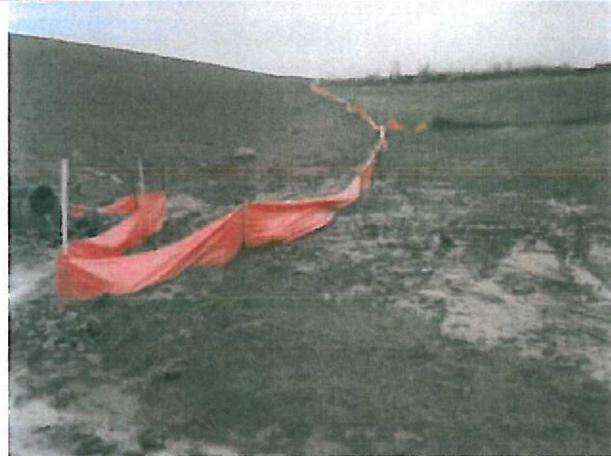
- e. Southeast of the culvert located at approximately Station 26+00 as concentrated storm water runoff had caused silt fence to fail (Figure 9). Sediment was observed discharging to "waters of the State" and had caused a significant amount of sediment to be deposited within the unnamed tributary of Newton's Run (Figures 6 to 8);

**Figure 9** – Concentrated storm water runoff had caused installed silt fence to fail.

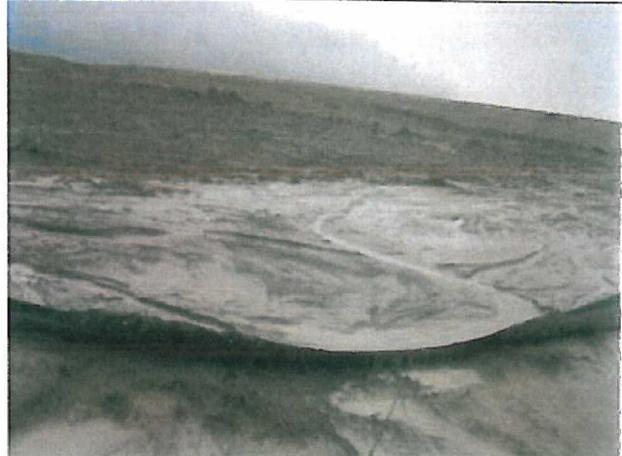
- f. South of "Proposed Runway 9-27" at approximately Station 35+00 as concentrated storm water runoff had caused silt fence to fail (Figure 10). Sediment was observed discharging to "waters of the State" (Figure 11).

**Figure 10** – Concentrated storm water runoff had caused installed silt fence to fail.

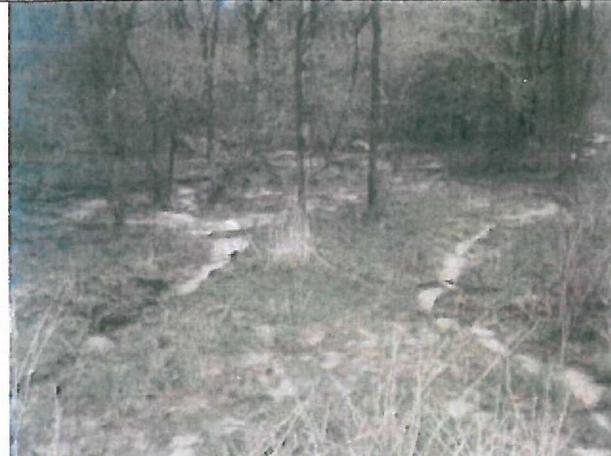
**Figure 11** – Sediment was observed discharging to “waters of the State”

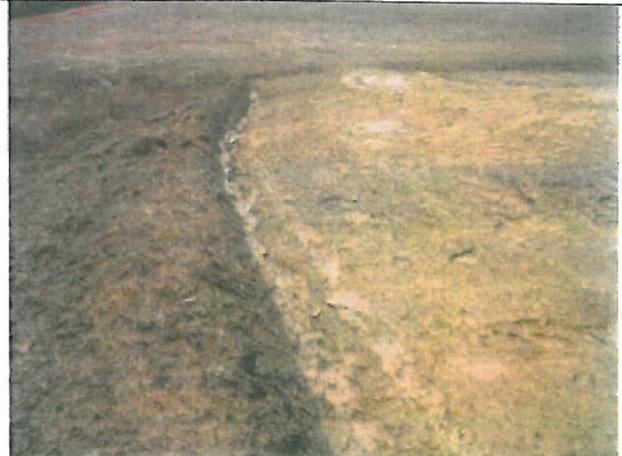
- g. A diversion berm (Figure 12) has been constructed south of the "Proposed Runway 9-27" at approximately Station 41+00 that directs runoff south to silt fence that has failed (Figure 13). Concentrated storm water runoff was discharging sediment to "waters of the State."

**Figure 12** – A diversion berm has been constructed that directs runoff to failing silt fence.

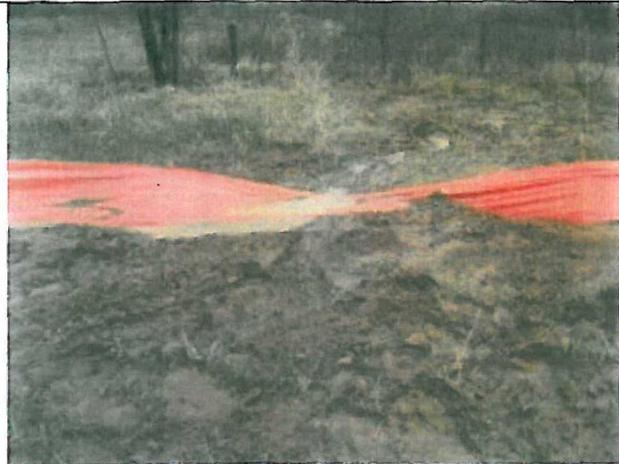
**Figure 13** – A diversion berm has been constructed that directs runoff to failing silt fence.

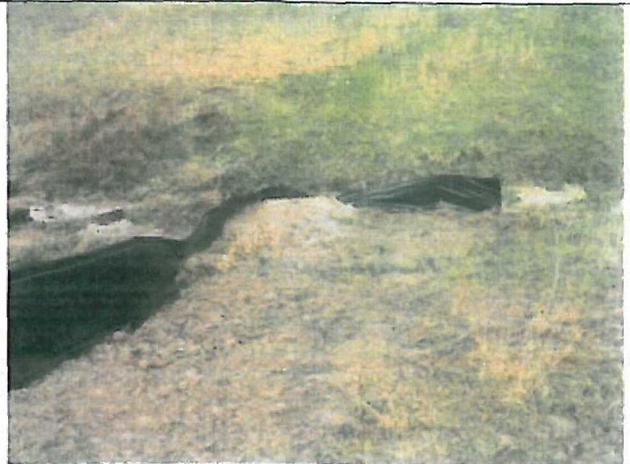
- h. The southwestern portion of the "Borrow Area" as concentrated storm water runoff has caused silt fence to fail (Figure 14). Sediment was discharging to "waters of the State" (Figure 15).

**Figure 14** – Concentrated storm water runoff has caused installed silt fence to fail. Sediment was discharged to "waters of the State."

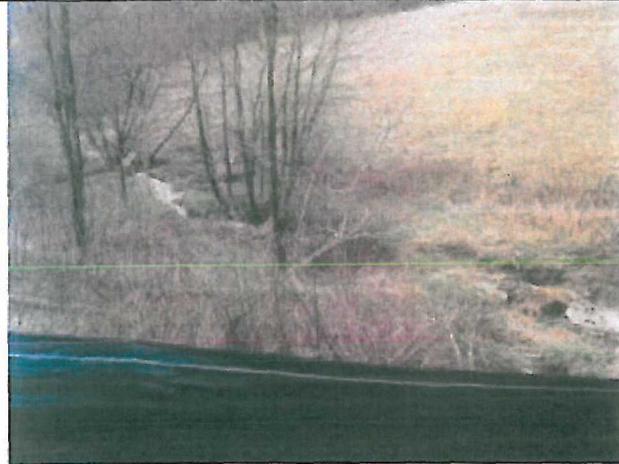
**Figure 15** – Sediment was discharged to "waters of the State."

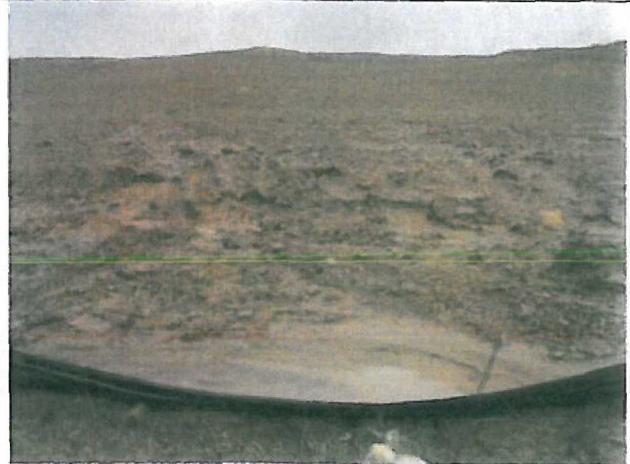
- i. The southeastern portion of the "Borrow Area" as concentrated storm water runoff has caused silt fence to fail (Figure 16). Sediment was discharging to "waters of the State" (Figure 17).

**Figure 16** – Concentrated storm water runoff has caused installed silt fence to fail. Sediment was discharged to "waters of the State."

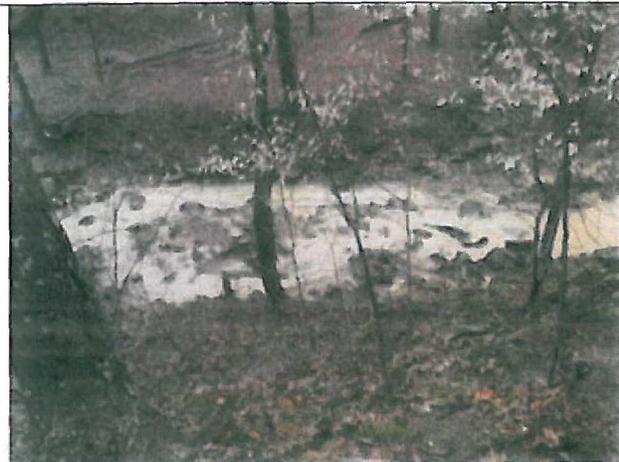
**Figure 17** – Sediment was discharged to "waters of the State."

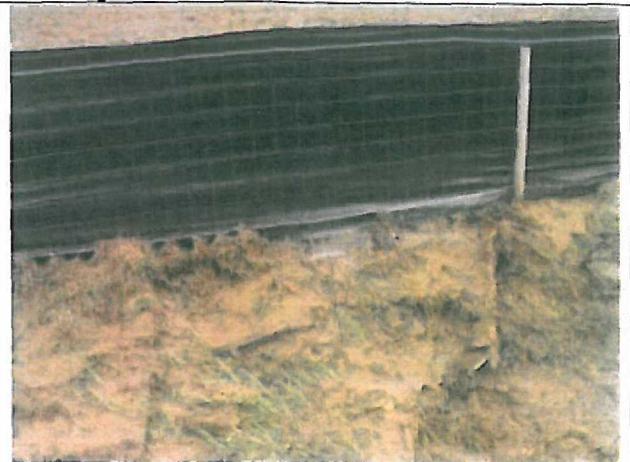
- j. South of "Proposed Runway 9-27" at approximately Station 56+00 as concentrated storm water runoff has caused installed silt fence to fail (Figure 18). Sediment was discharging to "waters of the State" (Figure 19).

**Figure 18** – Concentrated storm water runoff has caused installed silt fence to fail.

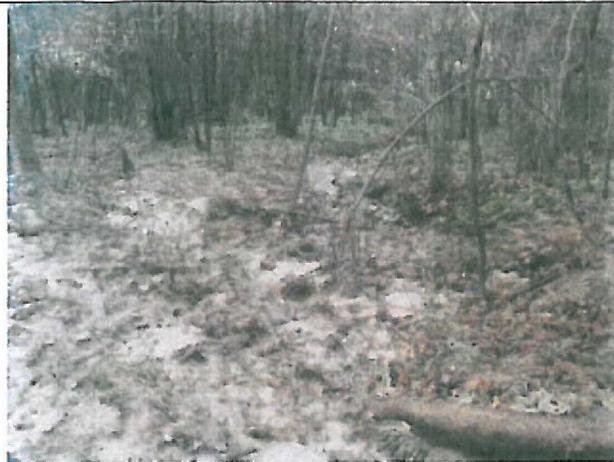
**Figure 19** – Sediment was observed discharging to “waters of the State.”

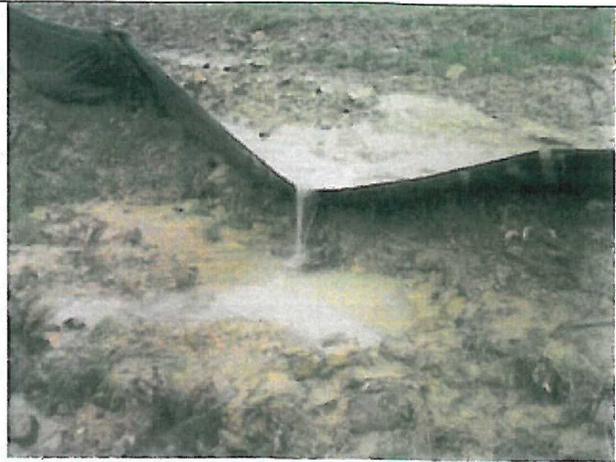
- k. South of "Proposed Runway 9-27" at approximately Station 59+00 as concentrated storm water runoff has caused installed silt fence to fail (Figure 20). Sediment was discharging to "waters of the State" (Figure 21).

**Figure 20** – Concentrated storm water runoff has caused installed silt fence to fail.

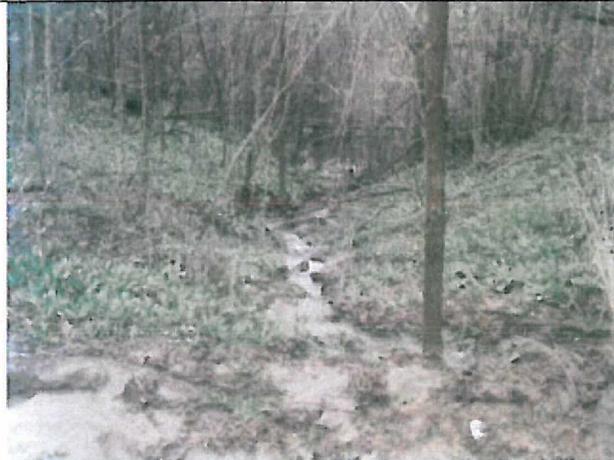
**Figure 21** – Sediment was observed discharging to “waters of the State.”

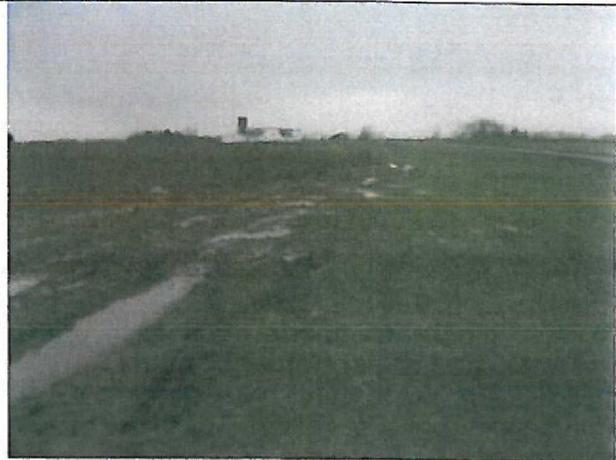
- Portions of the site do not have any BMPs installed to prevent the discharge of sediment-laden runoff to "waters of the state." These areas include:
  - i. The western portion of site north of the "Proposed Runway 9-27" (Figure 22).
  - ii. The borrow area located south of "Proposed Runway 9-27" at approximately Station 36+00 (Figure 23). Concentrated storm water runoff was discharging sediment to "waters of the State" (Figure 24).
  - iii. A diversion berm has been constructed southeast of "Proposed Runway 9-27" at approximately Station 61+00 (Figure 25). Concentrated storm water was discharging sediment to "waters of the State" (Figure 26).

**Figure 22** – The western portion of site north of the “Proposed Runway 9-27” had no BMPs installed.

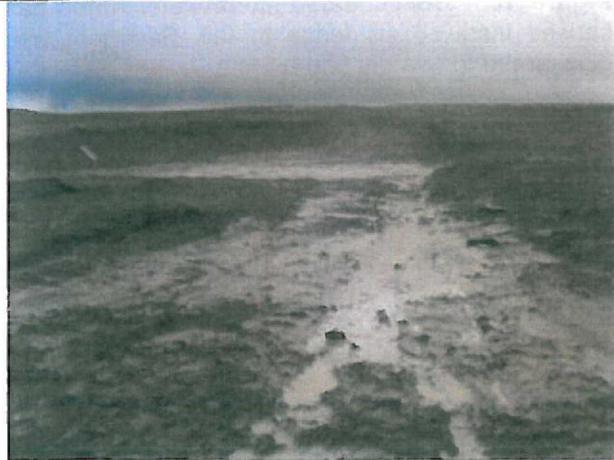
**Figure 23** – The borrow area located south of “Proposed Runway 9-27” had no BMPs installed.

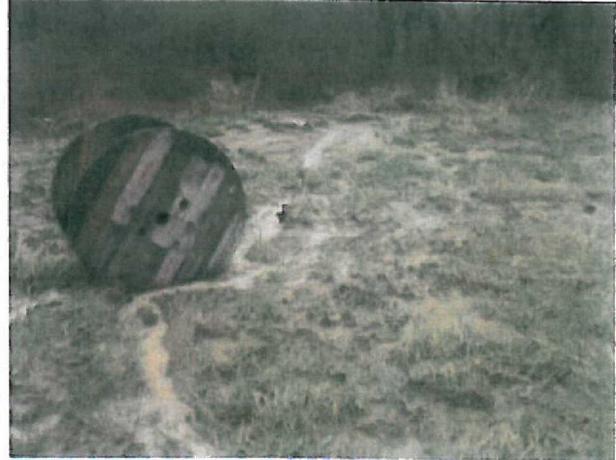
**Figure 24** – Concentrated storm water runoff was discharging sediment to “waters of the State.”

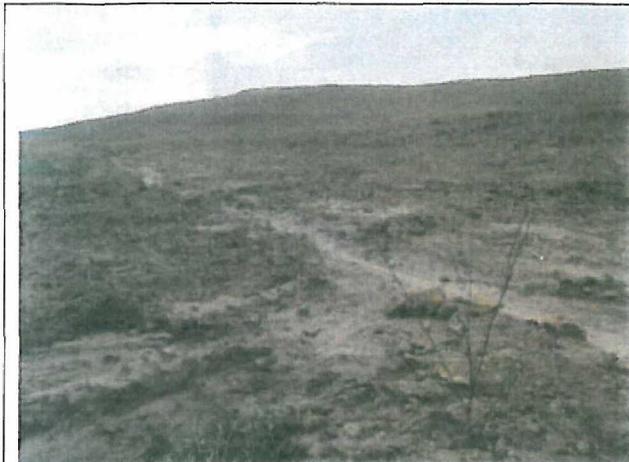
**Figure 25** – A diversion berm has been constructed southeast of “Proposed Runway 9-27” with no BMPs installed.

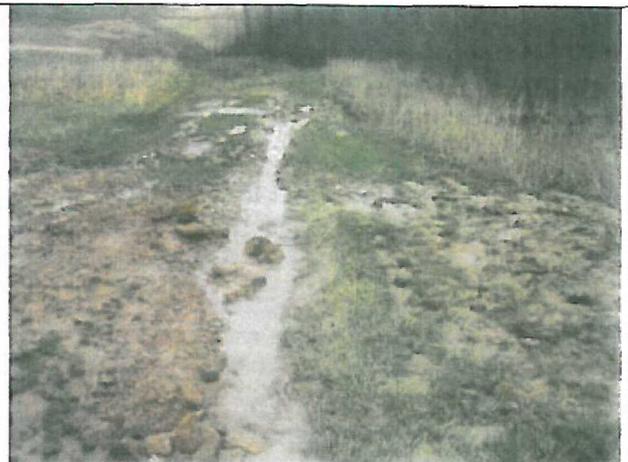
**Figure 26** – Concentrated storm water was discharging to “waters of the State.”

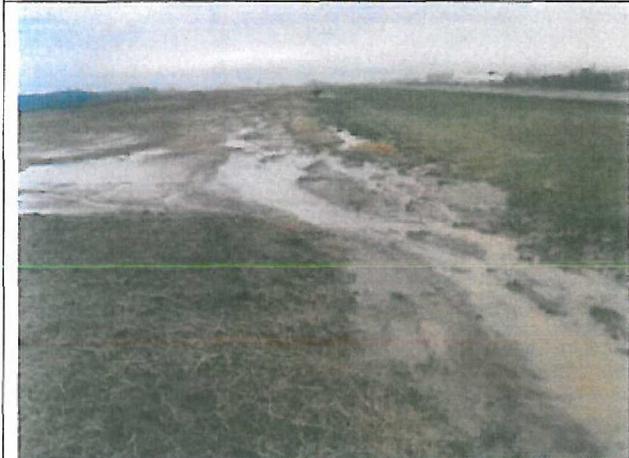
- iv. North of the "Proposed Runway 9-27" at approximately Station 64+00 (Figure 27). Concentrated storm water runoff was discharging sediment to "waters of the State" (Figure 28).

**Figure 27** – North of the “Proposed Runway 9-27” no BMPs were installed.

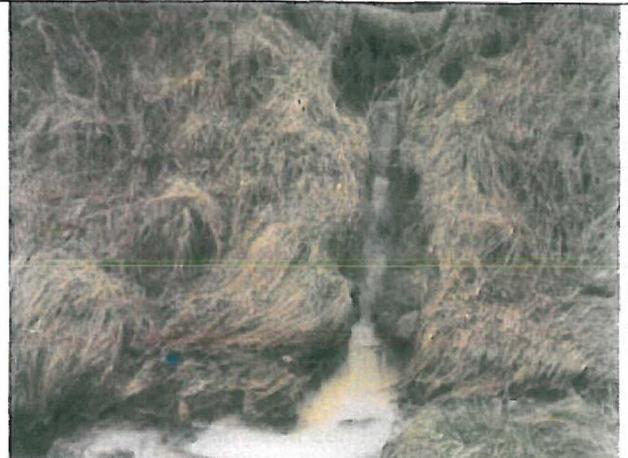
**Figure 28** – Concentrated storm water runoff was discharging sediment to “waters of the State.”

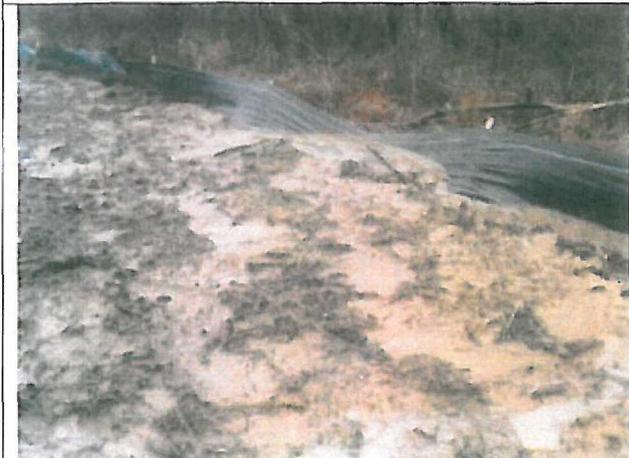
- Silt fence was failing throughout the site and requires maintenance to be performed, at a minimum, in the following locations:
  - a. West of the "Potential Additional Borrow Area 1" (Figure 29).

**Figure 29** – Failing silt fence was located west of the “Potential Additional Borrow Area 1.”

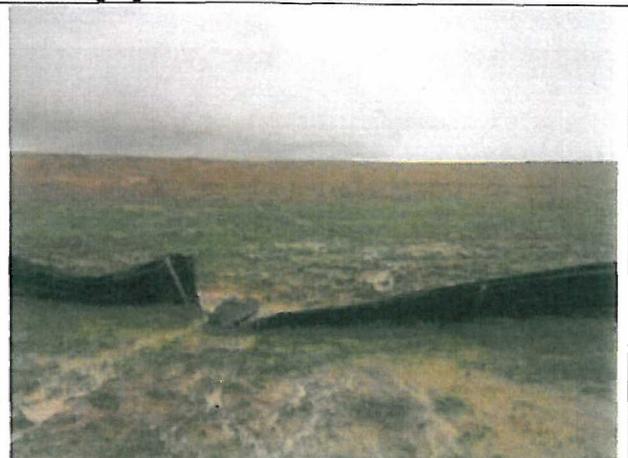
- b. South of the "Proposed Runway 9-27" at approximately Station 39+00 (Figure 30).
  - c. West of the "Abandoned Township Road 307" (Figure 31).
  - d. South of the "Proposed Runway 9-27" at approximately Station 42+00;

**Figure 30** – Failing silt fence was located south of the “Proposed Runway 9-27.”

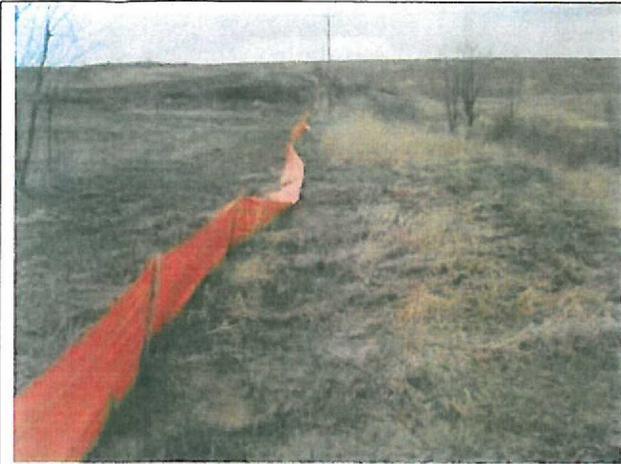
**Figure 31** – Failing silt fence was located west of the “Abandoned Township Road 307.”

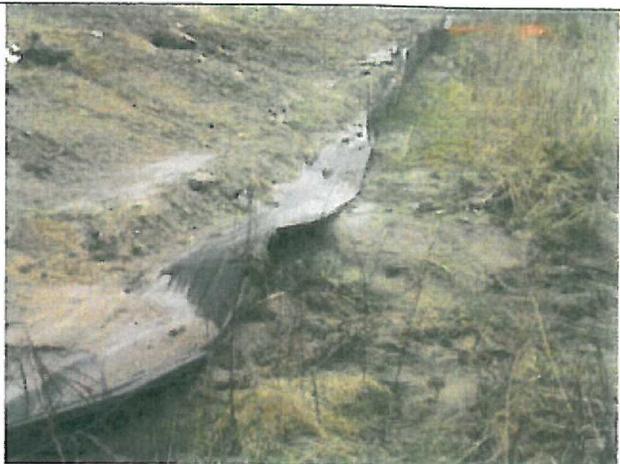
- e. South of the "Proposed Runway 9-27" at approximately Station 44+00 (Figure 32). Sediment has been discharged into the wetland" (Figure 33); and
  - f. The western boundary of the "Borrow Area."

**Figure 32** – Failing silt fence was located south of the “Proposed Runway 9-27.”

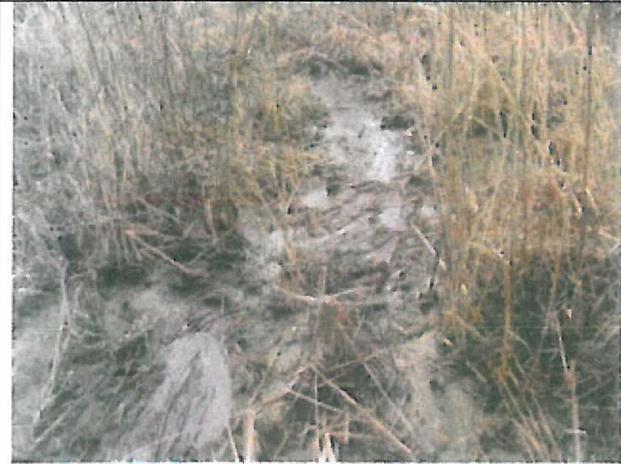
**Figure 33** – Sediment has been discharged into the wetland.”

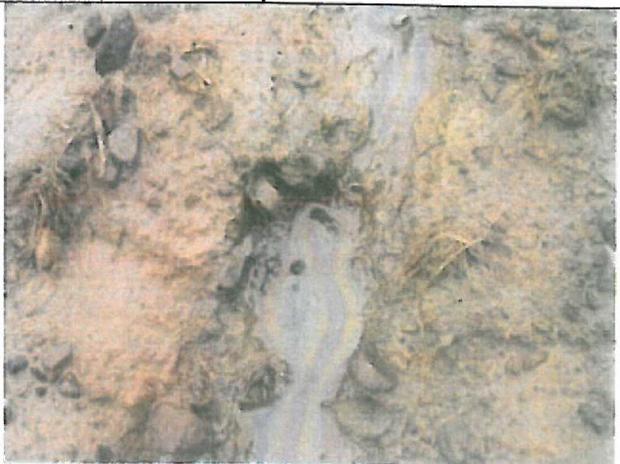
- Oil was leaking from Grader No. 1116 that was being discharged to "waters of the State" (Figure 34). Appropriate BMPs (i.e. maintenance and drip pans) must be implemented to prevent the discharge of oil to "waters of the State." **The discharge of oil to "waters of the State" constitutes violations of ORC 6111.07, OAC 3745-1-04, and Part III.G.2.g of the General Storm Water Permit.**

**Figure 34** – Oil was leaking from Grader No. 1116 that was being discharged to “waters of the State.”
