May 8, 2013

RE: THE DIAMOND LODGE  
PERMIT NO. 3PR00505\*AD  
PORTAGE COUNTY  
EDINBURG TOWNSHIP

On April 29, 2013, an inspection of the above referenced facility's wastewater treatment system was conducted. A representative of the facility was not present during the inspection. The purpose of the inspection was to evaluate the operation and maintenance of the treatment system along with the facility's compliance status with respect to the terms and conditions of the above referenced National Pollutant Discharge Elimination System (NPDES) permit.

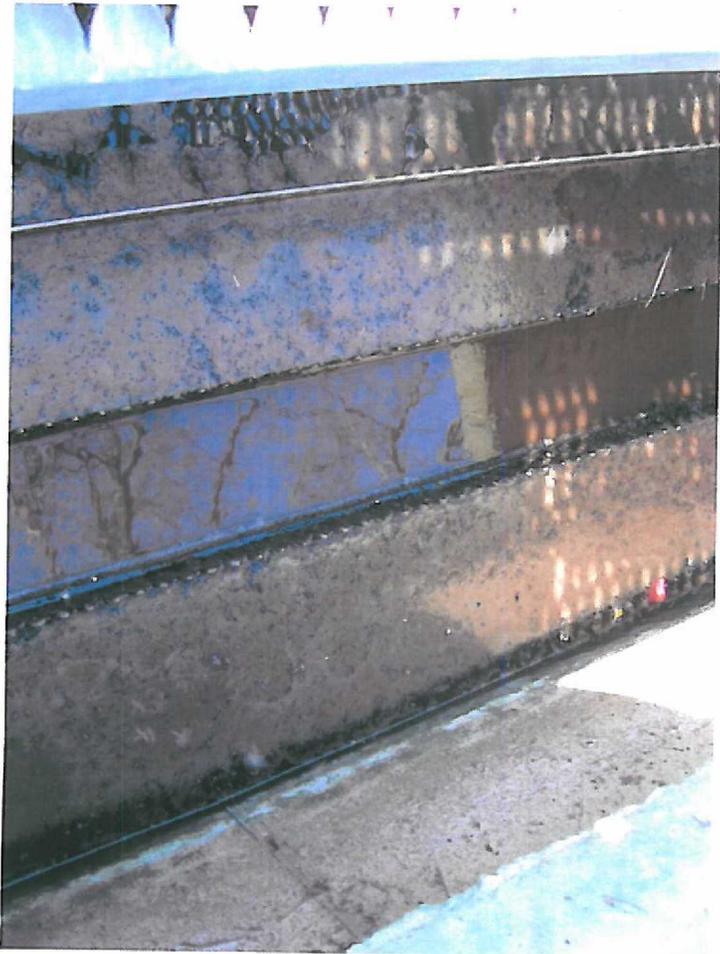
Figure 2

13. The weirs and trough in the settling tank were covered with solids deposition. See Figure 2.
14. Solids build-up was present behind the baffle in the settling tank. This material should be pumped out routinely when the trash trap is pumped. See Figure 3.

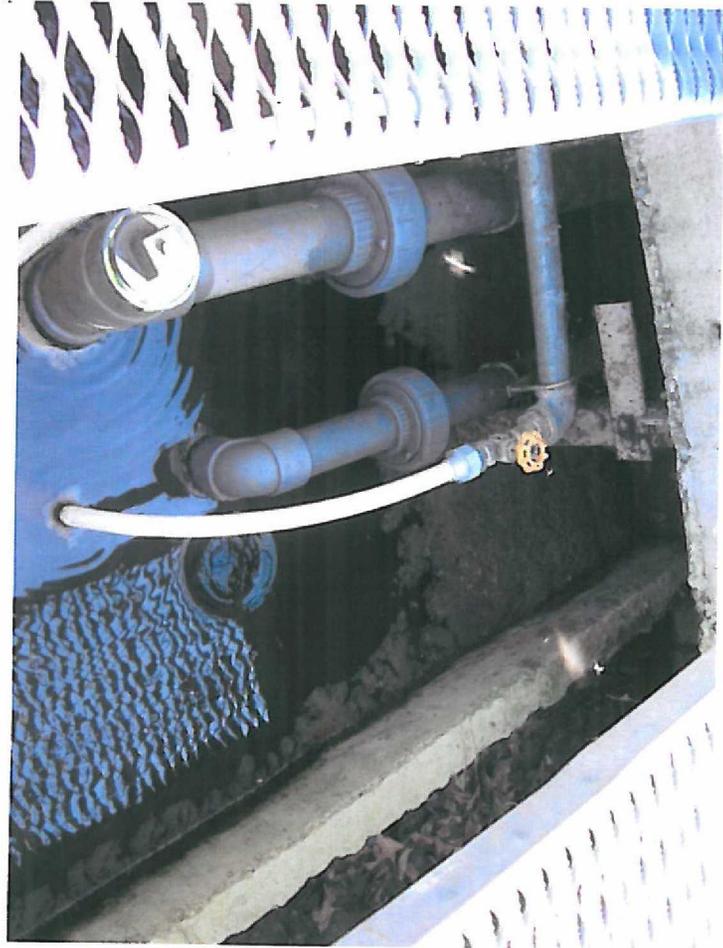
Figure 1

9. The sludge return line was functioning properly and returning medium brown water.
10. The skimmer return line was returning clear water.
11. The surface of the settling tank was covered with a significant amount of floating solids. See Figure 1.

12. The skimmer appeared to be functioning. However, it was not drawing in any solids. The top of the skimmer should be adjusted to approximately a quarter of an inch below the liquid surface when the blowers are in operation.

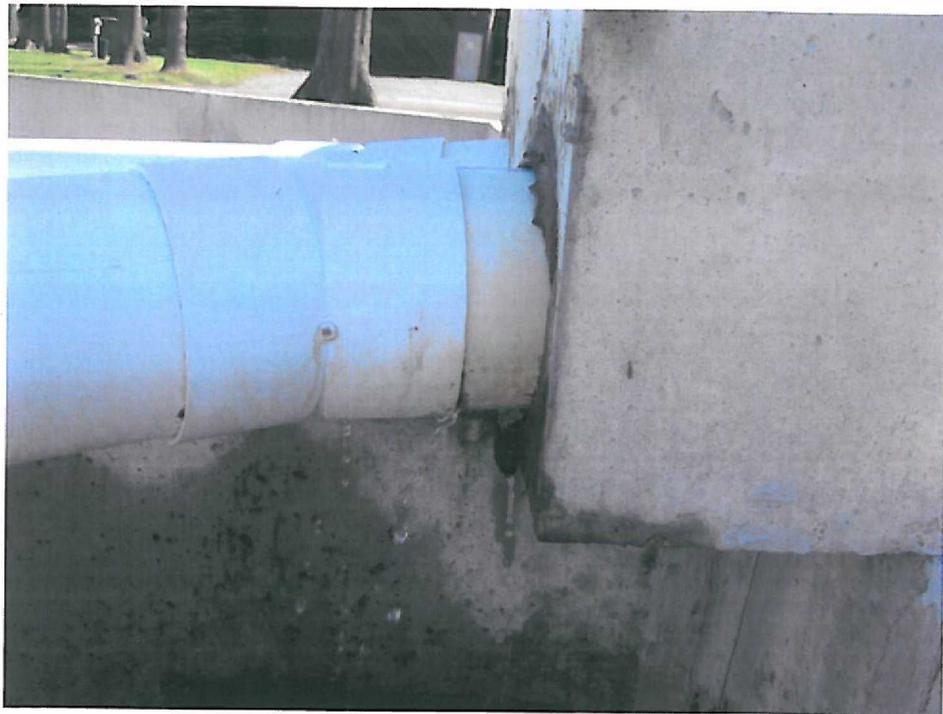
Figure 4

16. Both distribution lines on the distribution box leak. See Figure 4. Both lines should be repaired immediately.
17. The surface sand filter consisted of two cells. A minimal amount of vegetation and sludge was present in each bed. The vegetation and sludge should be removed immediately. It should be noted that both cells should be maintained free of vegetation and sludge at all times. All material removed from the cells should be properly disposed at a licensed solid waste landfill. Placing this material in the facility's dumpster is acceptable.

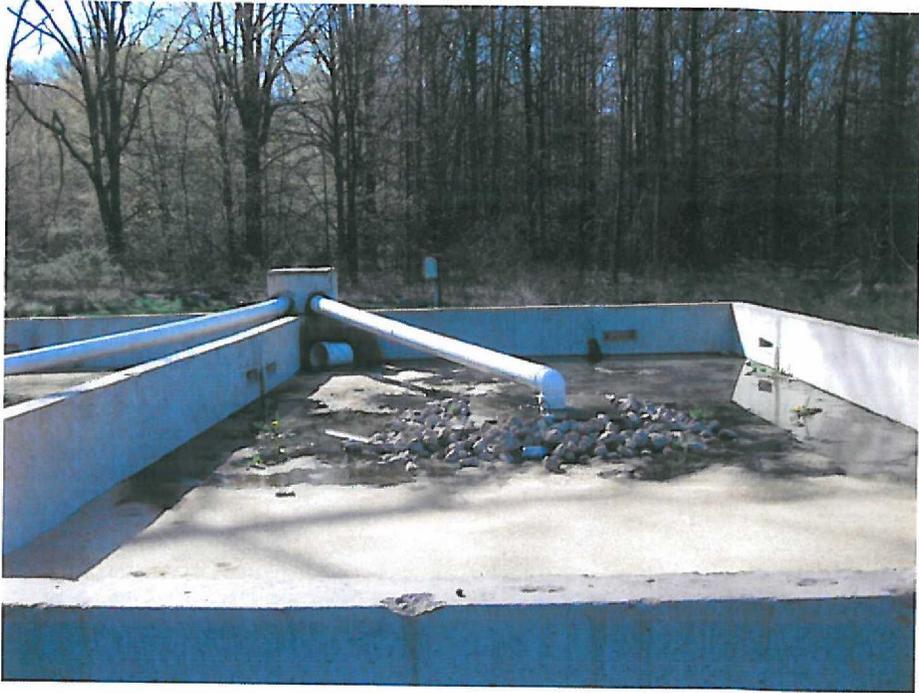
19. Currently, the west cell is being used. The west cell splash pad needs to be leveled. The effluent is not being evenly distributed across the cell. The effluent is flowing to the south side of the cell and ponding. This is the result of a layer of sludge that is present on the surface of the filter media. See Figure 5 & 6. The condition of surface sand filter cells should be addressed immediately.

18. Once the vegetation and sludge is removed in the surface sand filter beds, additional filter media may be required. In general, 18 inches of approved filter sand is necessary. Any filter sand that is used must meet the requirements of Ohio Administrative Code (OAC) 3745-42-09. More specifically, for conventional surface sand filters, filter sand shall be washed and free of silt; have an effective size of 0.4 mm to 1.0 mm; and have a uniformity coefficient less than 3.0.
