May 17, 2013

RE: FIRST ENERGY ASHTABULA POWER PLANT  
NPDES PERMIT NO. 3IB00012\*KD  
ASHTABULA TWP, ASHTABULA COUNTY  
COMPLIANCE INSPECTION EVALUATION

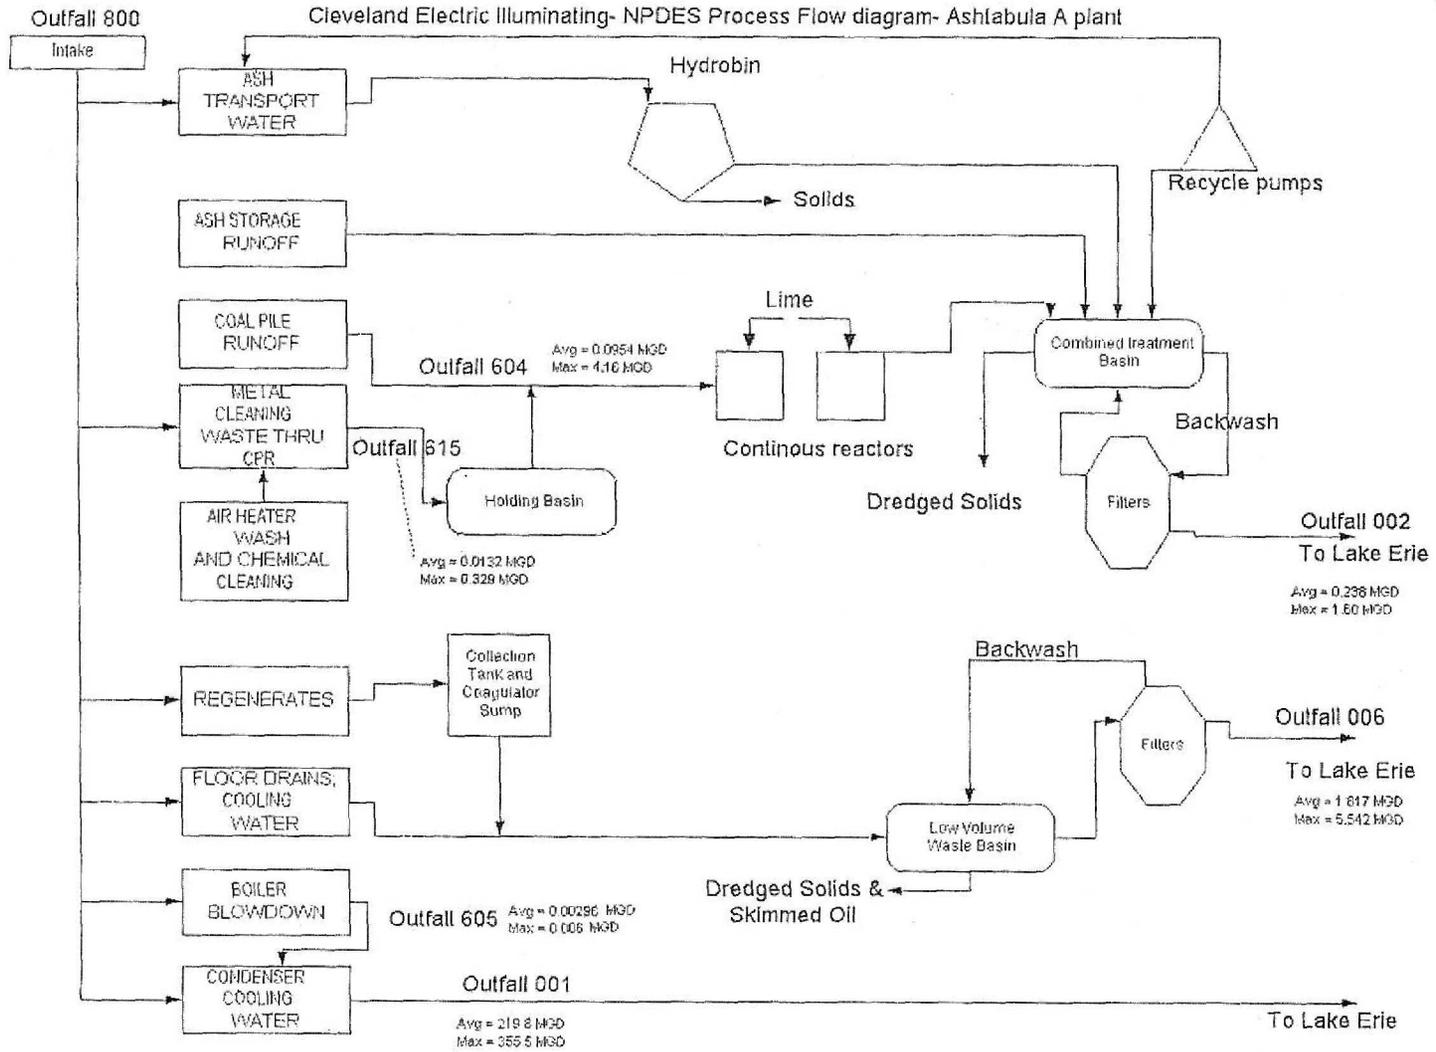
The plant currently provides only auxiliary power and is no longer used on a continual basis. No other changes to the industrial process and discharges have been noted since the last inspection. The plant is expected to continue to operate through at least 2015. The system consists of the following industrial processes and discharges (see attached figure):
