**RE: MAHONING COUNTY, ACME COMPANY, NPDES PERMIT NO. OHR000005,  
OHIO EPA PERMIT NO. 3GR01194\*EG, INDUSTRIAL STORM WATER  
INSPECTION, NOTICE OF VIOLATION**

### **Site Inspection**

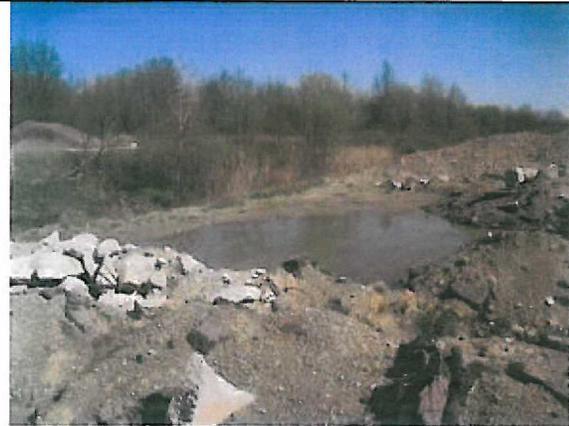
- The SWP3 details that a “permanently stabilize vegetated swale” is to be installed along the western property boundary to direct storm water runoff to a “proposed stormwater pond.” The swale has not been installed; however, a partially constructed diversion berm has been constructed. A portion of the area where materials are stockpiled discharges directly into “waters of the state” without a best management practices (BMP) installed (Figure 1). **The failure to implement appropriate BMPs to prevent the discharge of pollutants to “waters of the State” constitutes violations of ORC 6111.07 and Part 2.1 of the Multi-Sector General Permit.**

**Figure 1** - A material stockpile area discharges directly into "waters of the state".

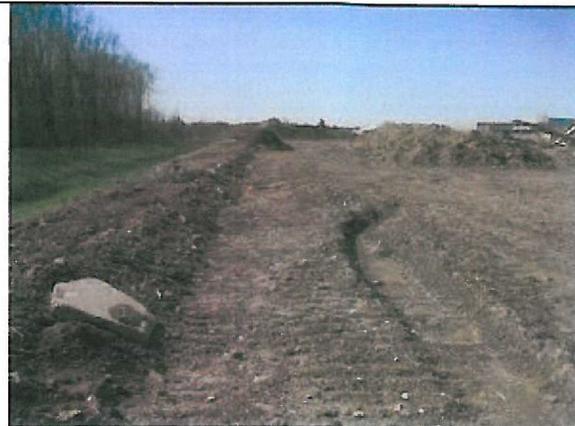
- Numerous portions of the facility appear to have remained idle and require stabilization to be performed to prevent erosion and the discharge of sediment to “waters of the State” (Figure 2). **The failure to stabilize disturbed portions of the facility constitutes violations of ORC 6111.07 and Part 2.1.2.5 of the Multi-Sector General Permit.**

**Figure 2** - Idle areas of the facility must be stabilized.

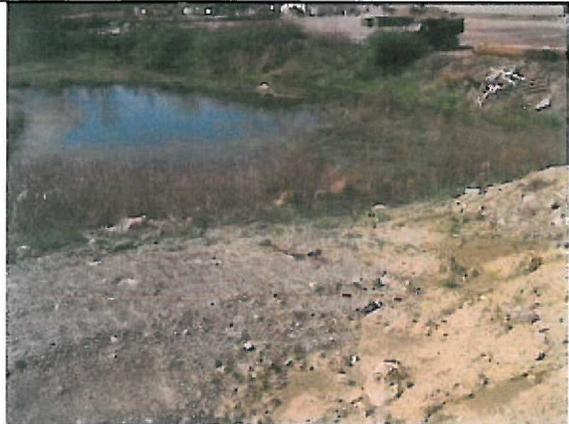
- The berm depicted to be installed within the southeastern portion of the facility to protect the “existing surface water body” has not been installed (Figure 3). Sediment laden-runoff from a soil stockpile is discharging directly into “waters of the state.” **The failure to prevent the discharge of pollutants to “waters of the state” constitutes violations of ORC 6111.07, Ohio Administrative Code Chapter (OAC) 3745-1-04, and Part 2.1.2.5 of the Multi-Sector General Permit.**

**Figure 3** - The berm depicted to be installed within the southeastern portion of the facility has not been installed.

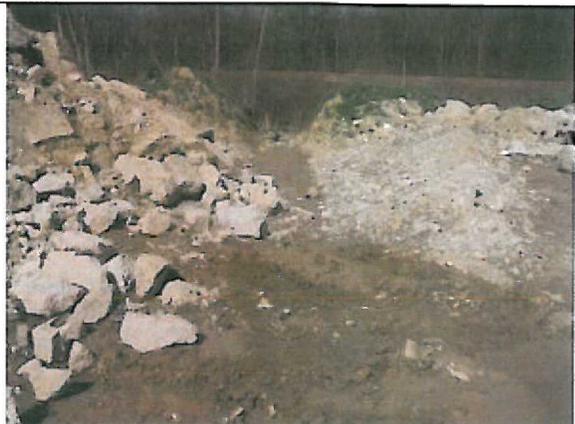
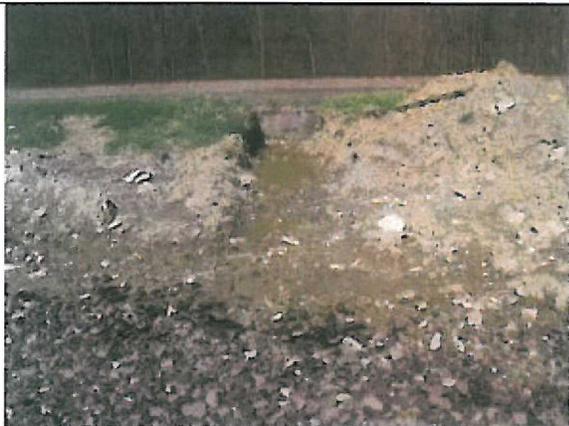
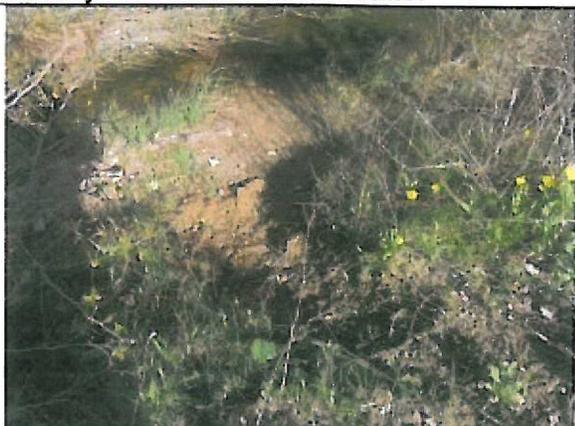
- Diversion channels have been installed through the western diversion berms to allow storm water runoff to discharge directly into “waters of the State” (Figures 4 to 6). Sediment deposition was observed within “waters of the State.” **The failure to implement appropriate BMPs to prevent the discharge of pollutants to “waters of the State” constitutes violations of ORC 6111.07 and Part 2.1 of the Multi-Sector General Permit.**

**Figure 4** - Diversion channels have been installed through the diversion berms to allow storm water runoff to discharge directly into "waters of the State."

**Figure 5** - Diversion channels have been installed through the diversion berms to allow storm water runoff to discharge directly into "waters of the State."

**Figure 6** - Diversion channels have been installed through the diversion berms to allow storm water runoff to discharge directly into "waters of the State."

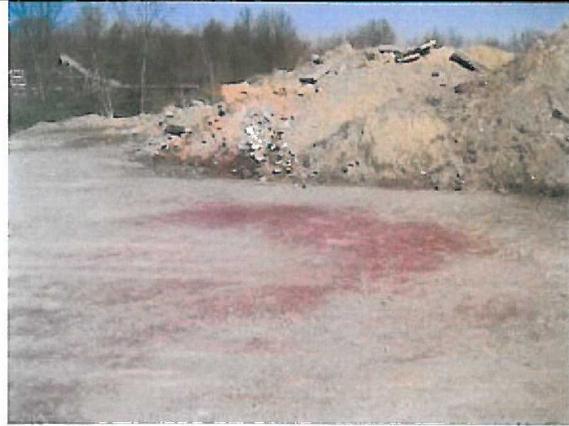
- Pink solids were observed on the ground within the area where a pink leachate was observed during Ohio EPA’s February 27, 2013 inspection (Figure 7). In addition, a pink leachate was observed in an area located southeast of the sediment pond and northeast of the crushing equipment (Figure 8). During Ohio EPA’s February 27, 2013 inspection, you previously stated that the pink leachate was from the acceptance of materials resulting from the demolition of a furnace. The pink solids and leachate must be contained, characterized, and properly disposed. In addition, Ohio EPA recommends that the stockpiled materials generating the pink leachate be covered in order to prevent the generation of the pink leachate during precipitation events.

**Figure 7** - Pink solids were observed on the ground within the area where a pink leachate was previously observed.

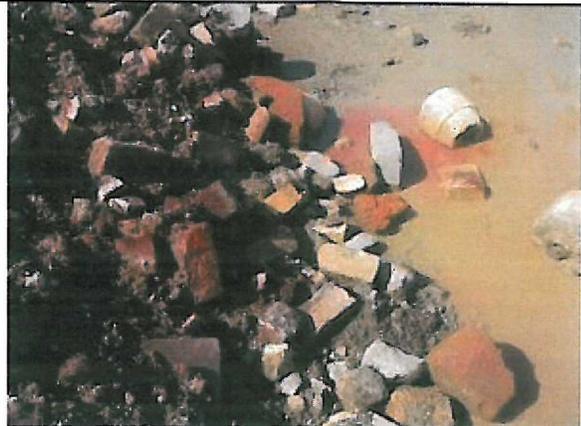
**Figure 8** - Pink leachate was observed in a new area of the facility.

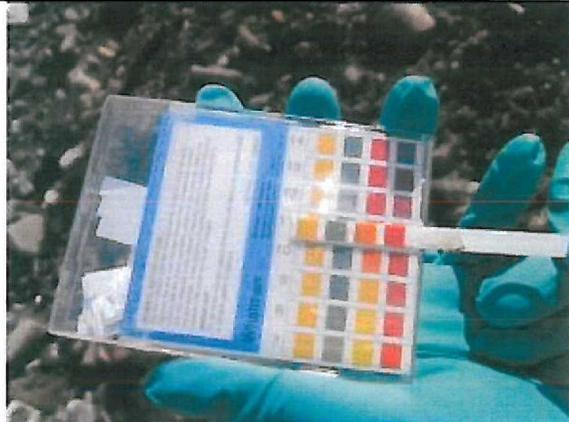
Ohio EPA utilized pH indicator paper to test the pink leachate. The pH result of the pink leachate was 10.0 S.U. (Figure 9). The water quality range for acceptable discharges to “waters of the State” is 6.5 to 9.0 S.U. Please be aware that a discharge of the pink leachate to “waters of the State” would result in violations of ORC 6111.07, Ohio Administrative Code Chapter (OAC) 3745-1-04(C) and (D), and OAC 3745-1-07, Table 7-1.

**Figure 9** - The pH result of the pink leachate was 10.0 S.U.

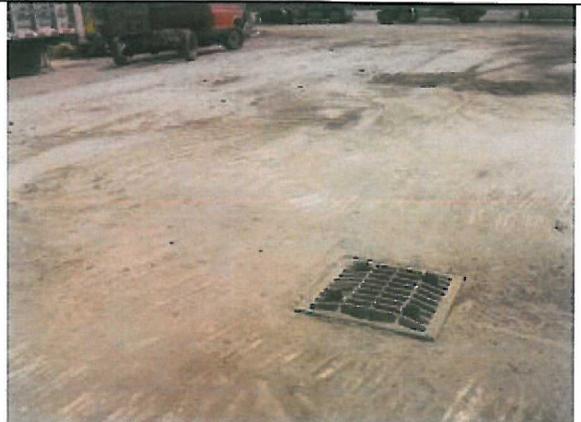
- The storm sewer catch basin located immediately north of the maintenance building has a large quantity of sediment on the ground that requires good housekeeping measures (i.e. sweeping) be increased to minimize the potential discharge of pollutants (Figure 10).

**Figure 10** - Good housekeeping measures (i.e. sweeping) must be increased.

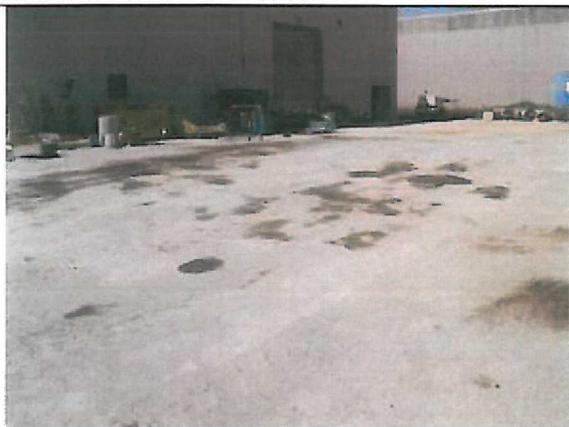
- Oil stains were observed within the area located immediately north of the maintenance building (Figure 11). The oil stains must be properly remediated with any oil contaminated soils disposed of properly.

**Figure 11** - Oil stains were observed within the area located immediately north of the maintenance building.

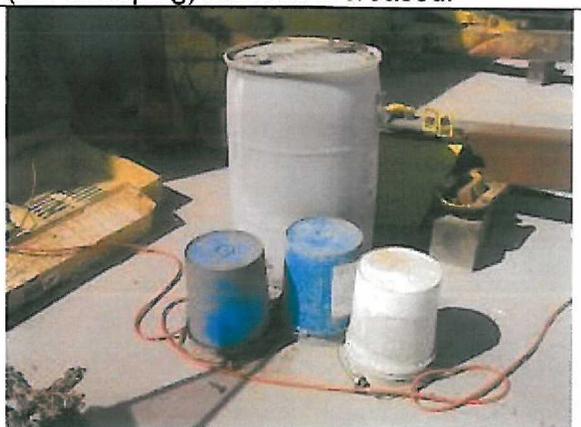
- Pails of oil were observed at the facility in areas exposed to precipitation events. Some of the pails were upside down. Materials must be properly managed and stored (i.e. not turned upside down to drain residual liquids) to eliminate the potential for pollutants to be discharged during precipitation events (Figure 12).

**Figure 12** - Materials must be properly managed and stored.
