May 23, 2013

RE: ASHTABULA COUNTY  
MASCO CABINETRY MIDDLEFIELD, LLC  
NPDES PERMIT NO. OHR000005  
OHIO EPA PERMIT NO. 3GR01386\*DG  
INDUSTRIAL STORM WATER INSPECTION

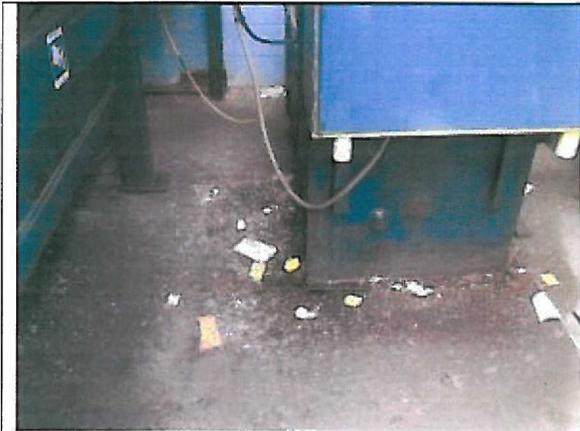
- A non-storm water discharge certification occurred on May 6, 2010.
- The trash compactor was leaking oil during the inspection due to a failed cover (Figure 1). Employees began cleaning this area immediately upon discovery. Via an email dated May 8, 2013, Mr. Wolfe provided verification that the trash compactor was repaired. Ohio EPA recommends that this area be inspected during the facility's routine inspections.

**Figure 1** - The trash compactor was leaking oil during the inspection due to a failed cover.

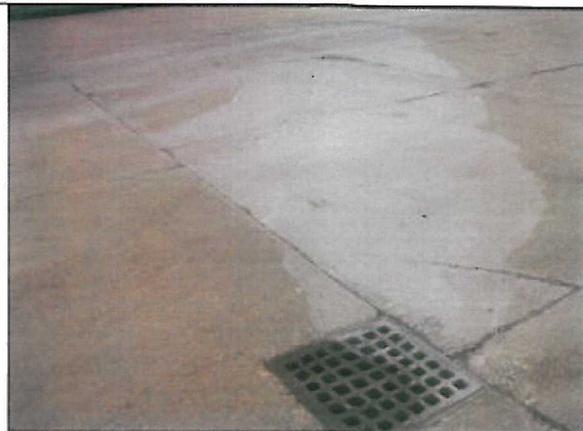
- The sludge dumpster was leaking a white leachate that was discharging into a storm sewer inlet (Figure 2). Employees began cleaning this area immediately upon discovery. Via an email dated May 8, 2013, Mr. Wolfe provided verification that the sludge dumpster area was cleaned. In addition, the sludge dumpster has been covered. Ohio EPA recommends that this area be inspected during the facility's routine inspections.

**Figure 2** - The sludge dumpster was leaking a white leachate that was discharging into a storm sewer inlet.

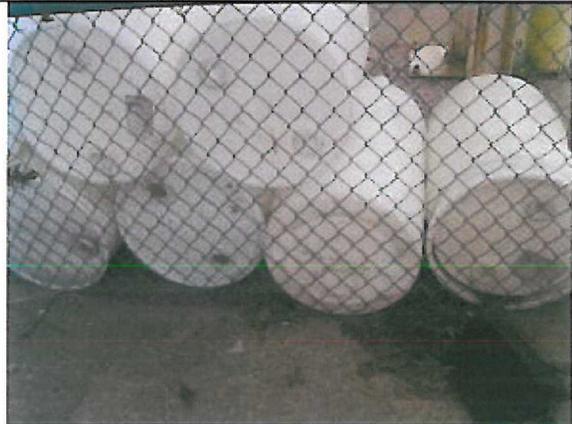
- A drum storage area was located outdoors where uncapped drums were observed (Figure 3). The drums must be properly capped to minimize the potential to discharge pollutants during precipitation events.

**Figure 3** - A drum storage area was located outdoors where uncapped drums were observed.
