**RE: Treewood Apartments; NPDES Permit # 1GC04463\*AG; Construction Site Inspection**

**Ohio EPA DSW Storm Water Section, Construction Site Visit Information Form**

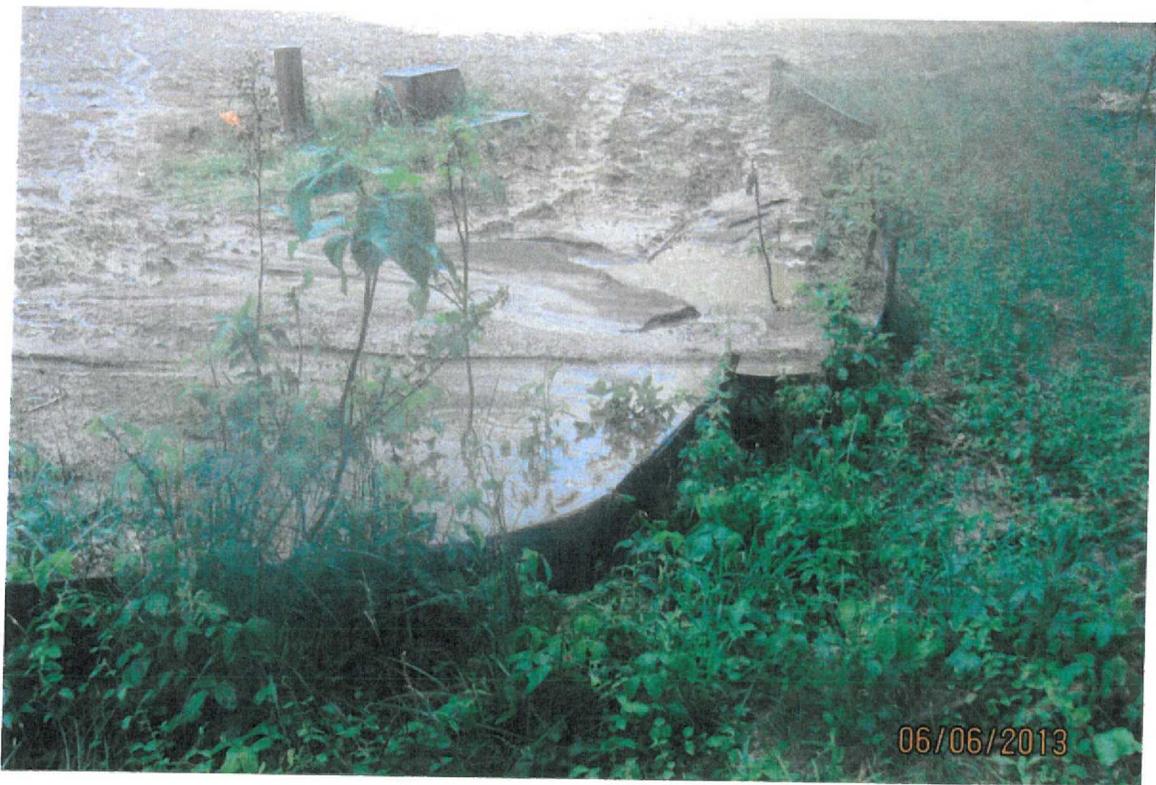
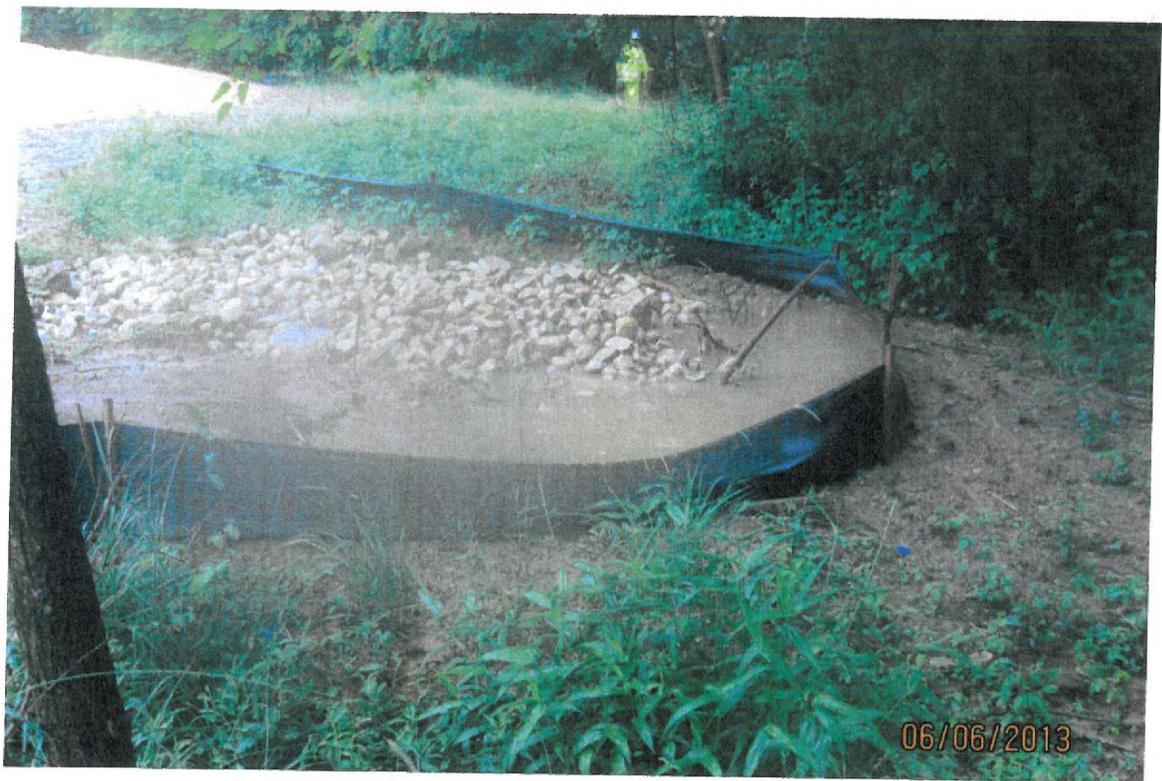
Based on my observations, there were no obvious violations of the project's storm water discharge permit. However, I would like to point out that several potential problem areas in the silt fence along the northwest end of the property. The specific areas are shown in the enclosed photos, and as you can see, they have worked properly. However, they are either close to reaching their sediment controlling capacity or have already failed. Maintenance of the silt fence in this location is needed to ensure it continues to function. This could include removal of accumulated mud from the upslope side of the silt fence, removal and replacement of the silt fence or addition of further lengths of silt fence downslope of the existing installation.

silt fence is at capacity & water spilling over the top

1. A copy of the site's storm water pollution prevention plan (SWPPP)
2. Copies of sediment control inspection records since work on the project begun.
3. An explanation of what will be done to resolve these potential problem areas.
