June 17, 2013

RE: CUYAHOGA COUNTY
OAKWOOD VILLAGE
INDUSTRIAL STORM WATER
AGMET LLC
3GR01823*EG

NOTICE OF VIOLATION

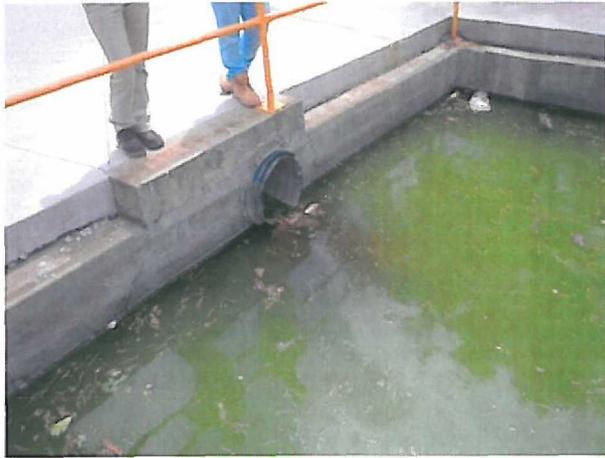
1. Outfall 003 is the discharge from a small concrete storm water pond. We noted that the water in the pond was green and there was a build-up of sediment at the inlet (see Fig 1). The pond receives runoff from the northern end of the Bulk Storage Building (BSB) where dust generated by the Shredder regularly falls outside on the pavement and the western side of the BSB where a drag chain conveyor is located. The water quality function of the pond can be improved by retrofitting the pond to provide extended detention of the Water Quality Volume (WQv) as described in Section 2.6 of the *Rainwater and Land Development* manual, which can be found at the following link:

Figure 1: Northwest corner of lot retention pond with built up sediment and green water.

6. Maintenance procedures and schedules must be developed for the storm water pond discharging to Outfall 003 and the “sediment separator” tributary to Outfall 005. You indicated that the storm water pond was cleaned out in Fall 2012, but were not sure when the sediment separator was last cleaned out. It was installed 5 years ago.

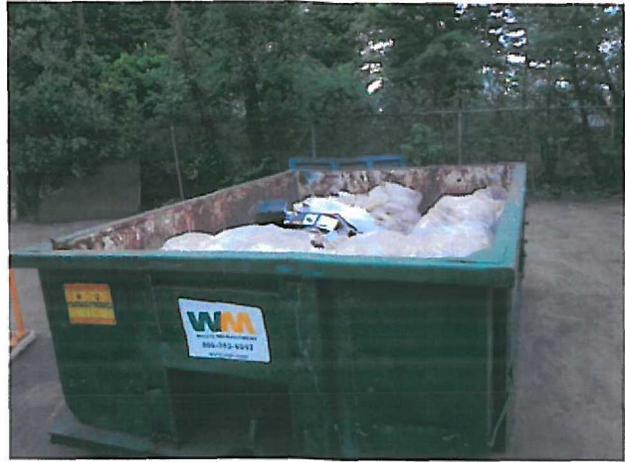
9. We noted a leak from the southernmost door of the Maintenance Building where old equipment is stored. After looking closer at it, it did not seem to be anything harmful, but to prevent any pollution in the future, all stored equipment should be drained before storing or have a drip pan in areas of need.
10. A number of 55-gallon drums and used pallets are stored in the drainage area tributary to Outfall 002. Drums should be stored in secondary containment and pallets should be inspected to ensure that there are no residuals from spills or leaks. If any are observed, those pallets should be moved under cover to prevent exposure to storm water.
11. All waste dumpsters need to be covered with a tarp or lid (see Fig 2).

Figure 3: Dumpsters need covered

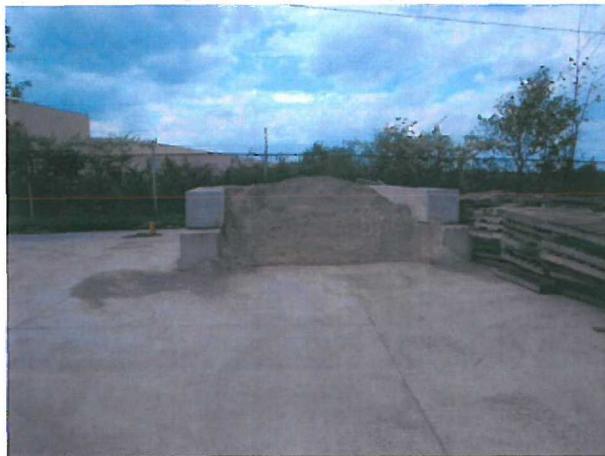
3. The sand stockpile outside of the BSB should be covered to help reduce sediment pollution (see Fig 3). A tarp or Quonset hut storage structure is suggested. **See Figure 3.**

Figure 2: Sand stock pile needs covered

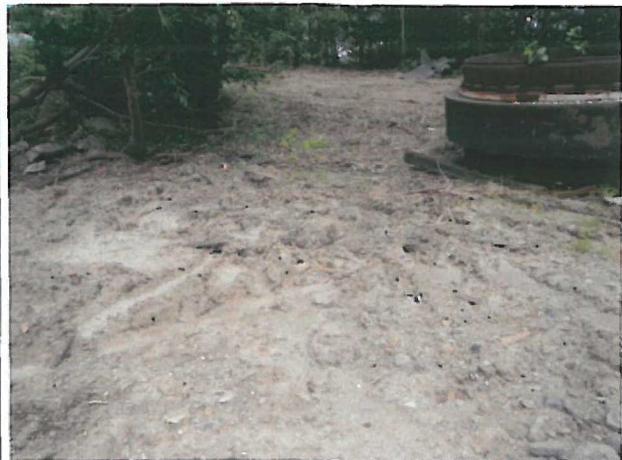
7. The yard south of the railroad tracks, where old pieces and parts were being stored, needs vegetated or graveled to reduce sediment pollution (see Fig 4).

Figure 4: Vegetate or gravel yard south of railroad
