June 18, 2013

RE: PORTAGE COUNTY
CITY OF STREETSBORO
STREETSBORO FAMILY HOMES
NPDES PERMIT NO. OHC000003
OHIO EPA PERMIT NO. 3GC05900*AG
CONSTRUCTION STORM WATER

STREETSBORO FAMILY HOMES

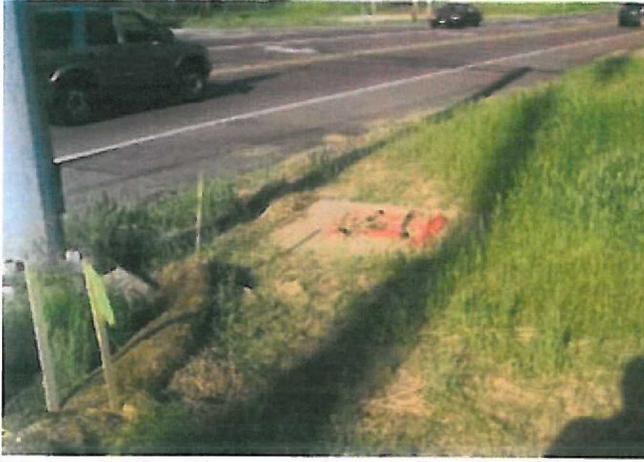
Figure 1. The filter sock is deteriorating. If filter socks are to be used as sediment control, the sock must be greater than or equal to 12" in diameter.

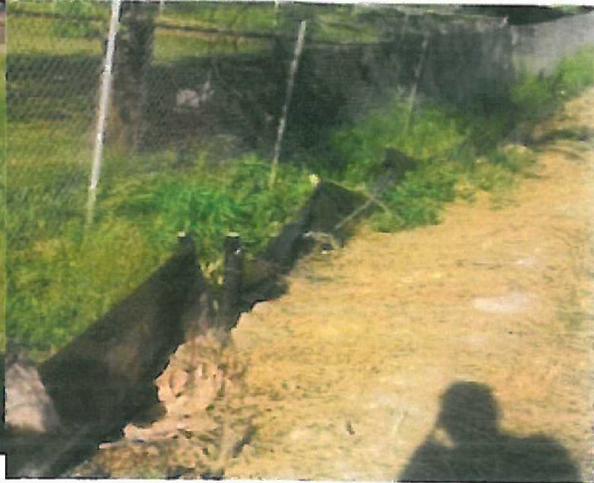
- The silt fence throughout the site needs to be repaired or replaced in many areas, particularly the southern perimeter and along the large stock pile. In addition, the silt fence was never properly installed. Referring to the detail drawings on the approved set of plans, the ends of two sections of silt fence must be wrapped together before staking to create a single continuous barrier (See Figure 2).

Figure 2. Silt fence is collapsing and the ends of each section are not twisted together properly.

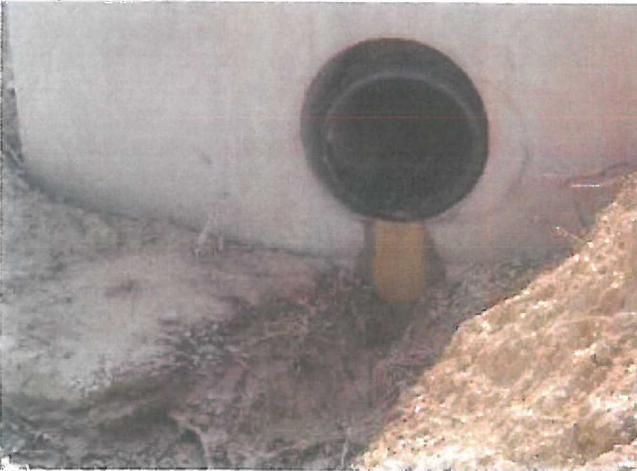
- The outfall which discharges into the sediment basin has severely eroded and lacks the appropriate outlet protection (i.e. Rock channel protection, Rip-rap). Eroded channels or gullies must be filled in before implementing outlet protection. Refer to the detail drawing on the approved SWP3 (See Figure 3).

Figure 3. The outfall is eroding severely and lacks appropriate protection.

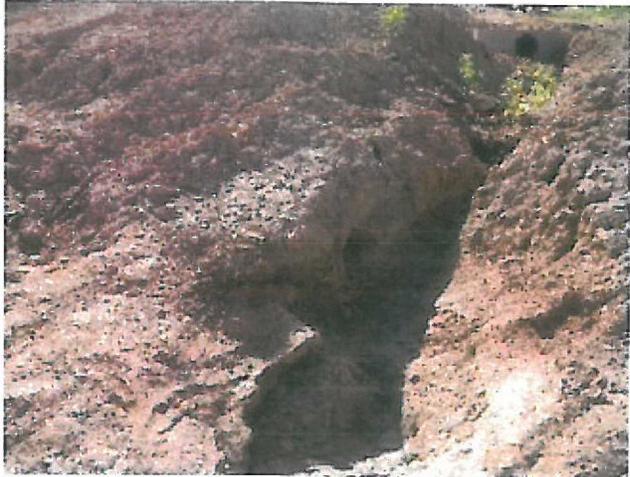
Figure 4. Channels and gullies must be filled in prior to stabilization.

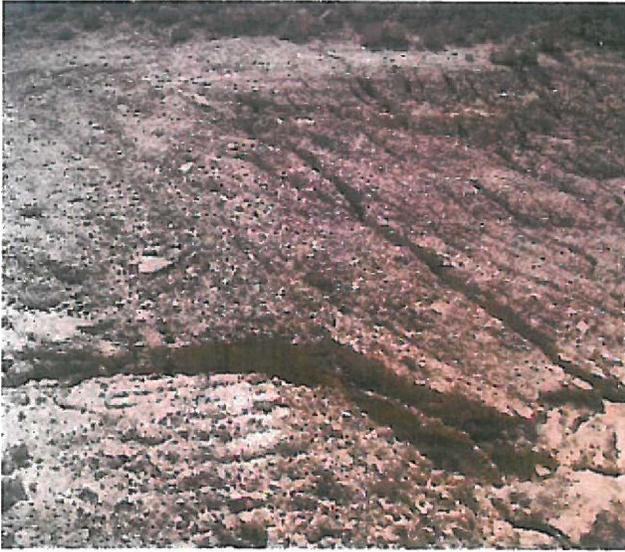
- Stabilization issues were very apparent throughout the entire site, particularly the stock piles and the embankment of the sediment basin. It was observed that the construction sequence on the approved set of plans dictates that stabilizing the embankment of the sediment basin was to occur during the early stages of construction; essentially immediately after constructing it. Eroded channels or gullies must be filled in prior to stabilizing the embankment. In addition, any other areas throughout the site (e.g. the stock piles) which shall remain idle for greater than twenty-one (21) days require temporary stabilization until final grading is completed and permanent seeding can be placed (See Figures 4&5). Please notice (for future reference) that the requirements of the most recent NPDES General Construction Permit (OHC000004) have been updated such that any permits issued after April of 2013 require temporary stabilization of any areas which shall remain idle for greater than *fourteen (14) days*.

Figure 5. The embankment of the sediment basin should have been stabilized long ago.

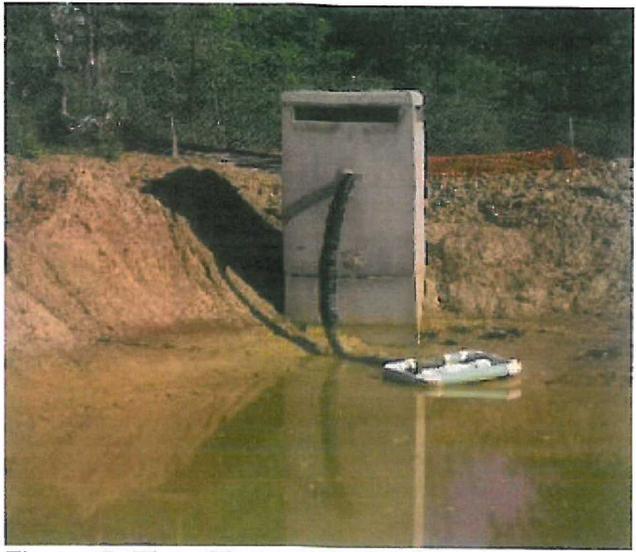
- The dewatering device connected to the outlet structure of the sediment basin for use during the construction process was not built per the details included on the SWP3. The approved SWP3 calls for a riser pipe while a skimmer device was used in practice. Although the skimmer device is actually *preferred* by Ohio EPA and is a new requirement of the General Construction Permit OHC000004 (effective April 2013), the plan must be amended to include details of the skimmer as well as provide calculations for sizing the orifice to ensure adequate draw down time of the de-watering volume. In addition, it was observed that the skimmer device was connected to the wrong orifice of the outlet structure and would not allow water to be drawn from the surface until nearly six feet (6') of runoff is accumulated in the basin. The skimmer is intended to be connected to the water quality orifice (located furthest from the top of the outlet structure) such that it can draw the cleanest water from the surface of the de-watering volume. The dewatering volume exists between the invert of the water quality orifice and the elevation specified on the approved SWP3. The SWP3 should also indicate whether or not the other orifices should be plugged during the construction process. In addition, guide posts should be installed to prevent the skimmer from moving sideways while floating in the basin (See Figure 6).

Figure 6. The skimmer device is not properly installed and will not function as intended.

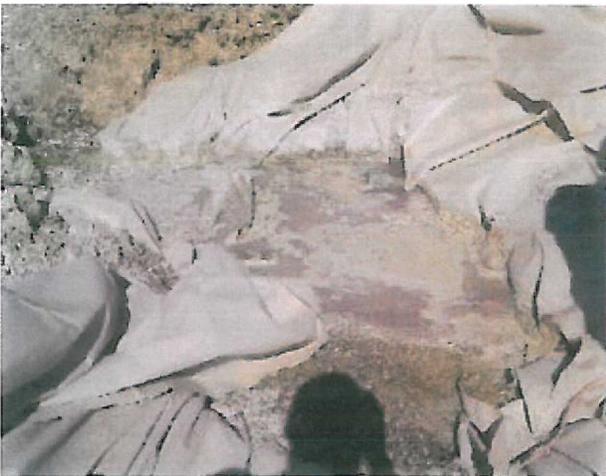
- The concrete washout pit in place was not adequate. The concrete washout pit must be reconstructed per the detail drawing on the SWP3 if additional concrete work is to occur on the project (See Figure 7). If the concrete washout pit needs to be moved to a different location for any reason, the SWP3 on site should indicate the new location of the BMP.

Figure 7. The concrete washout pit must be reconstructed.

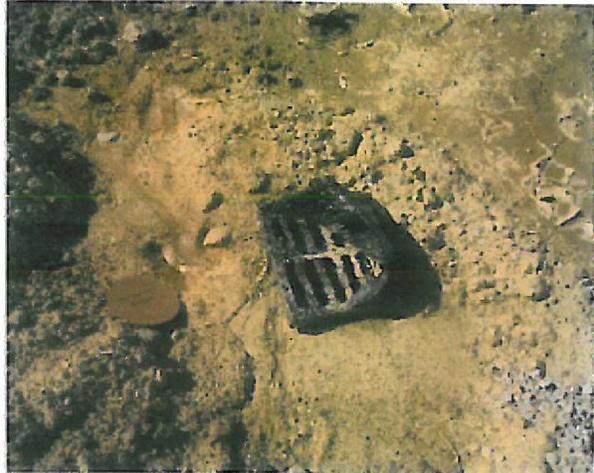
- The inlet protection for the yard drains was inadequate or completely missing (See Figure 8). Inlet protection must be constructed per the detail drawing on the SWP3 including 2"x4" framing, chicken wire mesh, and geotextile fabric for all yard drains. The BMPs must remain intact until all contributing drainage areas have been completely stabilized.
- The dumpster(s) on site do not have a lid or a tarp to prevent their contents from polluting storm water runoff (See Figure 9). Storm water which comes in contact with solid wastes is considered to be a leachate and is not authorized to be discharged under the NPDES Permit issued for this site. If the dumpster company does not offer lidding options for these containers, a tarp must be laid over and tied down to the dumpster at the end of each work day or during any rain event.

Figure 8. Inlet protection must be constructed per the detail drawing on the SWP3.

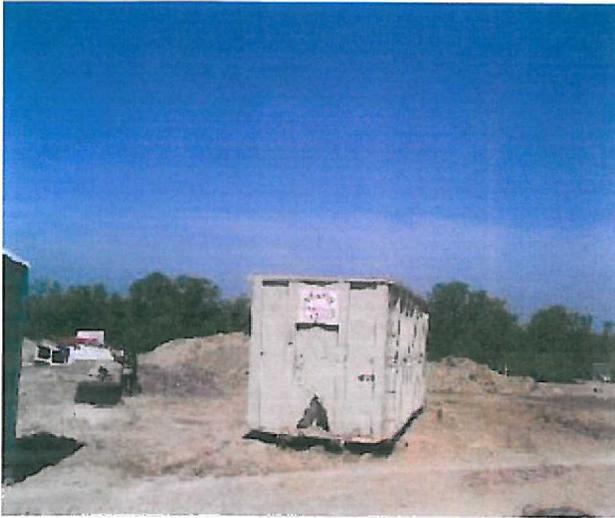
Figure 9. The dumpster needs to be covered at the end of each work day or during any rain event.
