June 19, 2013

RE: CUYAHOGA COUNTY
VILLAGE OF WALTON HILLS
INDUSTRIAL STORM WATER
FORD MOTOR COMPANY
3GR00663*EG

NOTICE OF VIOLATION

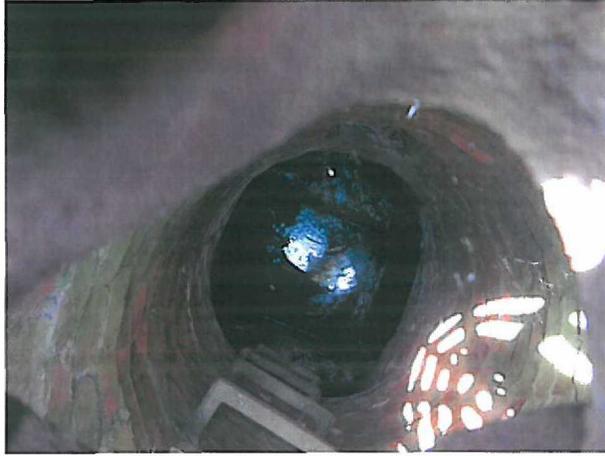
7. We identified a previously unidentified white pipe entering the manhole labeled 002 on the current site map (see Fig 1). Please determine what discharges from this pipe and whether it is storm water, an allowable non-storm water discharge or an unauthorized non-storm water discharge. If this pipe conveys an unauthorized non-storm water discharge, you must take action to eliminate it.

Figure 1: Unidentified white pipe entering the manhole labeled 002.

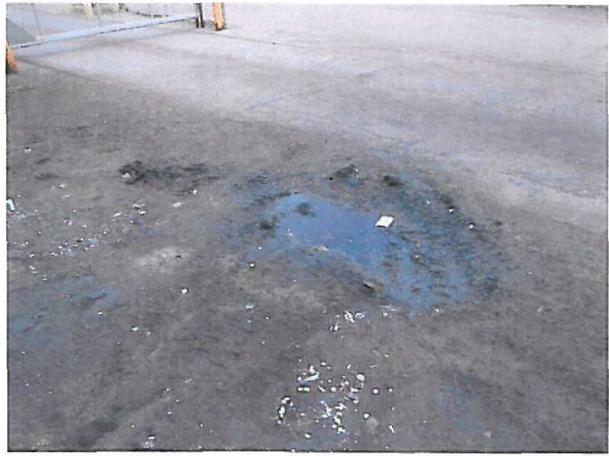
Figure 2: Clean up all spills immediately, and record if significant.

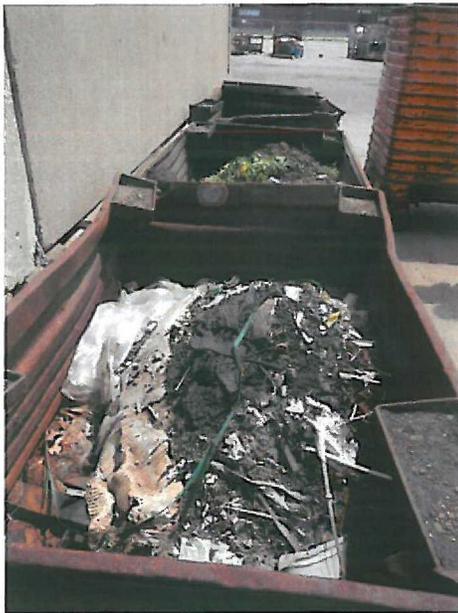
5. All dumpsters must be covered. This includes the dumpster in the Shipping and Receiving Lot between Docks 1 and 2, the JIL Door dumpsters, and others containing waste or scrap materials (see Fig 3). Dumpsters may also be stored indoors in lieu of providing cover with a tarp or lid.

Figure 3: All dumpsters outside need to be covered.

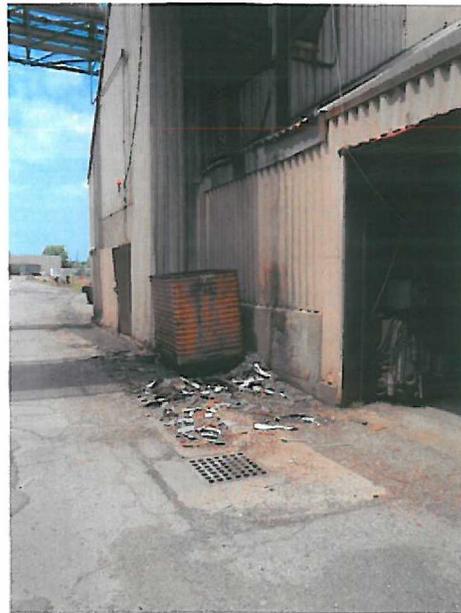
1. Good Housekeeping practices such as sweeping sediment and grit, and picking up trash are needed throughout the site to help eliminate potential storm water pollution. It was most necessary in the following locations:
 - a. The Backup Truck Access near the southwest corner of the lot.
 - b. JIT Dock
 - c. Adjacent sewer to the east of SW004.
 - d. All along the fence along the railroad tracks on the east side of the property
 - e. Around the Baler House to clean up overflowing metal scrap (see Fig 4)
2. There were some visible spills that need to be cleaned up immediately. These were found in the locations of:
 - a. The leaking dumpster in the Dumpster Area on the east side.
 - b. Oil spill on the ground by the A-6 door (see Fig 2).
3. Make sure all spill kits are labeled which includes the one by the shipping and receiving dumpsters and next to the diesel tank.

Figure 4: Good Housekeeping skills need to be implemented throughout the site.
