June 21, 2013

**RE: MAHONING COUNTY, CANFIELD TOWNSHIP, SUMMER WIND PRIVATE ESTATES
(PARRY FARMS), NPDES PERMIT NO. 3GC04939*AG, OHIO EPA PERMIT NO. OH000003
CONSTRUCTION STORM WATER INSPECTION, NOTICE OF VIOLATION**

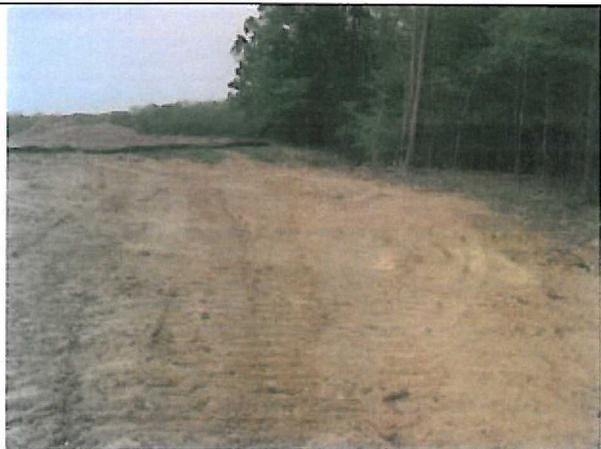
- Construction activities are occurring within Phases III, V and VI, a drainage swale located west of Phase VI, and a sediment basin located west of Phase VI (Site II) that have exceeded the site's permitted ten acres of earth disturbance (Figures 1 to 3). According to the Mahoning County Geographic Information System, approximately fourteen acres of earth disturbance have occurred within Site II. Ohio EPA records do not indicate that the construction activities occurring on Site II have received General Storm Water Permit coverage.

Ohio Administrative Code 3745-38-02 requires that General Storm Water Permit coverage for construction activities must be obtained by submitting a Notice of Intent (NOI) at least twenty-one days prior to the start of construction activities. Ohio EPA records do not indicate that Site II has received General Storm Water Permit authorization. **The failure to submit an NOI at least twenty-one days prior to the commencement of construction activities constitutes violations of Ohio Revised Code Chapter (ORC) 6111.07 and Ohio Administrative Code Chapter 3745-08-02.**

Figure 1 – Unpermitted construction activities are occurring in Site II.

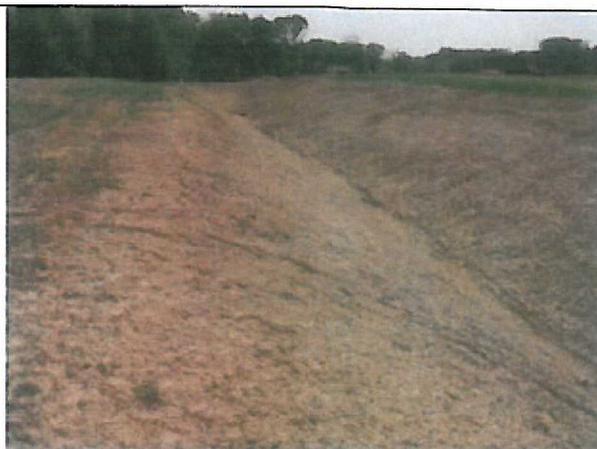
Figure 2 – Unpermitted construction activities are occurring in Site II.

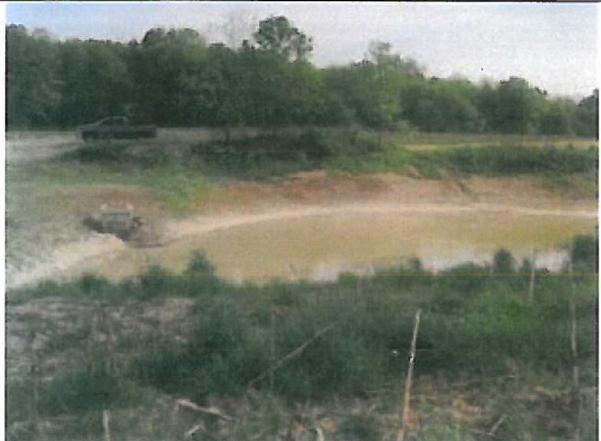
Figure 3 – Unpermitted construction activities are occurring in Site II.

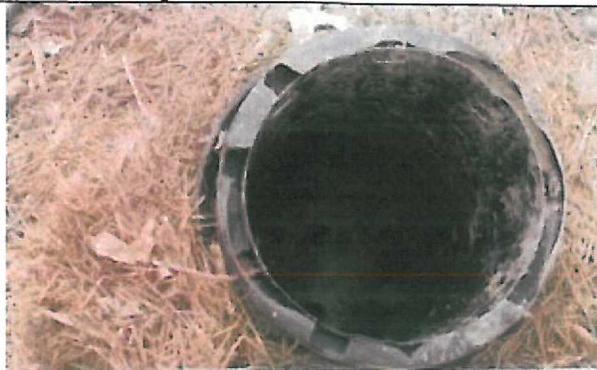
- Unauthorized discharges of sediment-laden runoff were occurring from Site II and discharging into "waters of the State." A sediment settling pond with an improperly designed dewatering device (i.e. a riser pipe with one inch diameter holes space approximately three inches apart) has been constructed within a possible onsite stream and wetlands (Figures 1 and 4). Within ten days of receiving this Notice of Violation (NOV), a properly designed dewatering device must be installed on the sediment settling pond's outlet. **The failure to have a properly designed dewatering skimmer constitutes violations of ORC 6111.07 and Part III.G.2.d.ii of the General Storm Water Permit.** Please be aware that permitting matters related to any impacts made to possible onsite streams and wetlands are to be addressed by Mr. Bintrim and/or Mr. Wilk.

Figure 4 – The Site II sediment settling pond has an improperly designed dewatering device.

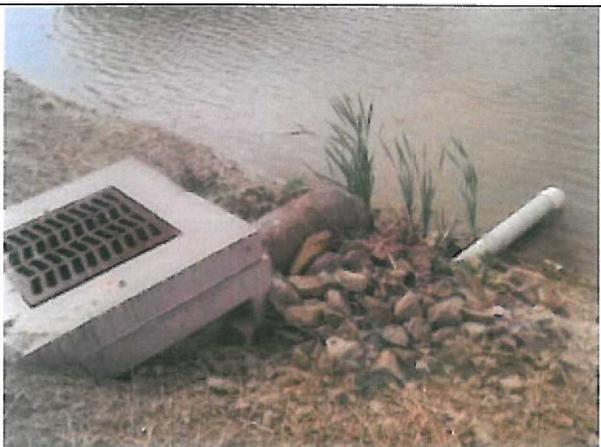
- Sediment basin No. 1 has not been designed as a sediment settling pond despite active construction activities occurring in Site II (Figure 5). Within ten days of receiving this NOV, the outlet to sediment basin No. 1 must be modified with a dewatering skimmer or equivalent device that has been properly designed with a minimum 48-hour drain time. **The failure to have a properly designed dewatering skimmer constitutes violations of ORC 6111.07 and Part III.G.2.d.ii of the General Storm Water Permit.**

Figure 5 – Sediment basin No. 1 has not been designed as a sediment settling pond with a properly designed dewatering device.

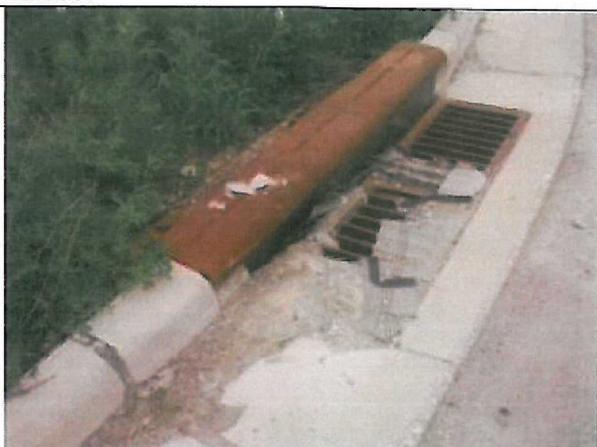
- Improperly installed curb inlet protection was observed within Bella Jean and Thats Life Lane that was unable to pond sediment-laden storm water runoff (Figure 6). Within three days of receiving this NOV, the curb inlet protection must be reinstalled in accordance with the specifications detailed within Chapter 6 of Ohio Department of Natural Resources' (ODNR) *Rainwater and Land Development* manual. For your convenience, this manual can be obtained from the following website:
<http://www.dnr.state.oh.us/water/rainwater/default/tabid/9186/Default.aspx>

Figure 6 – Improperly installed curb inlet protection was installed within Site II.

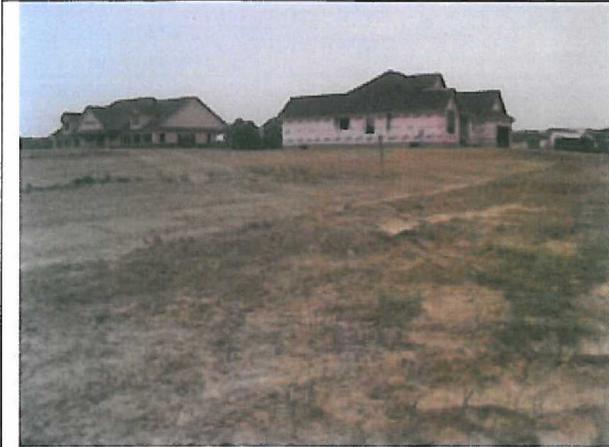
- Temporary stabilization is required to be performed within seven days of the most recent disturbance on all portions of the site that have remained idle for greater than fourteen days (Figures 1, 2, and 7). At a minimum, the idle areas include lots 37 through 42, 63 through 67, and the portion of Site II located west of Phase V. **The failure to perform temporary stabilization constitutes violations of ORC 6111.07 and Part II.B of the General Storm Water Permit.**

Figure 7 – Improperly installed curb inlet protection was installed within Site II.

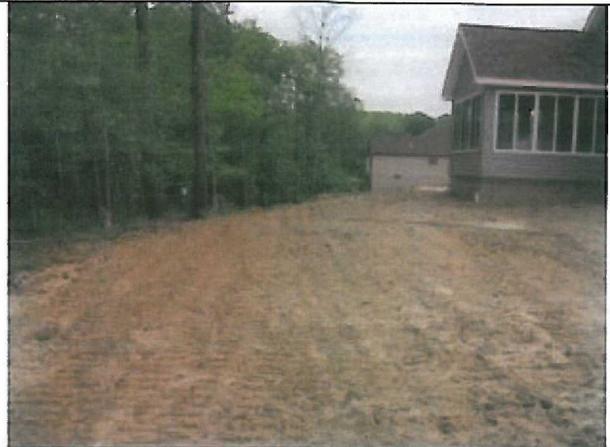
- No sediment best management practices (BMP) have been installed along the northern portion of Site II, where sediment-laden storm water runoff discharges to the north and is not treated within Sediment Basin No.1 (Figures 1 and 8). Within ten days of receiving this NOV, appropriate sediment BMPs (i.e. sediment traps, diversions, and silt fence, etc.) must be installed to prevent the discharge of sediment-laden. **The failure to provide functional sediment BMPs during the course of earth disturbing activities constitutes violations of ORC 6111.07 and Part III.G.2.d.i. of the General Storm Water Permit.**

Figure 8 – No BMPs have been installed along the northern portion of Site II.

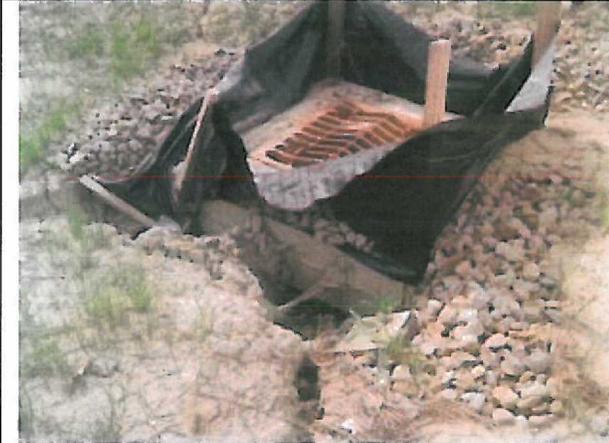
- Silt fence and yard inlet protection was failing throughout Site II and requires maintenance (Figures 9 to 10). Within three days of receiving this NOV, all inlet protection and silt fence must be repaired and/or replaced, if applicable. **The failure to provide functional sediment BMPs during the course of earth disturbing activities constitutes violations of ORC 6111.07 and Part III.G.2.d.i. of the General Storm Water Permit.**

Figure 9 – Yard inlet protection was failing throughout Site II.

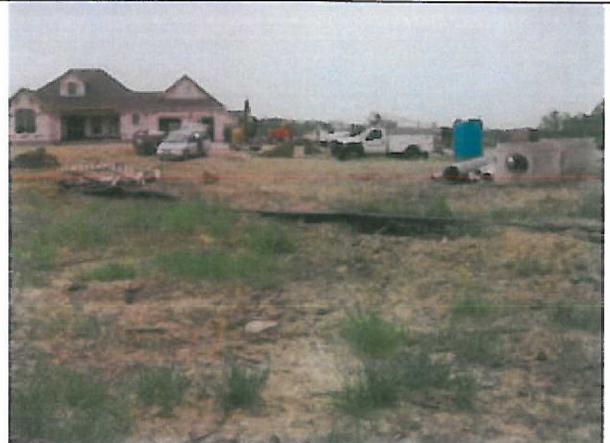
Figure 10 – Silt fence was failing throughout Site II.

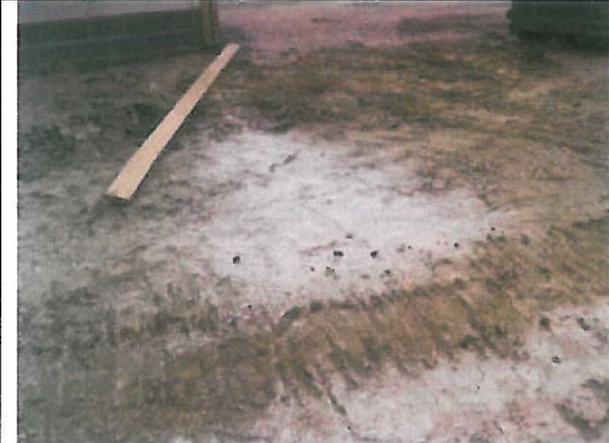
- Joint compound was dumped onsite in a location that discharges to "waters of the state" (Figures 11 to 12). Within three days of receiving this NOV, appropriate BMPs (i.e. cleaning and proper disposal, etc.) must be implemented to prevent the joint compound from discharging to "waters of the state." **The failure to prevent the discharge of non-sediment pollutants constitutes violations of ORC 6111.07 and Part III.G.2.g.i. of the General Storm Water Permit.**

Figure 11 – Joint compound was dumped onsite in a location that discharges to "waters of the state."

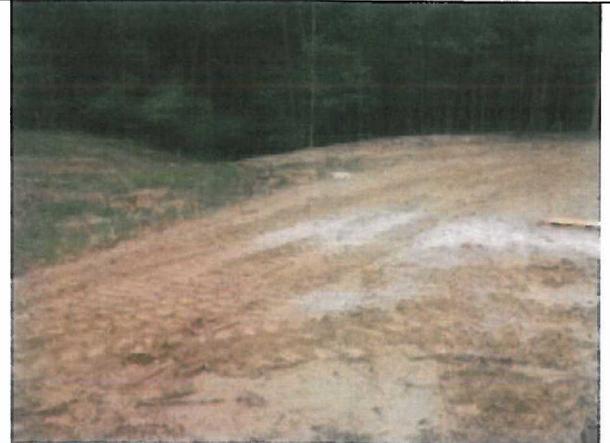
Figure 12 – Joint compound was dumped onsite in a location that discharges to "waters of the state."

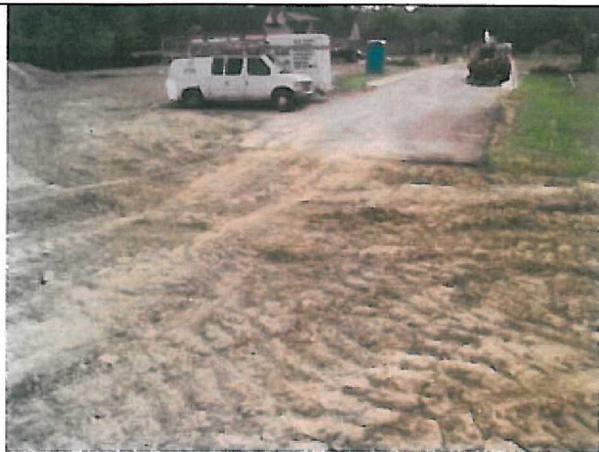
- Construction vehicles access the portion of Site II located west of Phase V from Thats Life Lane without a properly designed construction entrance installed (Figure 13). Offsite tracking of sediment was occurring within Thats Life Lane. **The failure to have a properly installed construction entrance to prevent the offsite tracking of sediment constitutes violations of ORC 6111.07 and Part III.G.2.g.ii of the General Storm Water Permit.**

Figure 13 – Offsite tracking of sediment is occurring due to a lack of a construction entrance.

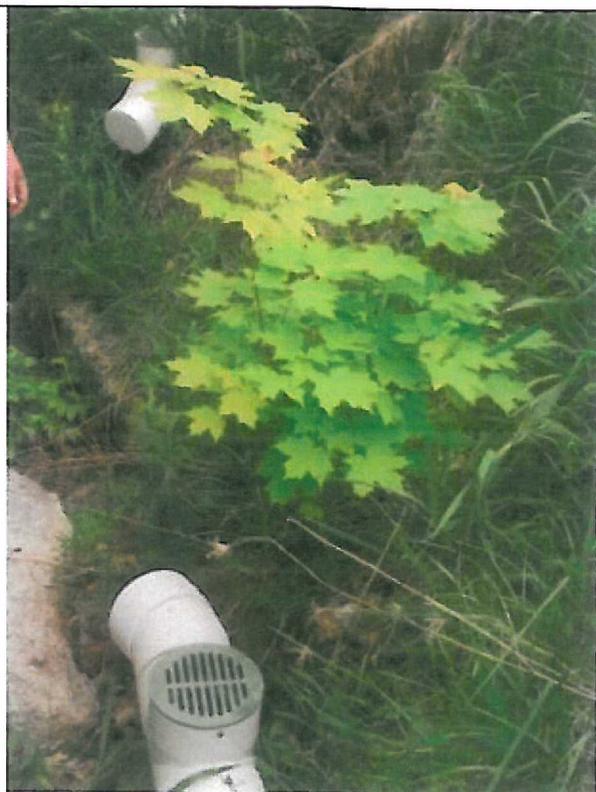
- A post-construction storm water management BMP has been incorrectly installed northeast of lots 59 through 61 (Figure 14). Within three days of receiving this NOV, the post-construction BMP must be repaired to be reflective of the SWP3 that was approved by Mahoning SWCD.

Figure 14 – A post-construction storm water management BMP has been incorrectly installed northeast of lots 59 through 61.
