RE: CUYAHOGA COUNTY  
VILLAGE OF WALTON HILLS  
INDUSTRIAL STORM WATER  
INTERCITY AUTO WRECKING  
3GR01525\*EG

**NOTICE OF VIOLATION**

On May 29, 2013, Ohio EPA conducted an inspection at the Intercity Auto Wrecking facility located at 7140 Northfield Rd. Our inspection's purpose was to determine compliance with the Ohio EPA General Storm Water National Pollutant Discharge Elimination System (NPDES) Permit for Industrial Activity #OHR000005. The site's industrial activities are categorized by the Standard Industrial Classification (SIC) Code 5015: Automobile Salvage Yard. This corresponds to Subsector M1 in Part 8 of the NPDES permit. During the inspection, Mary Ann Meyer and you represented Intercity Auto Wrecking. Dan Bogoevski and I represented Ohio EPA.

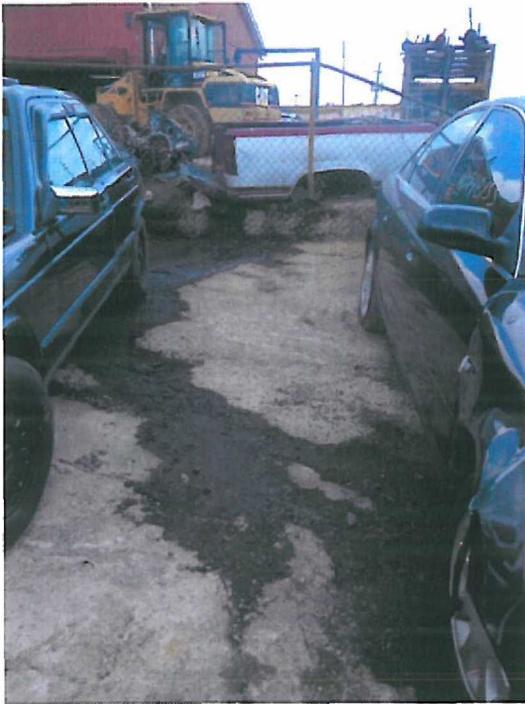
- Vehicles intended to be dismantled are to be drained of all fluids upon arrival at the site as a means to prevent spills and leaks. Not all vehicle fluid is drained upon arrival. No drip pans were observed under vehicles with leaks. (See **Fig 1**)

- Oily engine blocks were stored in old truck beds, but significant leaks of oil were observed from the truck beds onto the ground. Thus, the truck beds do not provide adequate containment. Still other engine blocks were stored on racks, but not under cover or within containment. Some cores were observed stored on the ground without cover. Note that Part 8.M.2.3 requires you to consider berms for uncovered outdoor storage of oily parts, engine blocks, and above-ground liquid storage. In lieu of berms, you may wish to consider storing all of these items within old trailers or storage lockers as you have with some of these items. You may also provide temporary cover over these items using tarps.

**Figure 1:** Leak from truck bed used as “containment” where engine blocks are stored during the dismantling process.

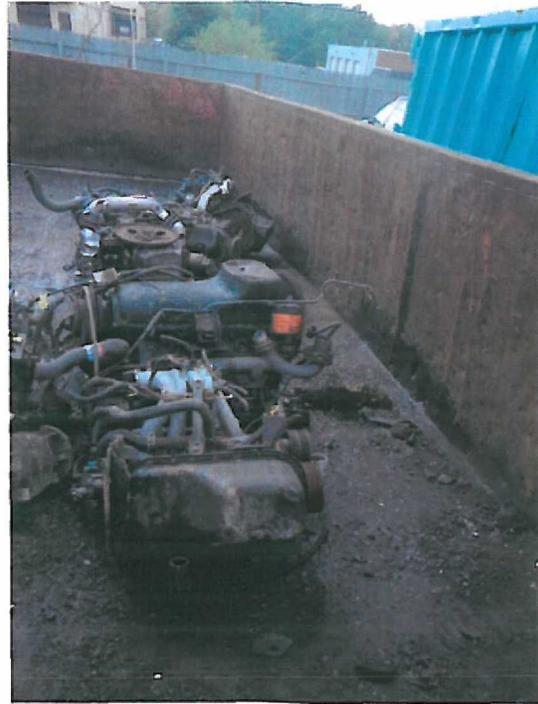
- Dumpsters in the Crushing Area were leaking. There is no berm around the Crushing Area as stipulated in the SWPPP. As a result, oil is being discharged to the drainage swale and MS4 located along Krick Road. Please immediately install a berm to prevent these discharges. (See **Fig 2**)

**Figure 2:** Dumpster used to store leaking and oily engines not covered. Dumpster was observed to be leaking onto ground.

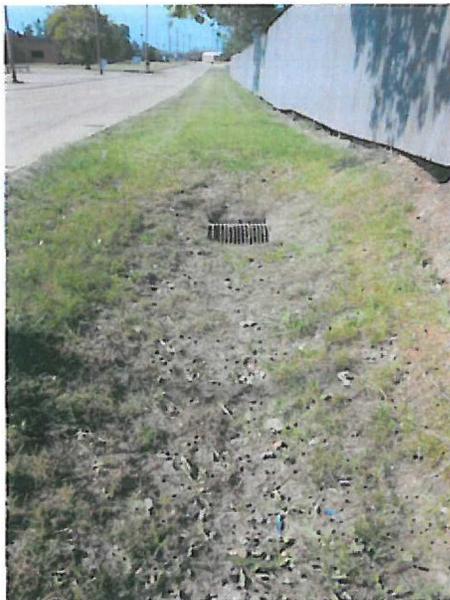
**Figure 3 (LEFT):** Discharge under fence along the west side of the site into the Krick Rd swale and storm sewer (Photo taken: May 30, 2013).

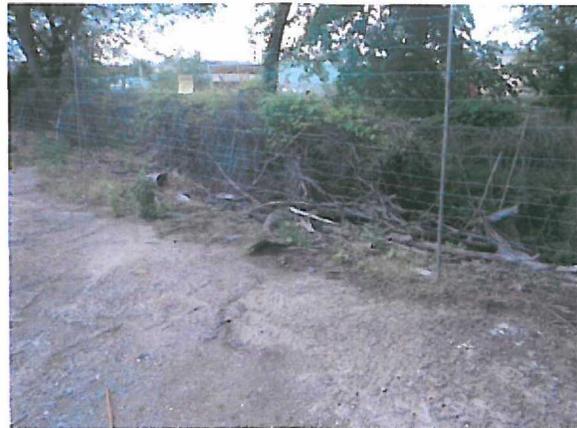
**Figure 4 (ABOVE):** Disturbed areas along the north side of site abutting creek.

In addition to these violations, we noted that the north side of the property abuts an unnamed tributary of Tinkers Creek. Intercity Auto Wrecking should consider establishing vegetation within a 50-foot width of the stream to provide a vegetated filter for runoff from the storage yard. (See **Fig 4**).

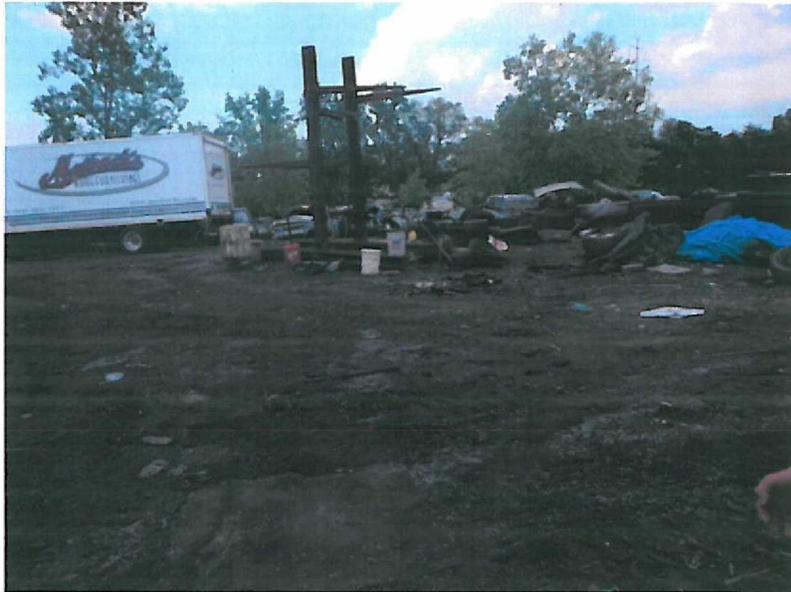
- Failure to implement procedures for expeditiously stopping, containing and cleaning up leaks, spills and other releases. As previously indicated and as shown in the photos, we observed significant oil spills on the ground throughout the dismantling and crushing areas of the facility. Good housekeeping must also be improved to reduce the exposure of pollutants to storm water. Promptly sweep up debris in the Crushing Area and wipe off excess oil on the outside of the Used Oil Tank, as example.

**Figure 5:** Significant amounts of oil spill onto the ground in Crushing Area. No clean-up efforts are evident. It does not appear that cars are drained of fluids prior to crushing.

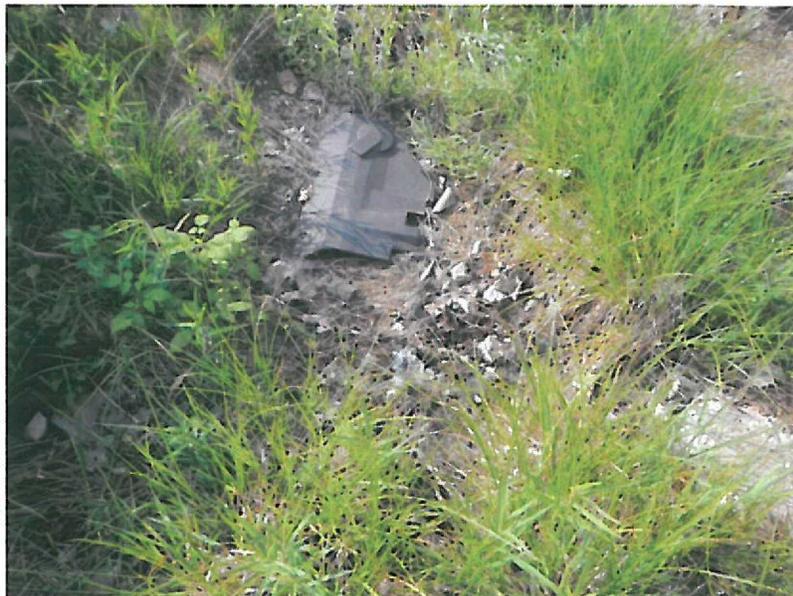
- The SWPPP indicates that oil-absorbent booms are to be placed around the Outfall 001 (catch basin). No booms were observed during this inspection. Rather, the catch basin was covered with sediment. Please clean up the sediment and debris that has collected on the catch basin and install booms as indicated in the SWPPP. You may also wish to install storm drain inlet protection as indicated in the *Rainwater and Land Development* manual to address sediment and debris. Storm drain inlet protection is located in Chapter 6 of the *Rainwater* manual available online at:

**Figure 6:** Outfall 001 is this catch basin above the culverted stream. Note that it is covered with sediment and debris. There are no oil-absorbent booms around the catch basin.
