June 25, 2013

RE: COLUMBIANA COUNTY
BUTLER TOWNSHIP
APPALACHIAN TRAILERS, INC.
NPDES PERMIT NO. OHR000005
OHIO EPA PERMIT NO. 3GR01226*EG
INDUSTRIAL STORM WATER INSPECTION

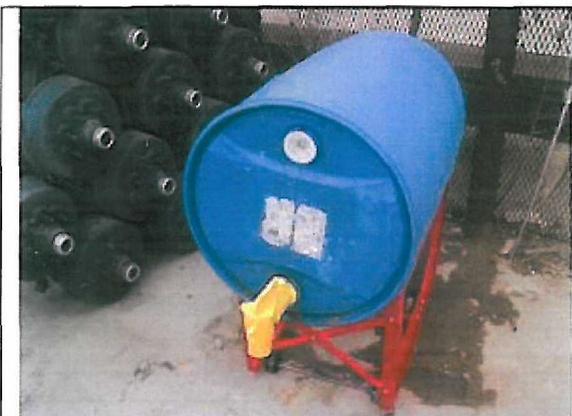
- Onsite mobile fifty-five gallon drums of coolant are utilized throughout the facility that are leaking (Figure 1 to 2). Appropriate best management practices (BMP) (i.e. secondary containment, berming, cover, etc.) must be implemented to prevent the discharge of pollutants during precipitation events. In addition, a spill kit must be located within the area where the mobile fifty-five gallon drums are utilized.

Figure 1 - Onsite mobile fifty-five gallon drums of coolant are leaking throughout the facility.

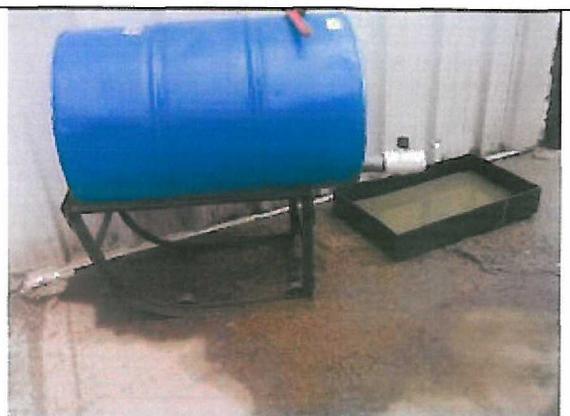
Figure 2 - Onsite mobile fifty-five gallon drums of coolant are leaking throughout the facility.

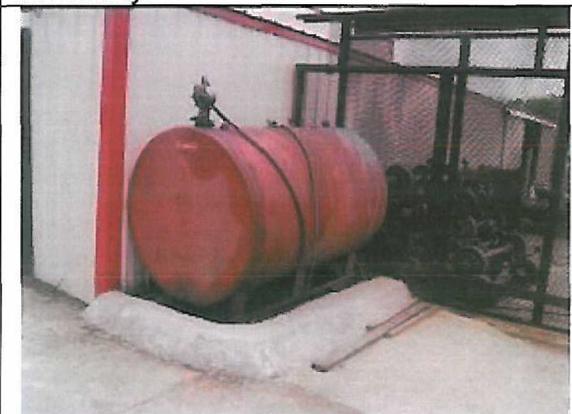
- A diesel tank with secondary containment is present at the facility (Figure 3). A spill kit must be located within this refueling area in order to address potential spills or leaks.

Figure 3 - A spill kit must be located within this refueling area in order to address potential spills or leaks.

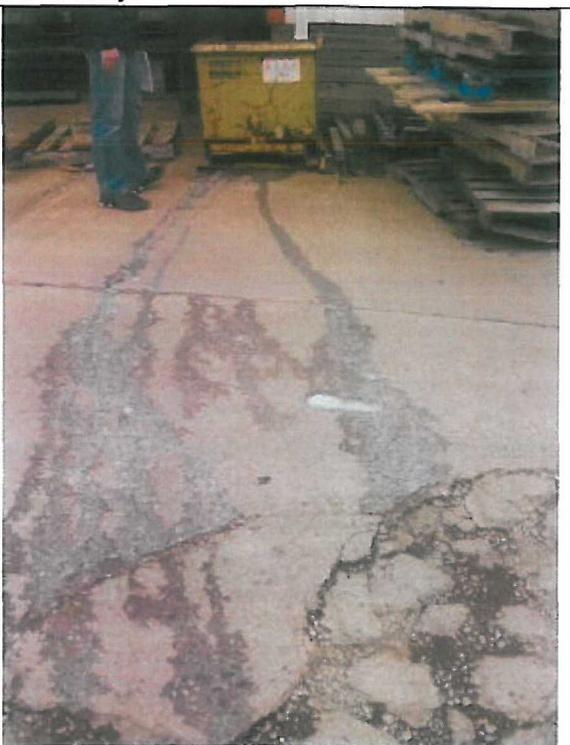
- A hopper containing coolant coated metal fines was leaking coolant in an area exposed to precipitation events (Figure 4). Appropriate BMPs (i.e. cover and pavement cleaning, etc.) must be implemented to address the hopper leaking coolant.

Figure 4 - A hopper containing coolant coated metal fines was leaking coolant.

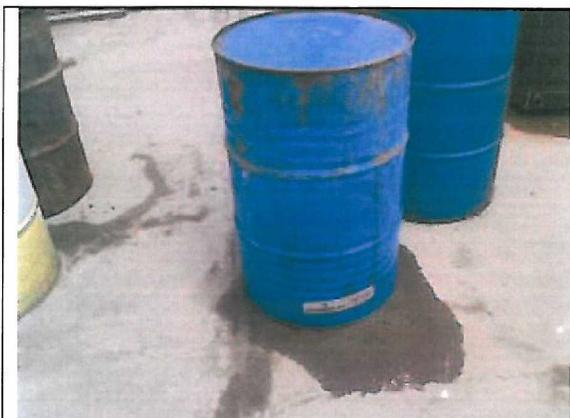
- Empty fifty-five gallon drums are turned upside down to drain residual liquids onto the ground (Figure 5). In addition, some of the empty fifty-five gallon drums were stored upright and were not properly capped (Figure 6). Appropriate BMPs (i.e. prohibiting draining residual liquids and capping the empty drums containing residual liquids prior to proper disposal, etc.) must be implemented to address the fifty-five gallon drum storage area.

Figure 5 - Empty fifty-five gallon drums are turned upside down to drain residual liquids onto the ground.

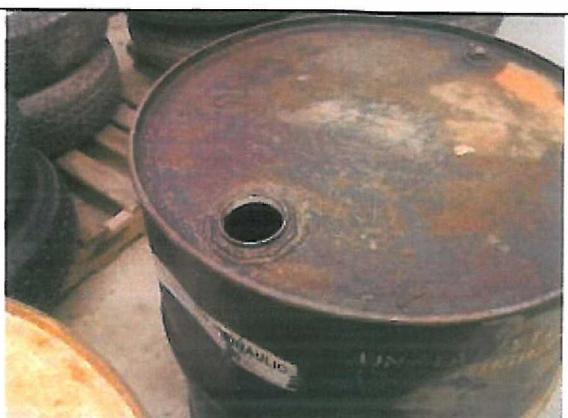
Figure 6 - Some of the empty fifty-five gallon drums were stored upright and were not properly capped.

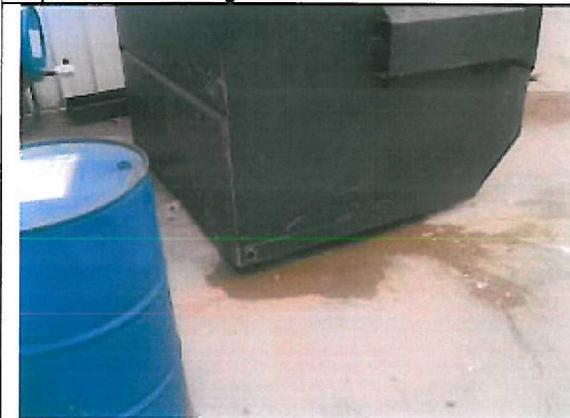
- The solid waste dumpster was leaking fluids (Figure 7). Please be aware that precipitation that contacts solid waste is considered a leachate that is not authorized for discharge under the Multi-Sector General Permit. Appropriate BMPs (i.e. cover the dumpster, ensuring no holes in the dumpster, lining the dumpster, etc.) must be implemented to prevent the discharge of leachate.
- Used paint filters are stored within an empty fifty-five gallon drum that is uncovered and exposed to precipitation events (Figure 8). Appropriate BMPs (i.e. cover, etc.) must be implemented to prevent the discharge of pollutants associated with the paint filters during precipitation events.

Figure 7 - The solid waste dumpster was leaking fluids.

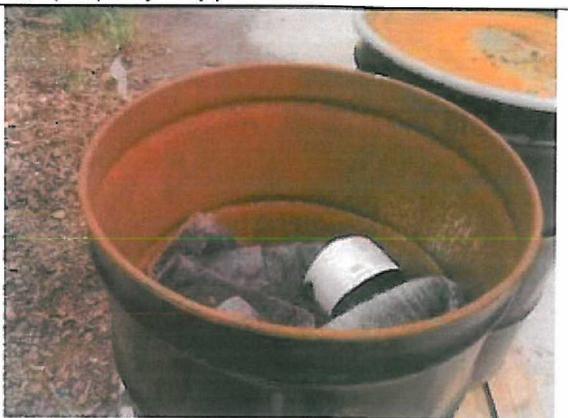
Figure 8 - Used paint filters are stored within an uncovered, empty fifty-five gallon drum.
