June 28, 2013

**RE: Acorn Walk Subdivision; NPDES Permit # 1GC04543*AG
Compliance Inspection Findings and Notice of Violation**

Ohio EPA DSW Storm Water Section, Construction Site Visit Information Form

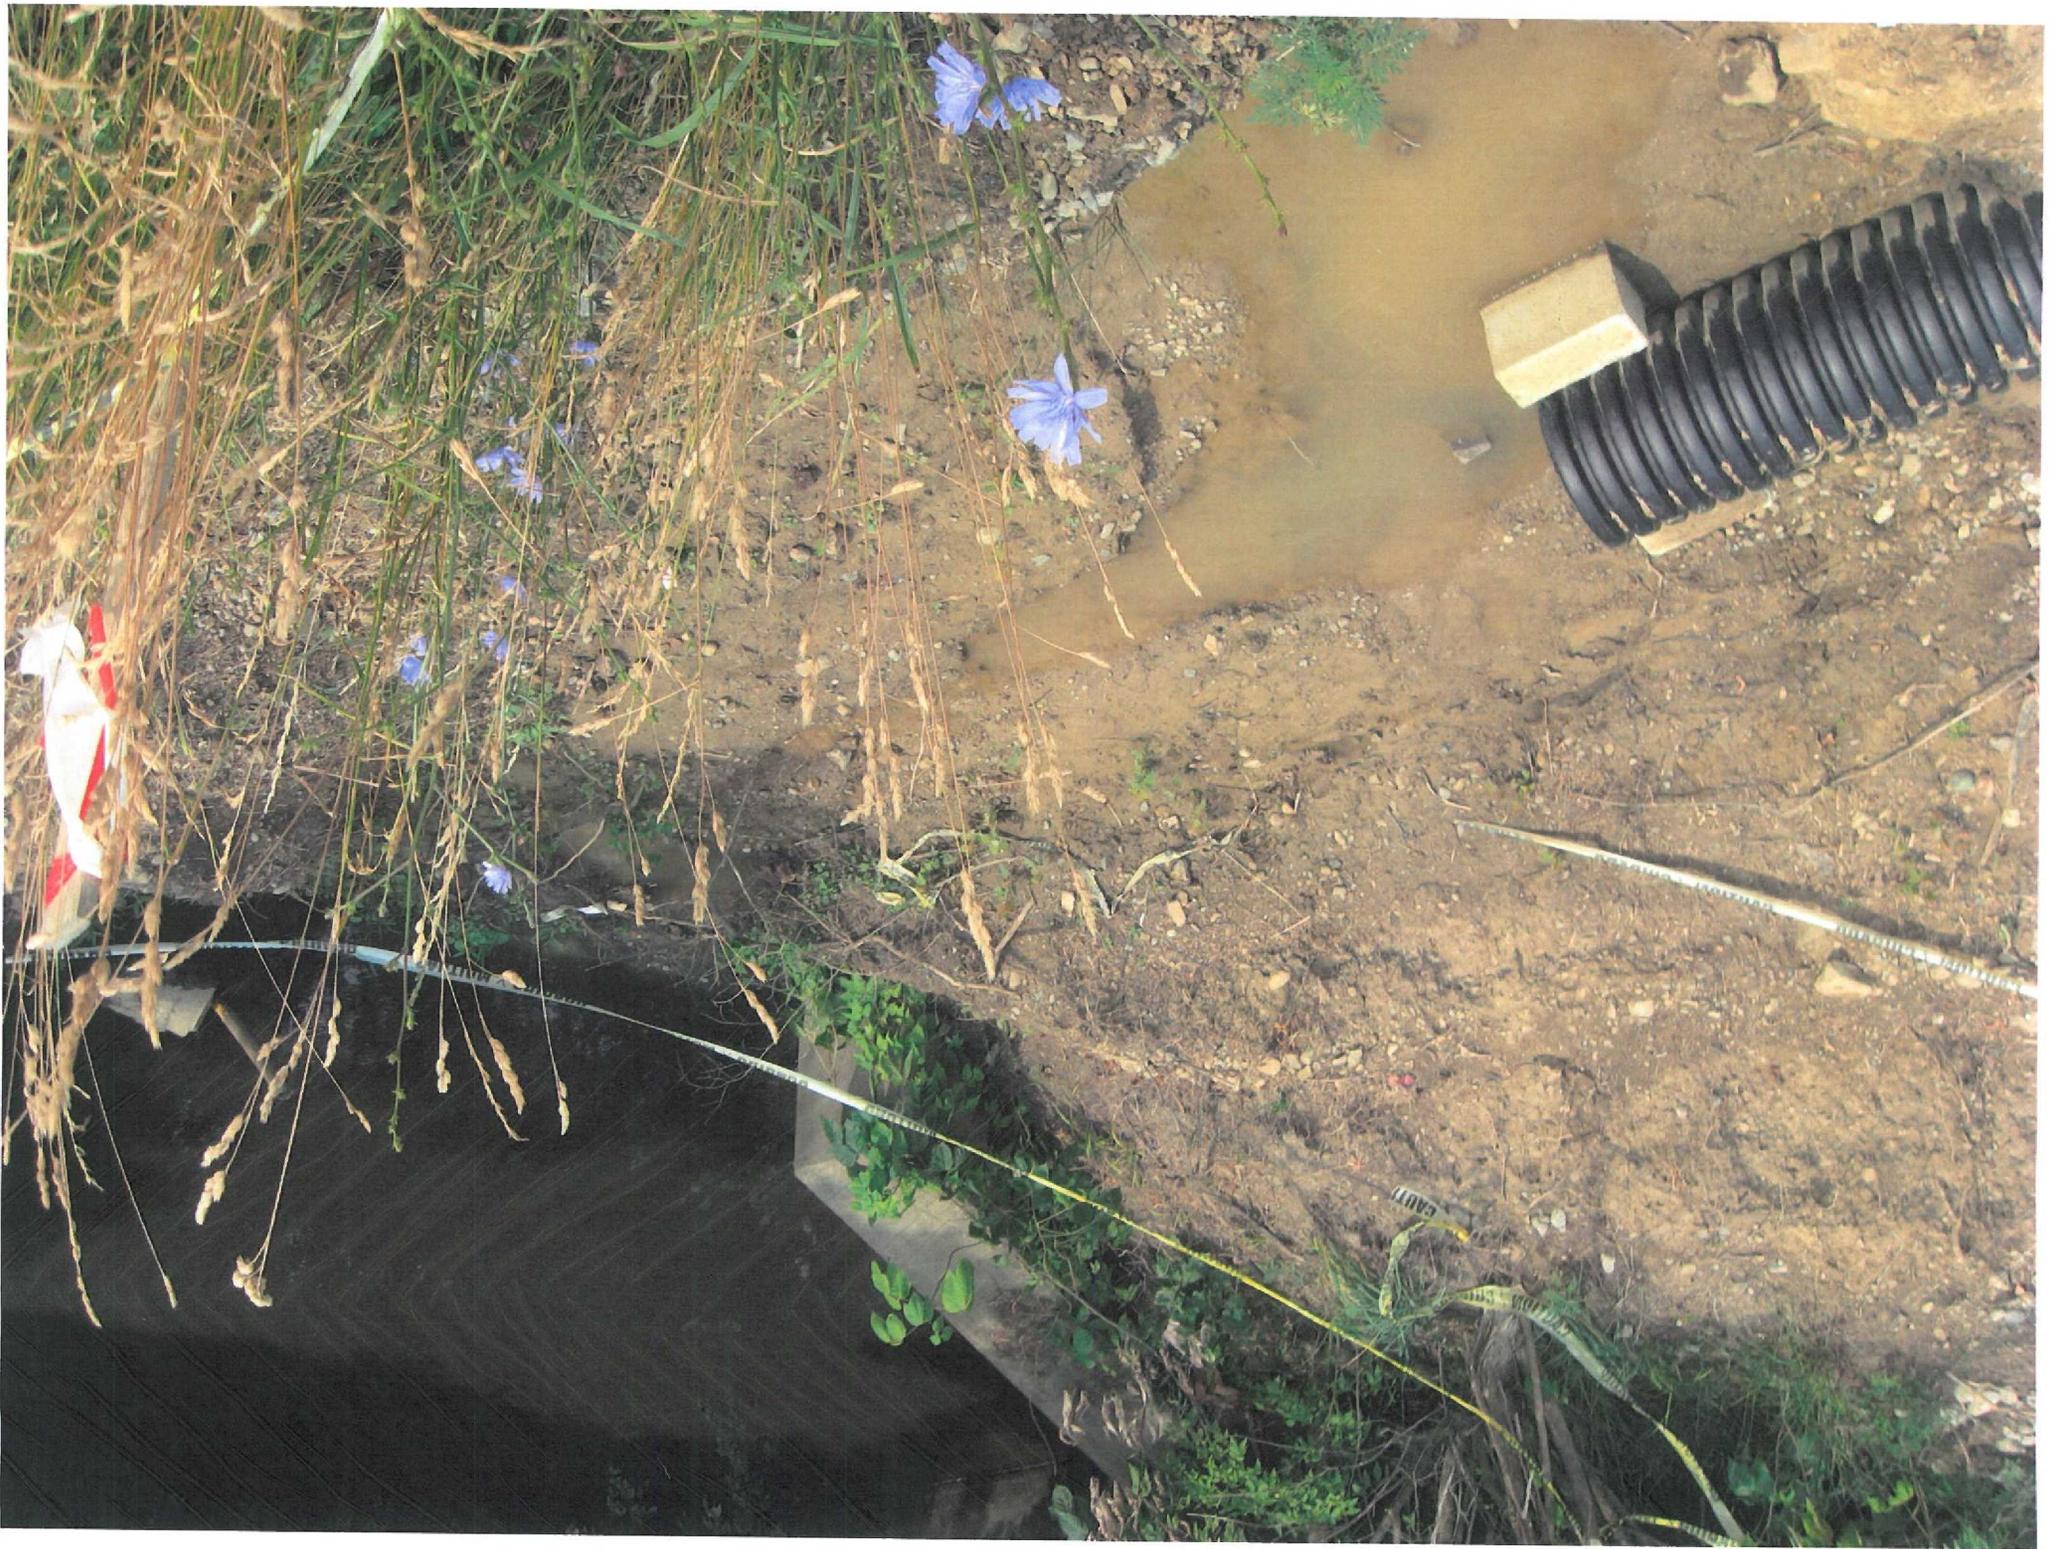
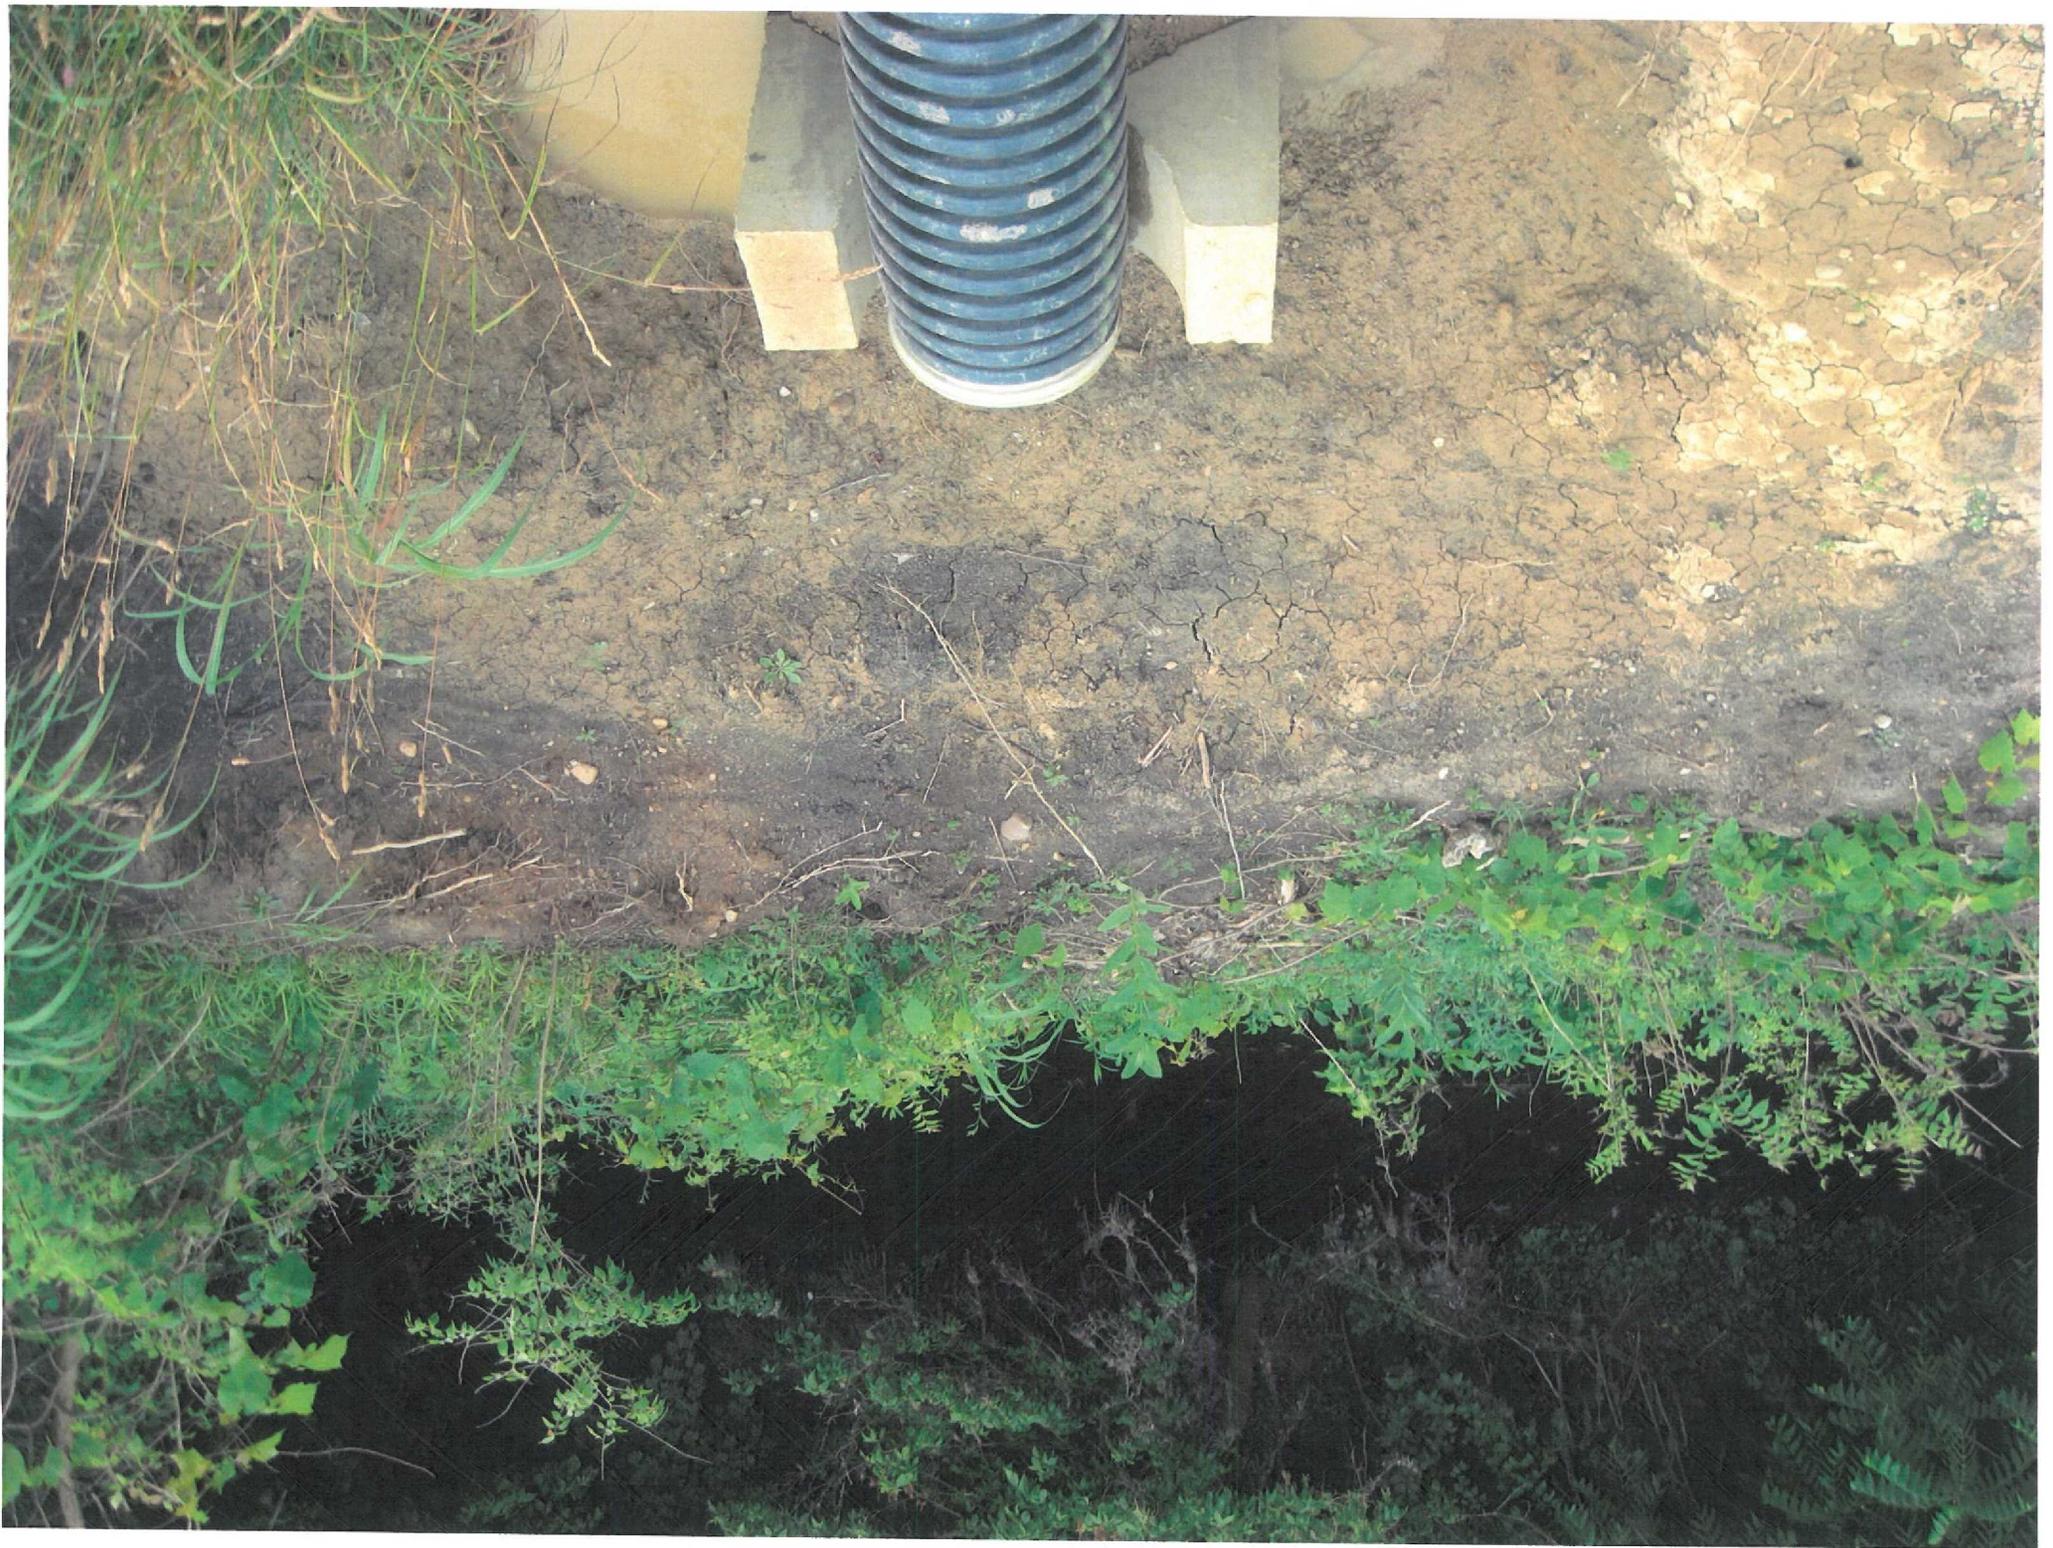
Storm drains located in the parking lot of the newly constructed building are allowing sediment-laden water to enter the storm sewer system, which discharges into an unnamed tributary of Beaver Creek. Inlet protection must be implemented if sediment-laden water is entering an active storm drain system, unless the storm drain system drains into a sediment settling pond. Inlet protection, such as dandy bags, must be installed until all disturbed areas on site are stabilized. The two outlet pipes, of the storm drain system are discharging storm water onto approximately five feet of disturbed soil before entering the stream. Rock outlet protection must be installed to provide an erosion resistant transition area where concentrated flows enter a natural stream. The photographs, included with this letter, document the violation.

Additional notes/comments:
Storm water sewer system outlet Discharge Pipe near creek does not have any rip rap in place. Storm water drains onto dirt then into creek
 - one south of the one w/o rip rap has a sediment trap around the discharge pipe. Water only enters the creek if it overflows. Highly Erodible use Stone.
 - Disturbance within 50ft of a State Body of water

Explain: Use Dandy Bags in Parking Lot until area is stabilized, Silt Fence running along sewer creek
