RE: Cherokee Run Landfill Reconnaissance Inspection / Notice of Violation

NPDES Compliance Inspection Report

Cherokee Run Landfill
2012 Final Cover Construction
Photograph Log

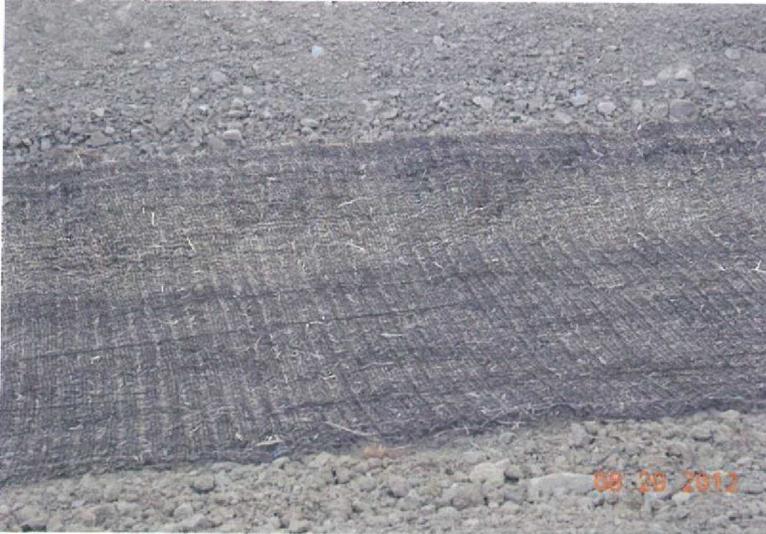
Photograph #67

Erosion control matting was installed in the flow line of the terraces.

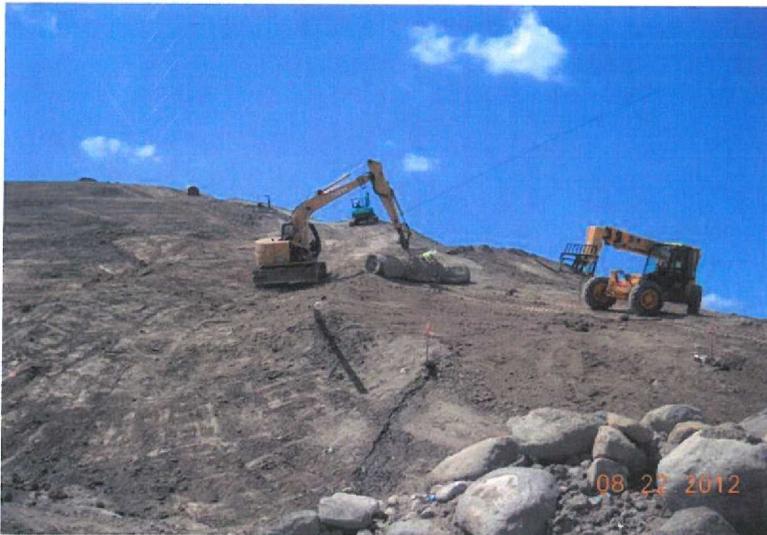
Photograph #68

The contractor placed Protective Cover soil to construct the down chute at the northwest corner of the Final Cover. In the down chute a tied concrete block mat (Flexamat) was installed.

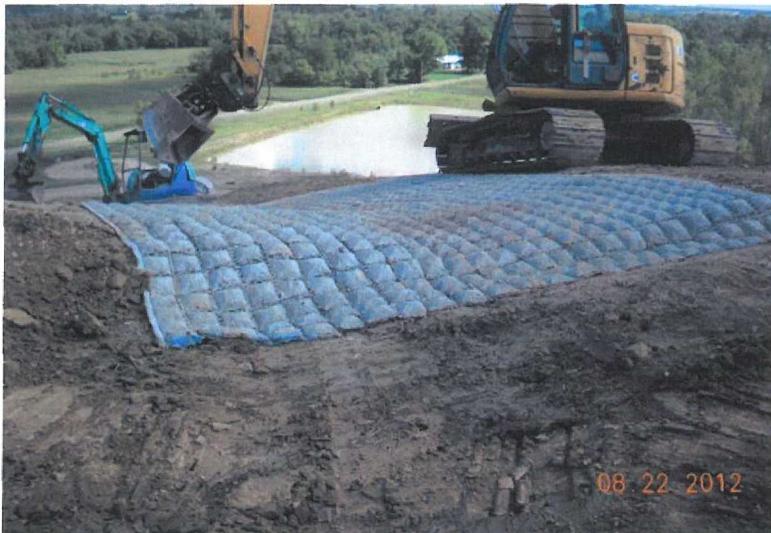
Photograph #69

The Flexamat was installed using a small excavator. The material was secured in place using pins.

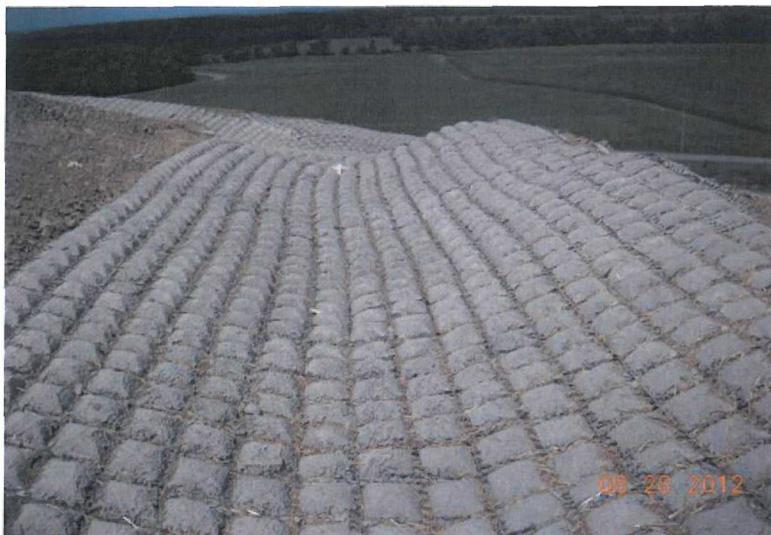
Photograph #70

A view of the Flexamat erosion control material.
