July 1, 2013

RE: CUYAHOGA COUNTY
CITY OF STRONGSVILLE
CONSTRUCTION STORM WATER
PERMIT NO: 3GC06132*AG
GIANT EAGLE MARKET DISTRICT #4086

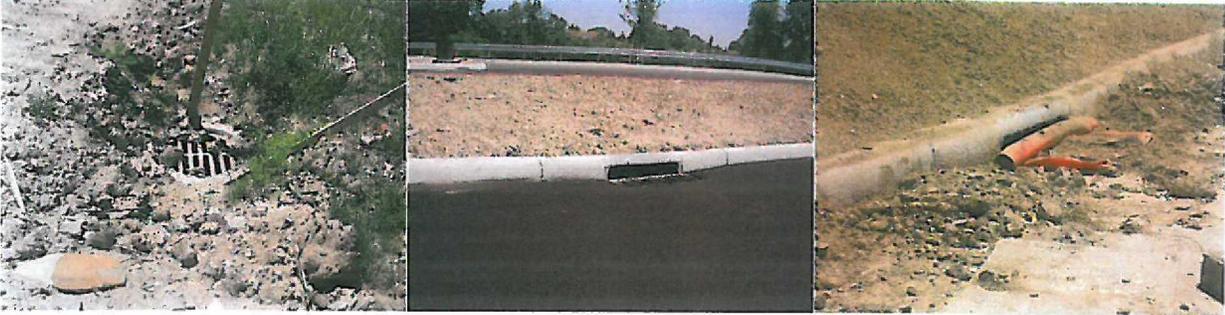
- **Storm drain inlet protection has not been constructed per specifications.** Catch basins on the strip that borders Pearl Road did not have any form of inlet protection. Please note that geotextile is to be supported by a wooden frame and cross braces constructed of 2"x4"s as well as wire mesh. The protections for the catch basins in the parking lot were either insufficient or lacking. Please review the specifications contained in the SWP3 and in *Rainwater and Land Development, Ohio's Standards for Storm water Management, Land Development and Urban Stream Protection* (Ohio Department of Natural Resources, 2006), and install/repair inlet protection to meet these standards.

Missing/insufficient inlet protection.

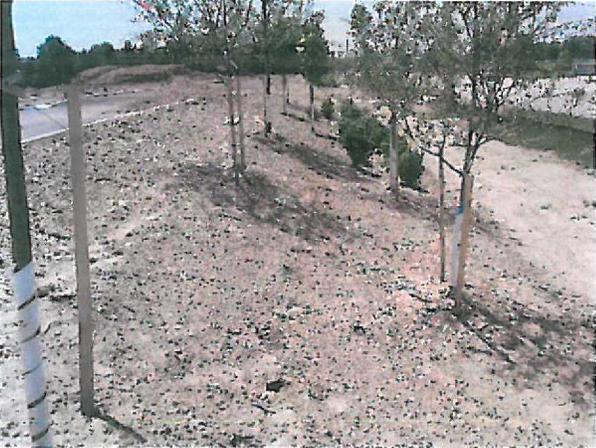
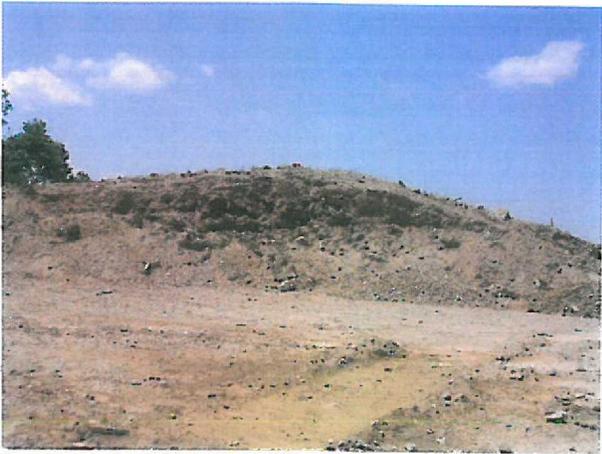
- **Stabilization (i.e., seeding and mulching), has not been initiated as required by the NPDES permit.** Temporary stabilization must be initiated within 7 days of last disturbance on any disturbed area of the site if it will not be further disturbed within 14 days of last disturbance. Permanent stabilization must be initiated within 7 days of reaching final grade. **No stabilization was evident on the sites perimeter or on the soil stockpiles.**

These areas are in need of stabilization if they will remain undisturbed for 14 or more days.

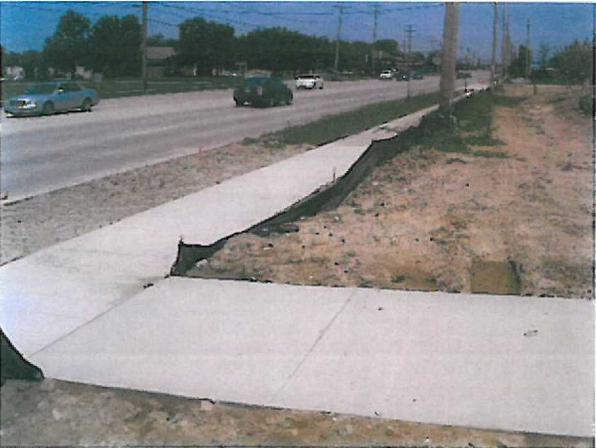
- **Silt fence has not been installed in a functional manner or has not been maintained as required by NPDES Permit.** All sediment controls, including silt fence, must be capable of ponding runoff in order to settle sediment. Silt fence must be trenched or backfilled and the joint stakes of the silt fence must be connected by twisting the stakes together prior to staking them into the ground. **Please ensure that all joints are twisted together and repair silt fence so that it is functional.** Silt fence must remain in place until the upslope contributing drainage area has reached final stabilization (i.e., a vegetative growth density of 70% or greater has been achieved).

Silt fence in need of repair.

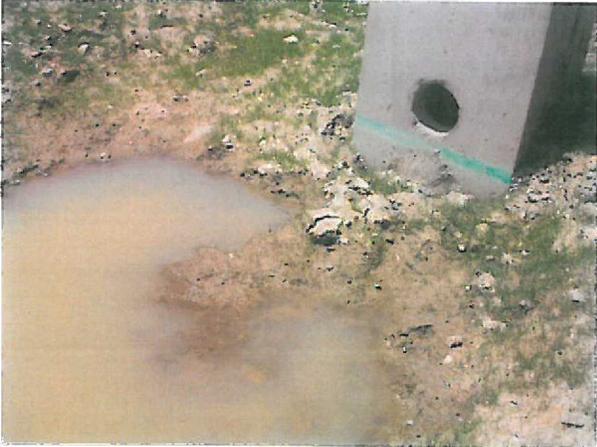
- The sediment basin outlet structure was incomplete. A sediment basin requires a sized orifice that is intended to drain down the basin's dewatering volume in no less than 48 hours and no more than 7 days. There was no orifice apparent on the basin's outlet structure.

There is no orifice present on this outlet structure.
