**RE: Reconnaissance Inspection/Notice of Violation,
Village of Pleasant Hill WWTP, 1PB00026*LD**

NPDES Compliance Inspection Report

Section B: Facility Data		
Name and Location of Facility Inspected	Entry Time	Permit Effective Date
Village of Pleasant Hill WWTP 317 Monument Street Pleasant Hill, OH 45359	9:00 a.m.	April 1, 2013
	Exit Time	Permit Expiration Date
	10:12 a.m.	March 31, 2013
Name(s) and Title(s) of On-Site Representatives	Phone Number(s)	
Mr. Jeff Derksen, WWTP Superintendent	(937) 974-8337 (Mobile)	
Name, Address and Title of Responsible Official	Phone Number	
Mayor and Council Village of Pleasant Hill 8 High Street; PO Box 557 Pleasant Hill, OH 45359	(937) 676-3241

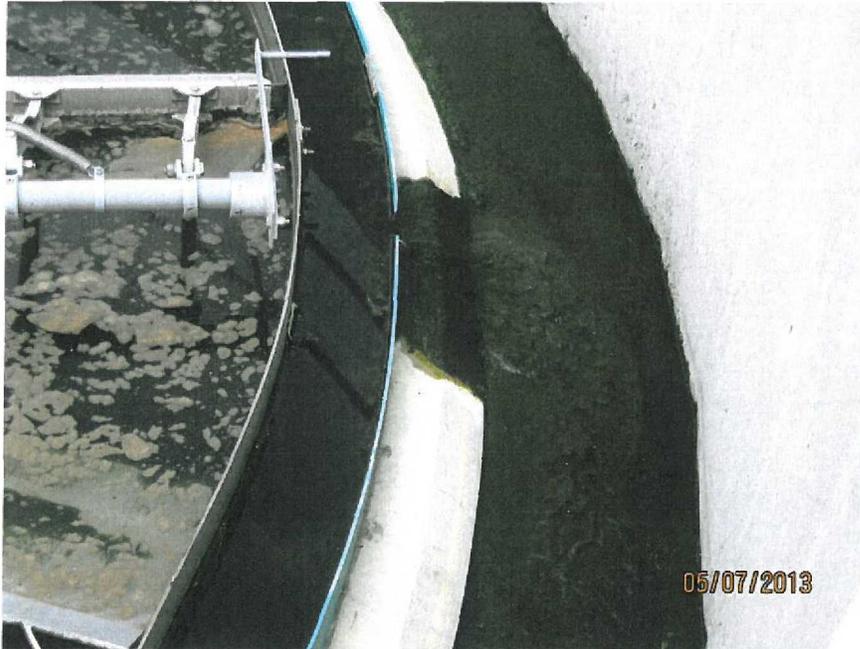
The occurrence of solids exiting the WWTP is a violation; hence this Notice of Violation. Mr. Derksen described the challenges faced in managing this condition. He indicated that the cleaning interval was about once per week. It is believed the condition leading to solids exit is caused by excessive algal growth at the clarifier location and resultant sloughing of this growth. This sloughing is believed to be the source for the observed solids exiting the UV chamber. Based upon discussions with Mr. Derksen, it is believed that this will be an on-going challenge faced by the WWTP. Please note that removal of the solids is necessary and that any washing should be conducted in a fashion that does not allow the transport of any loosened materials to a downstream location.

The inspection was conducted in response to observations of solids exiting the clarifier and the Ultraviolet (UV) Disinfection Chamber by Water Quality Personnel from the Division of Surface Water, Ohio EPA. On May 7, 2013, Diana Zimmerman and Hugh Trimble, both of Ohio EPA, were at the WWTP in relation to the forthcoming Stillwater watershed sampling effort. Please see Photos 1 and 2 for views of the solids of concern.

Photo 1 - Clarifier Weir Discharge - Note Solids in Channel. Photo from May 7, 2013.

Please provide a written response to this Notice of Violation. It is asked that a brief description of measures to be undertaken to address the solids problem be part of the response. The response is to include measures that will be taken to prevent solids migration beyond the clarifier during cleaning activities. I ask that this response be provided by July 12, 2013. If you should have any questions and/or comments, please email me at glen.vonderembse@epa.ohio.gov or call me at (937) 285-6033.

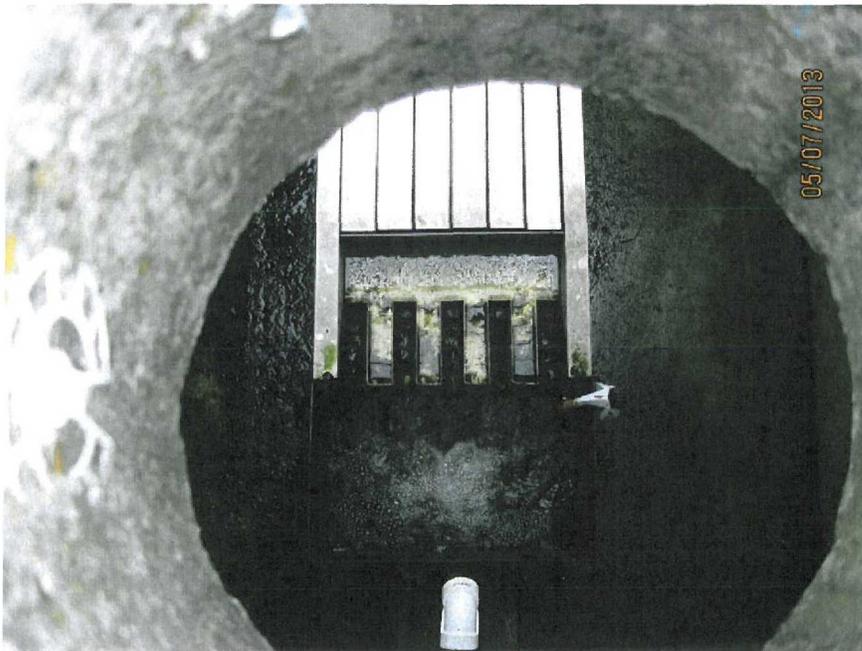
Photo 2 - Leveling Weir after Ultraviolet Disinfection. Note solids within the weir. Photo taken May 7, 2013

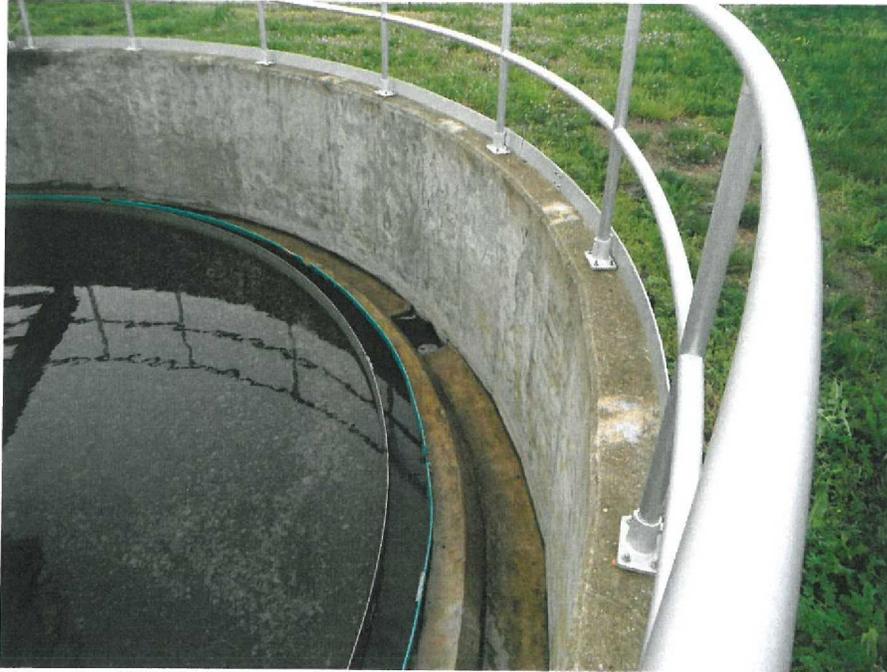
In response to their observations, I performed a Reconnaissance Inspection of the WWTP on May 10, 2013. Mr. Jeff Derksen, Operator of Record, met me at the plant. At the time of inspection, I observed no solids leaving the clarifier nor any at the leveling weir downstream of the UV disinfection unit. Please see Photos 3 and 4.

Photo 3 - Clarifier Weir and Channel. No solids present. Photo taken May 10, 2013.

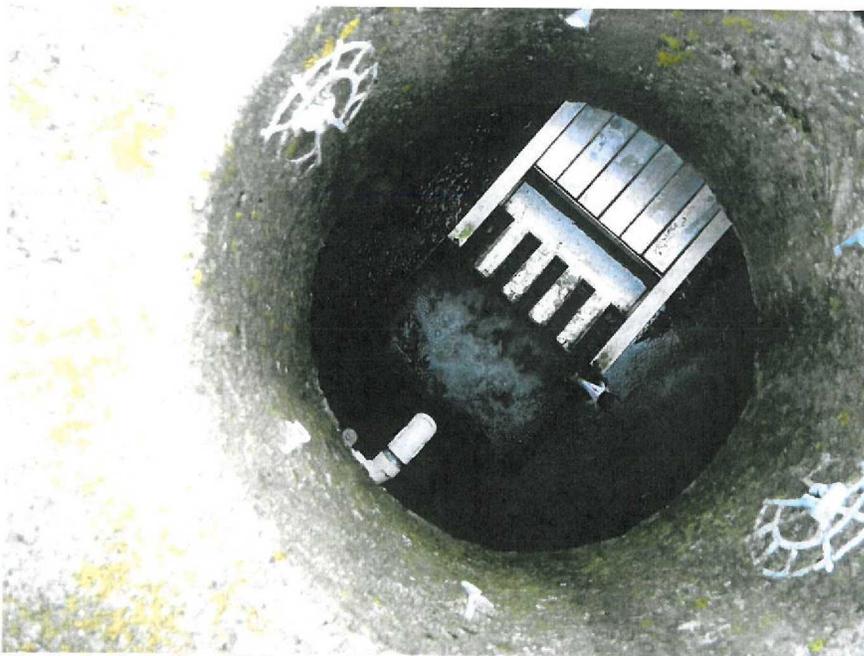
Photo 4 - Leveling Weir after Ultraviolet Disinfection. No solids within the weir. Photo taken May 10, 2013.
