June 12, 2013

**RE: Le-O-Na Falls Mobile Home Park Reconnaissance Inspection
NPDES Permit No. 1PV00123*AD / OH0133698**

NPDES Compliance Inspection Report

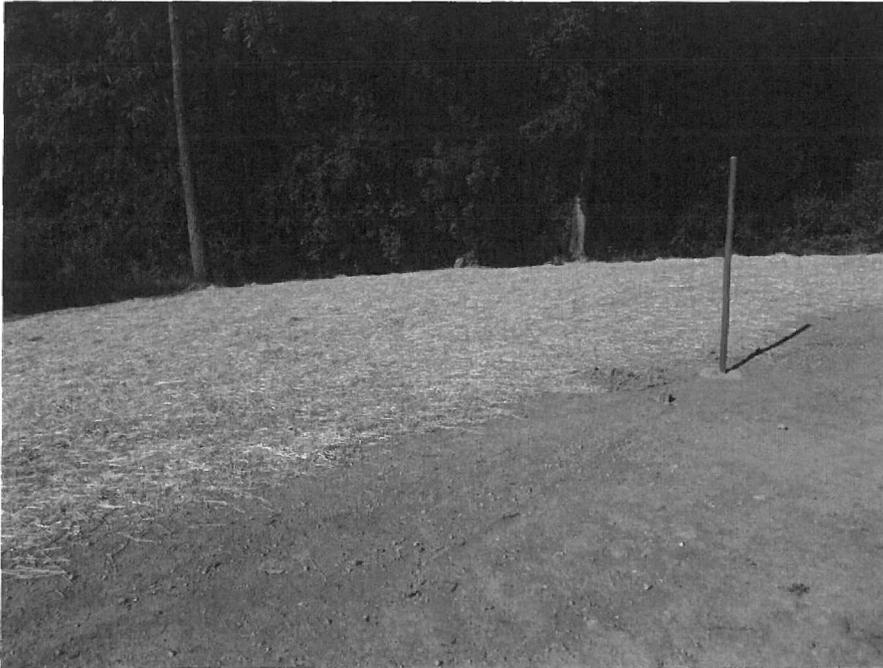
The previous lagoon was found to be abandoned and filled. A package aeration system with surface sandfilters and ultraviolet disinfection was found to be functioning, in lieu of the former lagoon. The location of the former lagoon was found to be mulched with straw. See Photo 1.

Photo 1 – Former Lagoon Location

1. Establishment of vegetation. Two areas require the establishment of a vegetative cover to prevent migration of soil into waterways. The first area is the former lagoon area. Although mulched, no vegetation was observed. The other was the area to the east of the former lagoon. This area was not mulched and no vegetation had yet been established. Please provide a means in which a good vegetative cover can be established.

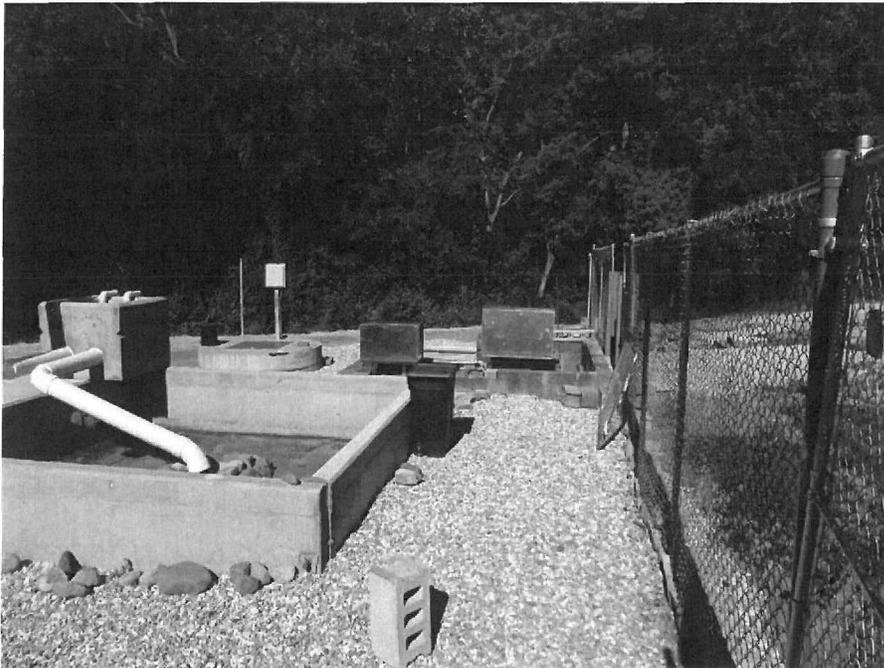
The package aeration system and subsequent treatment components were inspected. Photo 2 provides a view of the north surface sandfilter, aeration tank with blowers, and surface sandfilter lift station. The blowers for the aeration tank were found to be operating at the time of inspection. The odor was noted as being earthy (which is indicative of proper aeration tank function). The color of waters being treated was brown in the aeration tank. The clarifier portion of the package system was observed. Water flowing over the weir was clear. Indications of denitrification were present in the clarifier. This was evidenced by the presence of floating sludge masses in the clarifier. Typically, denitrification occurs due to an "old" sludge age. A reduction in the age of sludge age is typically accomplished by increasing the frequency of wasting sludge (i.e. - sending sludge to the recently installed sludge holding tank). This is the reason for the Marginal rating on Operations & Maintenance. The sludge holding tank was observed. Some sludge was noted within this tank. See Photo 4.

Photo 2 – Package Aeration, North Surface Sandfilter, Surface Sandfilter Lift Station

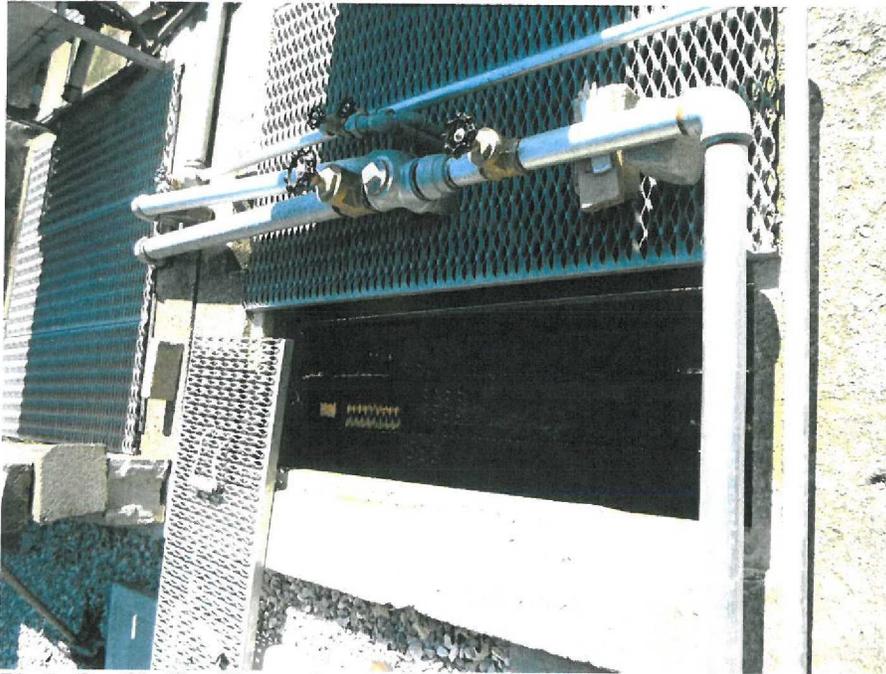
Denitrification appears to be occurring in the clarifier, as evidenced by the floating balls of sludge at the water surface. However, no solids were observed flowing over the weir of the clarifier. The following items were noted as requiring additional action:

Photo 3 – Clarifier Compartment - Note Denitrication "balls," below (as oriented in this picture) the weir.

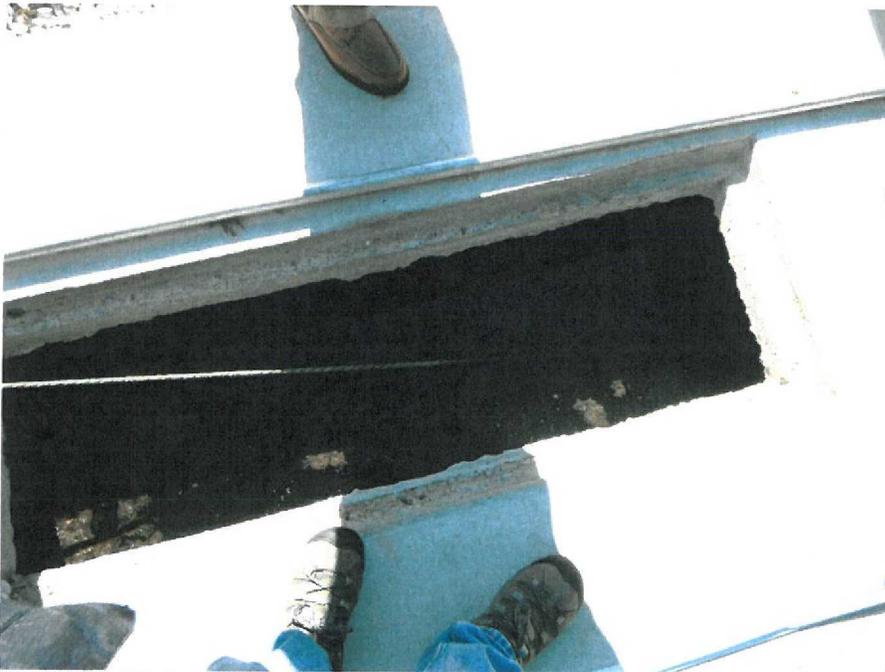
Photo 4 – Sludge Holding Tank

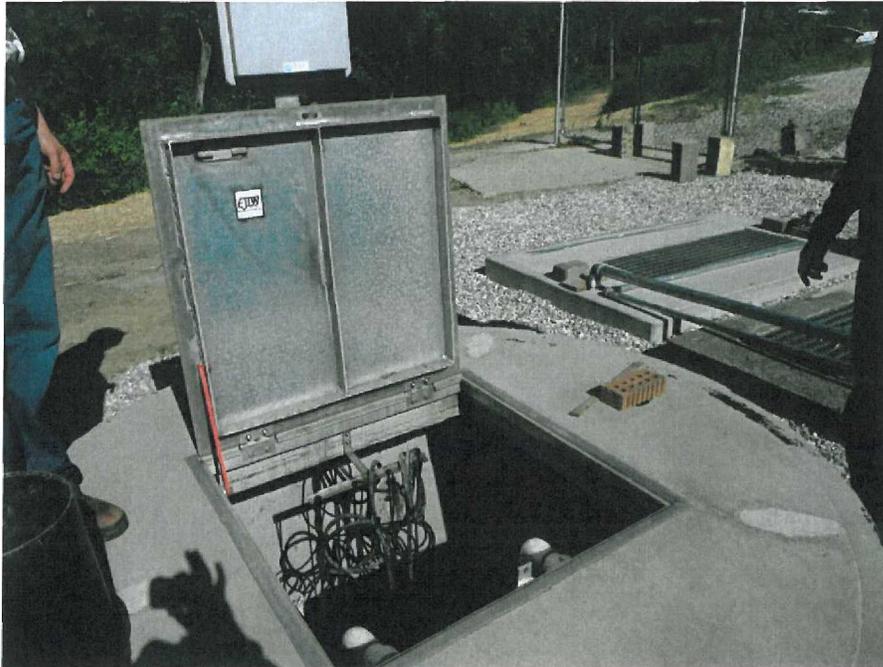
The surface sandfilter lift station was observed and found to be operational. The distribution box for these sandfilter was observed. An upturned PVC elbow was present on the outlet of the south filter. This filter was being rested, as evidenced by the upturned discharge pipe. The surface sandfilters were observed (north and south). The north filter was set up as the active filter. The sand surface of

Photo 5 – Surface Sandfilter Lift Station

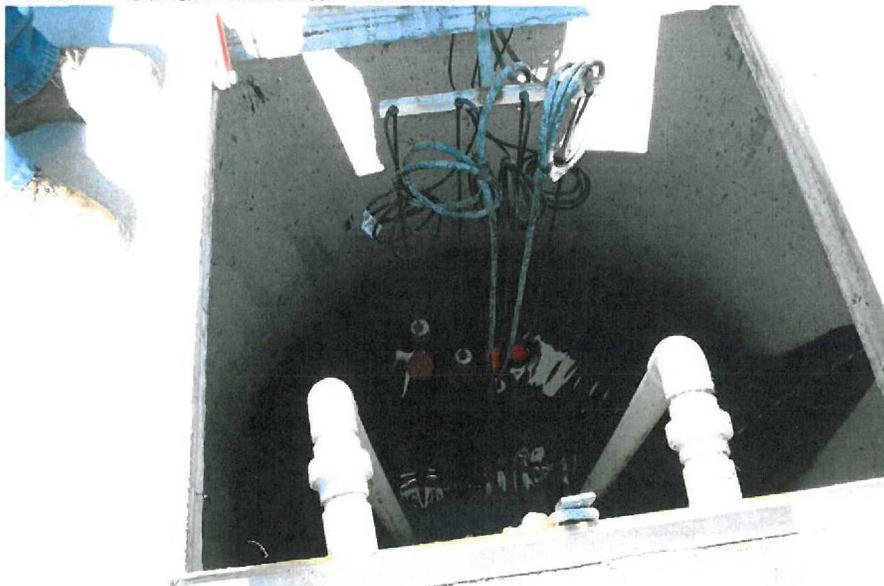
Photo 6 – Surface Sandfilter Lift Station internal view.

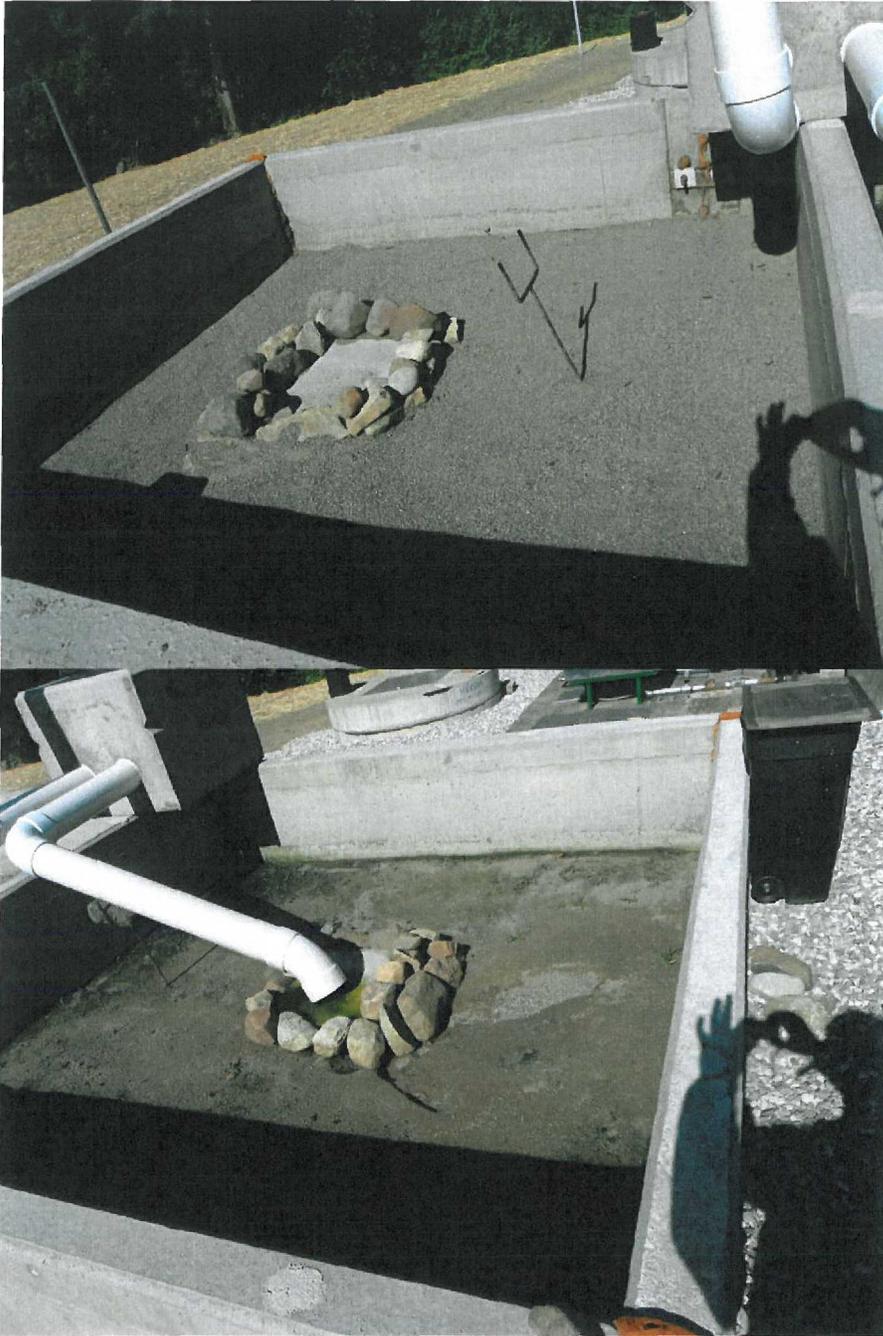
each filter was free of vegetation. However, it was noted that rilling and rivulets existed on the north sand surface in each filter. The south (resting) filter did not have these features. See Photo 7.

Photo 7 – Upper Picture: South Surface Sandfilter Lower: North Surface Sandfilter

3. Fencing around the wastewater treatment plant. The fencing around the wastewater facility was incomplete. It was evident that this appears to be in progress. Please complete this fencing installation.
4. The North Surface Sandfilter. Erosion (rutting and rilling) was present on the surface of the sand within this filter. Please smooth this sand surface via raking.
5. Surface Sandfilter Pump Station. A brick was covering a four-inch diameter hole in the top of this pump station. It is suspected that this penetration is to be utilized for a vent for the pump station. Please note that the vent typically resembles an upside down J and may be fabricated from PVC pipe.

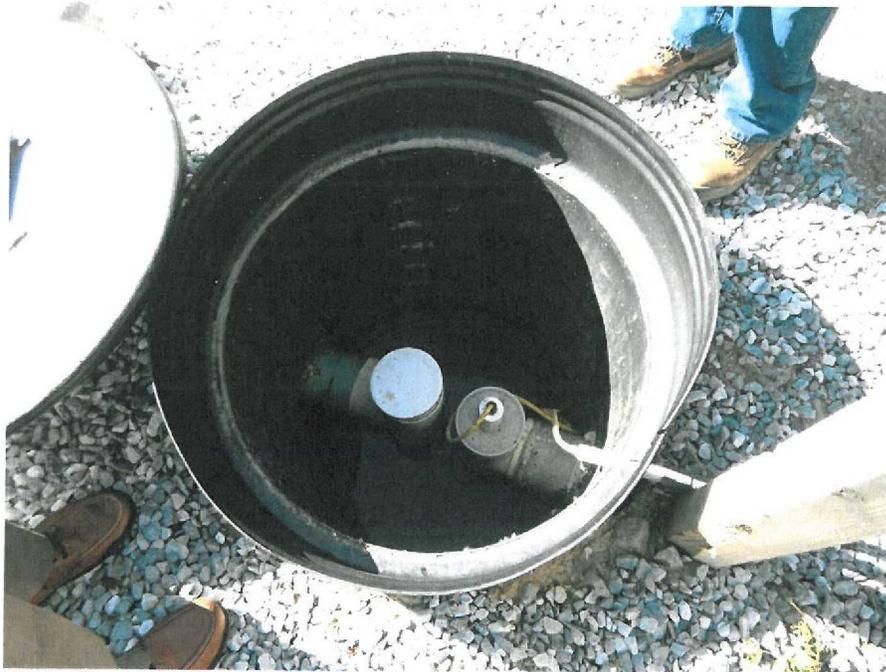
The Ultraviolet (UV) disinfection unit was observed, as well as, the sampling chamber (See Photos 8 and 9). Both units were in very good physical condition. No evidence of solids carryover was noted in either of these locations. The UV unit was noted as being electrically connected.

Photo 8 – Ultraviolet Disinfection Unit

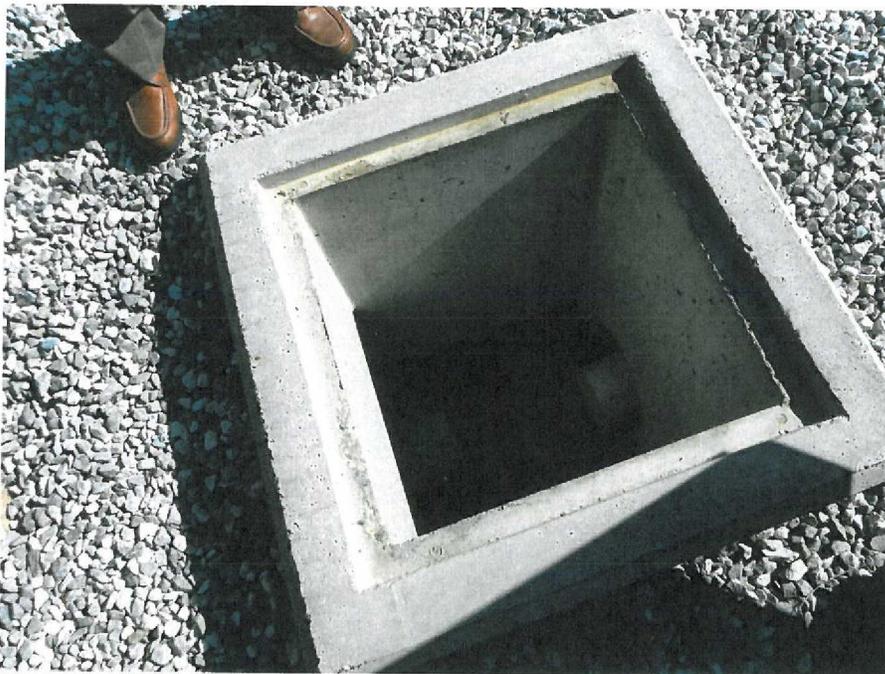
Photo 9 – Sampling Chamber

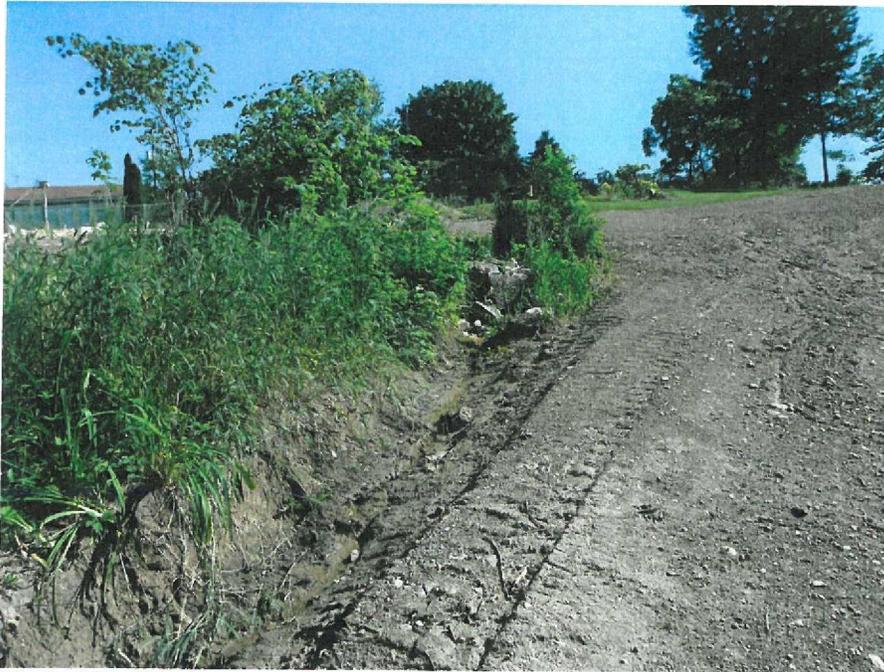
Photo 10 is a view of the discharge. The swale downstream requires stabilization to prevent the migration of soil due to the action of flowing water. Also, at the bottom of the slope, this swale becomes non-defined, allowing the water to spread out and create a ponding situation, prior to flowing into the unnamed tributary of Ludlow Creek. Please note this condition may create an environment that allows mosquito's to breed, possibly leading to a mosquito nuisance situation (See Photo 11).

Photo 10 – Discharge and Associated Surface Water Conveyance (Swale)

2. The surface water conveyance from the discharge to the unnamed tributary of Ludlow Creek. No controls are provided to minimize the potential for erosive action to cause the migration of soil within this drainage course. Please install control measures within this swale that will prevent soil migration. Also, prior to entry into the unnamed tributary, the discharged water is tending to pond (standing water). This condition may lead to conditions conducive to mosquito breeding. It is recommended that water flow be improved through this channel segment to minimize the potential for a mosquito breeding area.

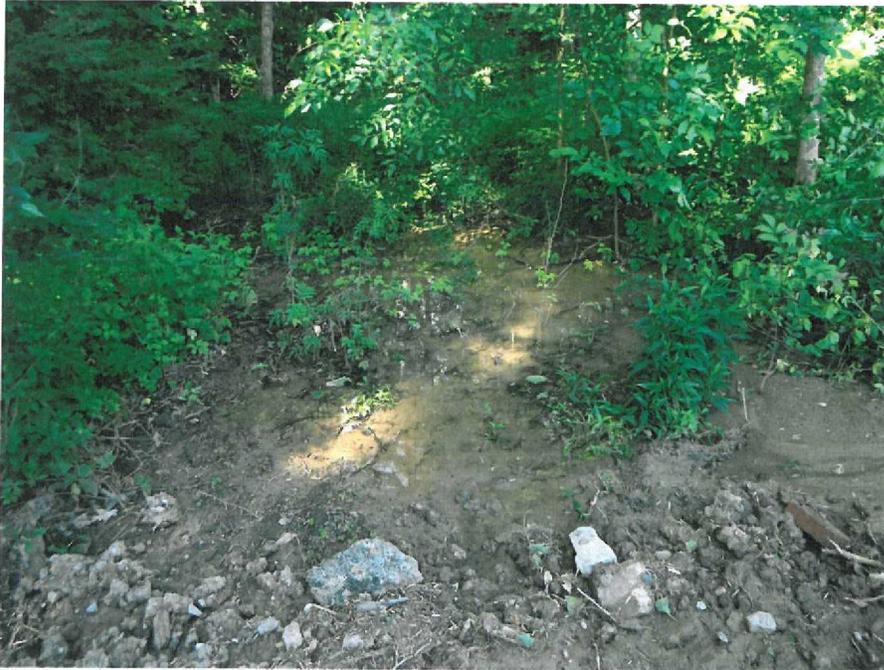
Photo 11- Ponding water prior to entry into an unnamed tributary of Ludlow Creek.

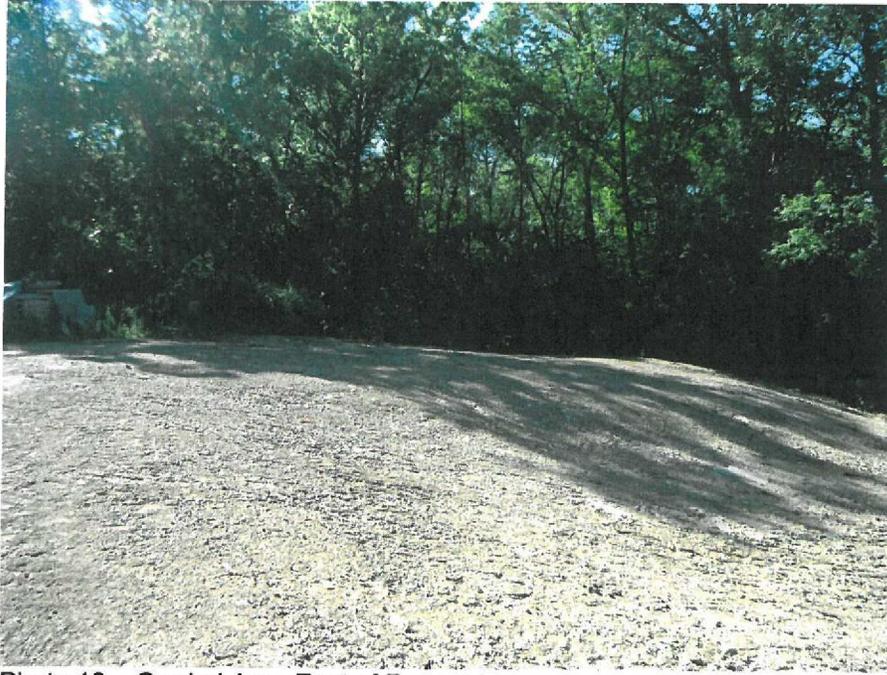
The fencing around the treatment plant was in-progress and requires completion. Also, areas east of the former lagoon had been recently re-graded. This area requires seeding and mulching to establish a vegetative stand to minimize any soil erosion potential. (See Photo 12)

Photo 12 – Graded Area East of Former Lagoon.
