July 5, 2013

**RE: Catholic Central School; NPDES Permit # 1GC04654*AG;
Compliance Inspection Findings and Notice of Violation**

Ohio EPA DSW Storm Water Section, Construction Site Visit Information Form

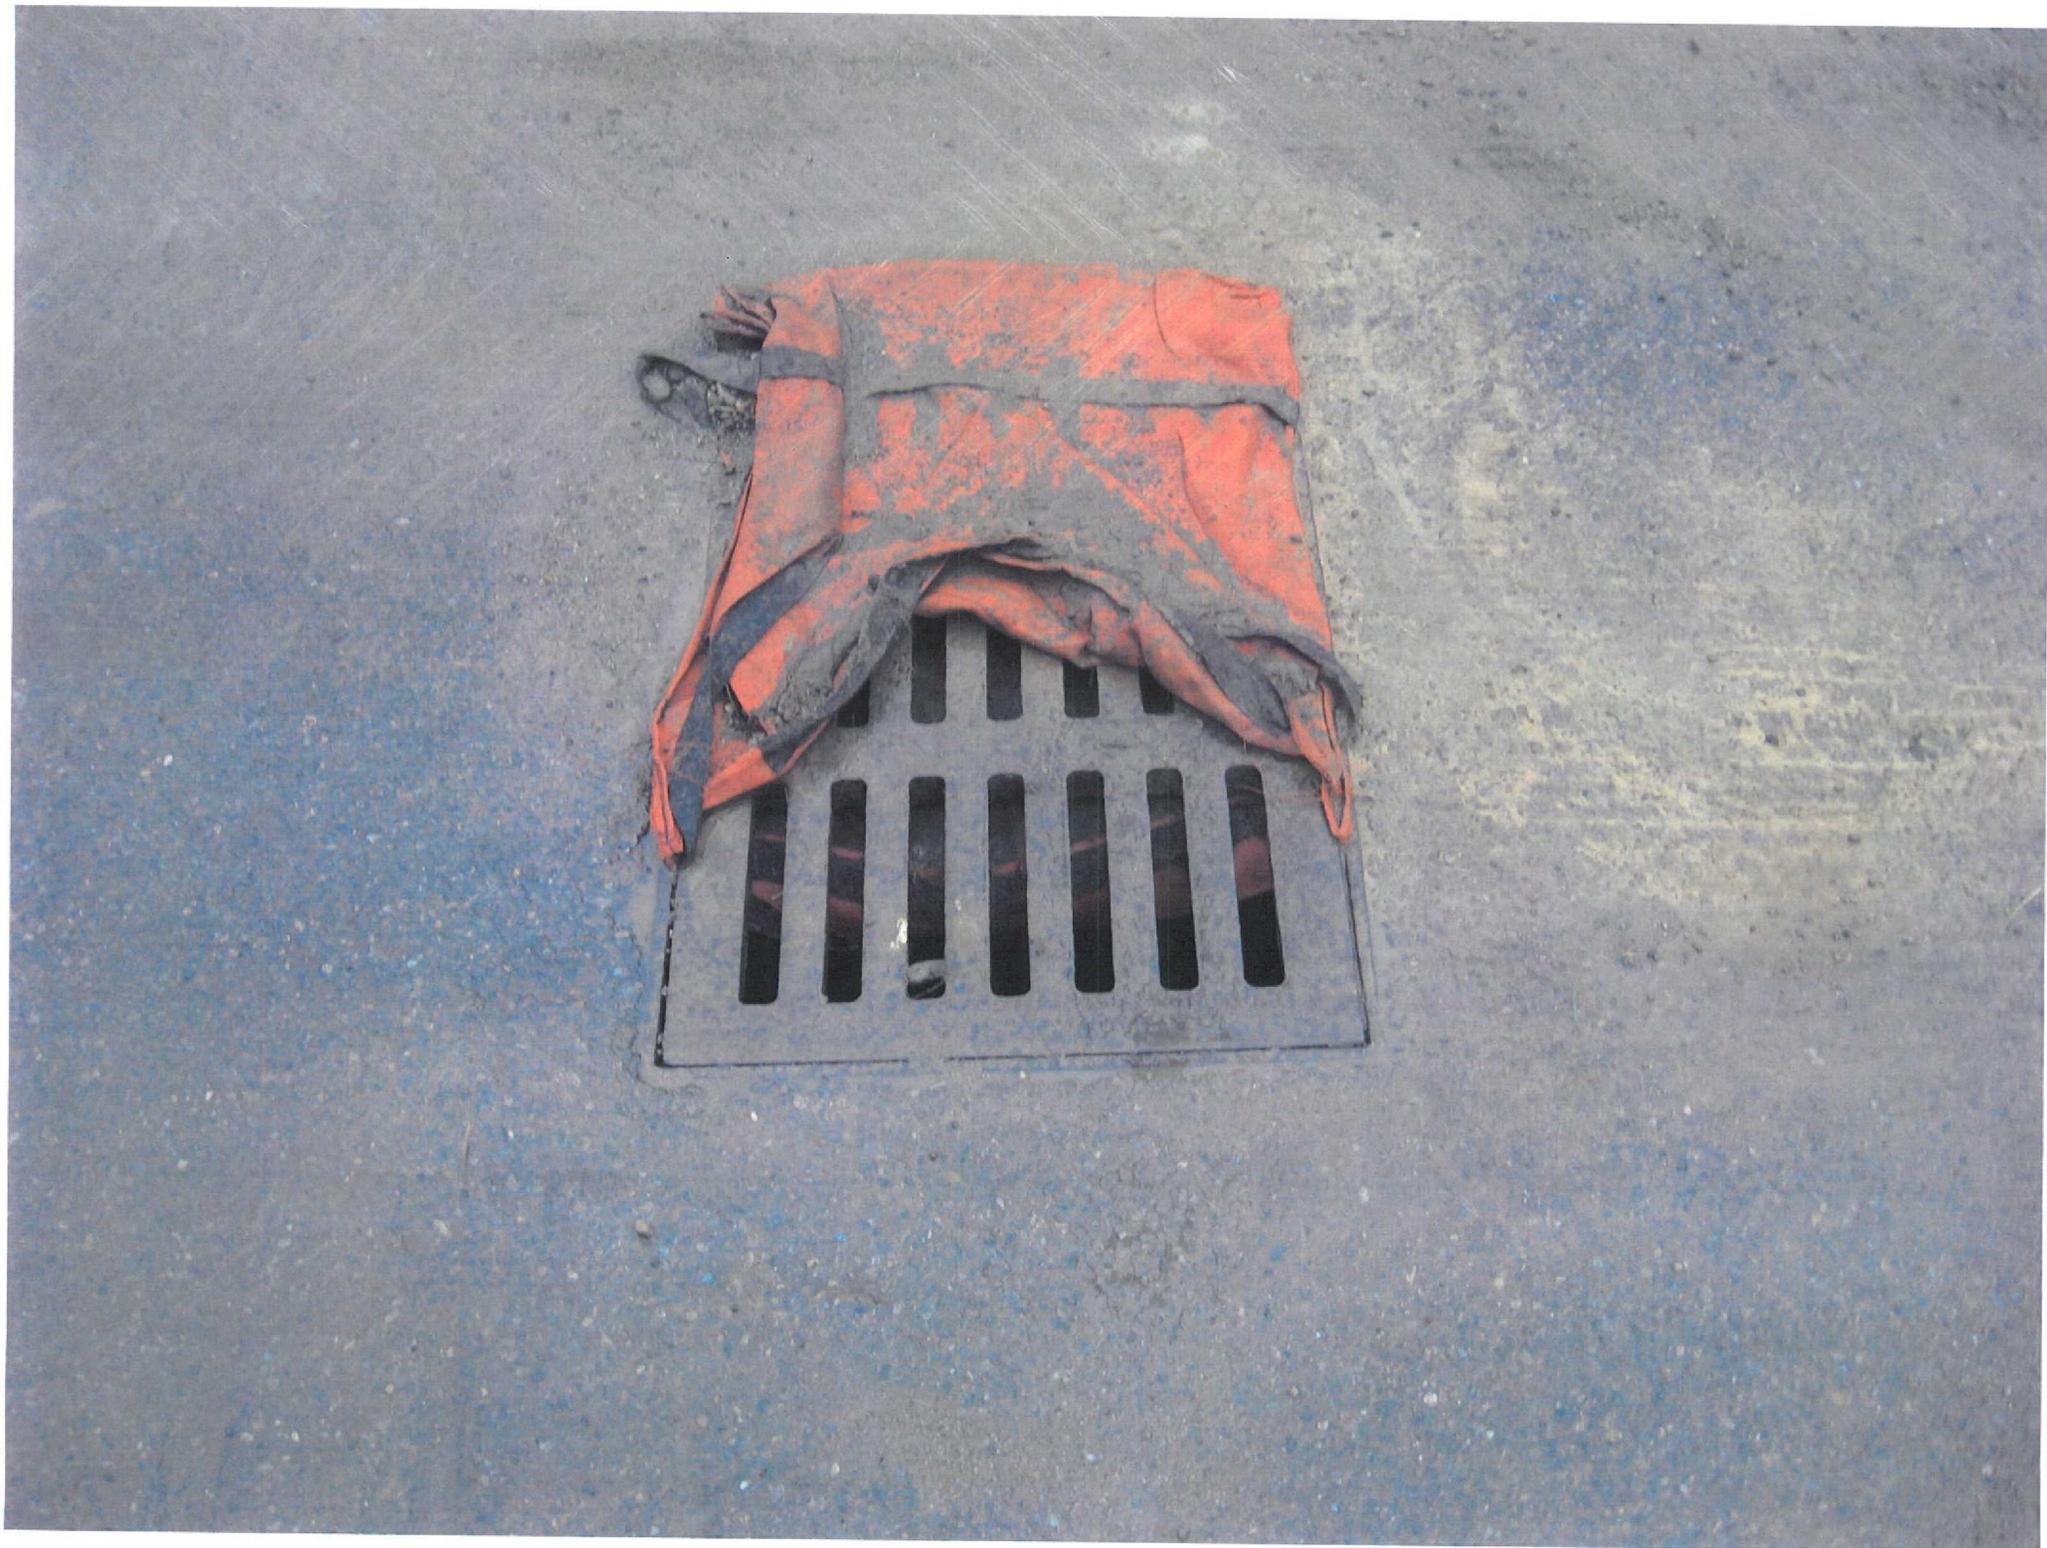
The silt fence located along McKinley Avenue, in the northwest corner of the property, is incapable of minimizing the loss of sediment in the event of a rainstorm. The photographs included, with this letter, document the violation. Sediment laden water is flowing over the damaged fence into the street and storm sewer system.

Explain: Silt Fence needs maintenance, Northwest corner (low spot) Ripped Dandy Bag, Need containment for everything drains into that corner

Additional notes/comments:
 Sediment laden water leaving property in Northwest corner
 In alley dandy bag ripped, was the sediment is leaving the property.

It is evident that this area is the low spot for the entire site. Silt fence is generally not recommended for use in areas where concentrated flows of runoff will occur. A better option might be to create a storm water detention basin to collect run off. Refer to Ohio's Rainwater Land Development Manual, Chapter 6 section 1 for more details. Another option is a Temporary Sediment Trap which would only be utilized until the site is stabilized. Refer to Ohio's Rainwater Land Development Manual, Chapter 6 section 2 for more details.

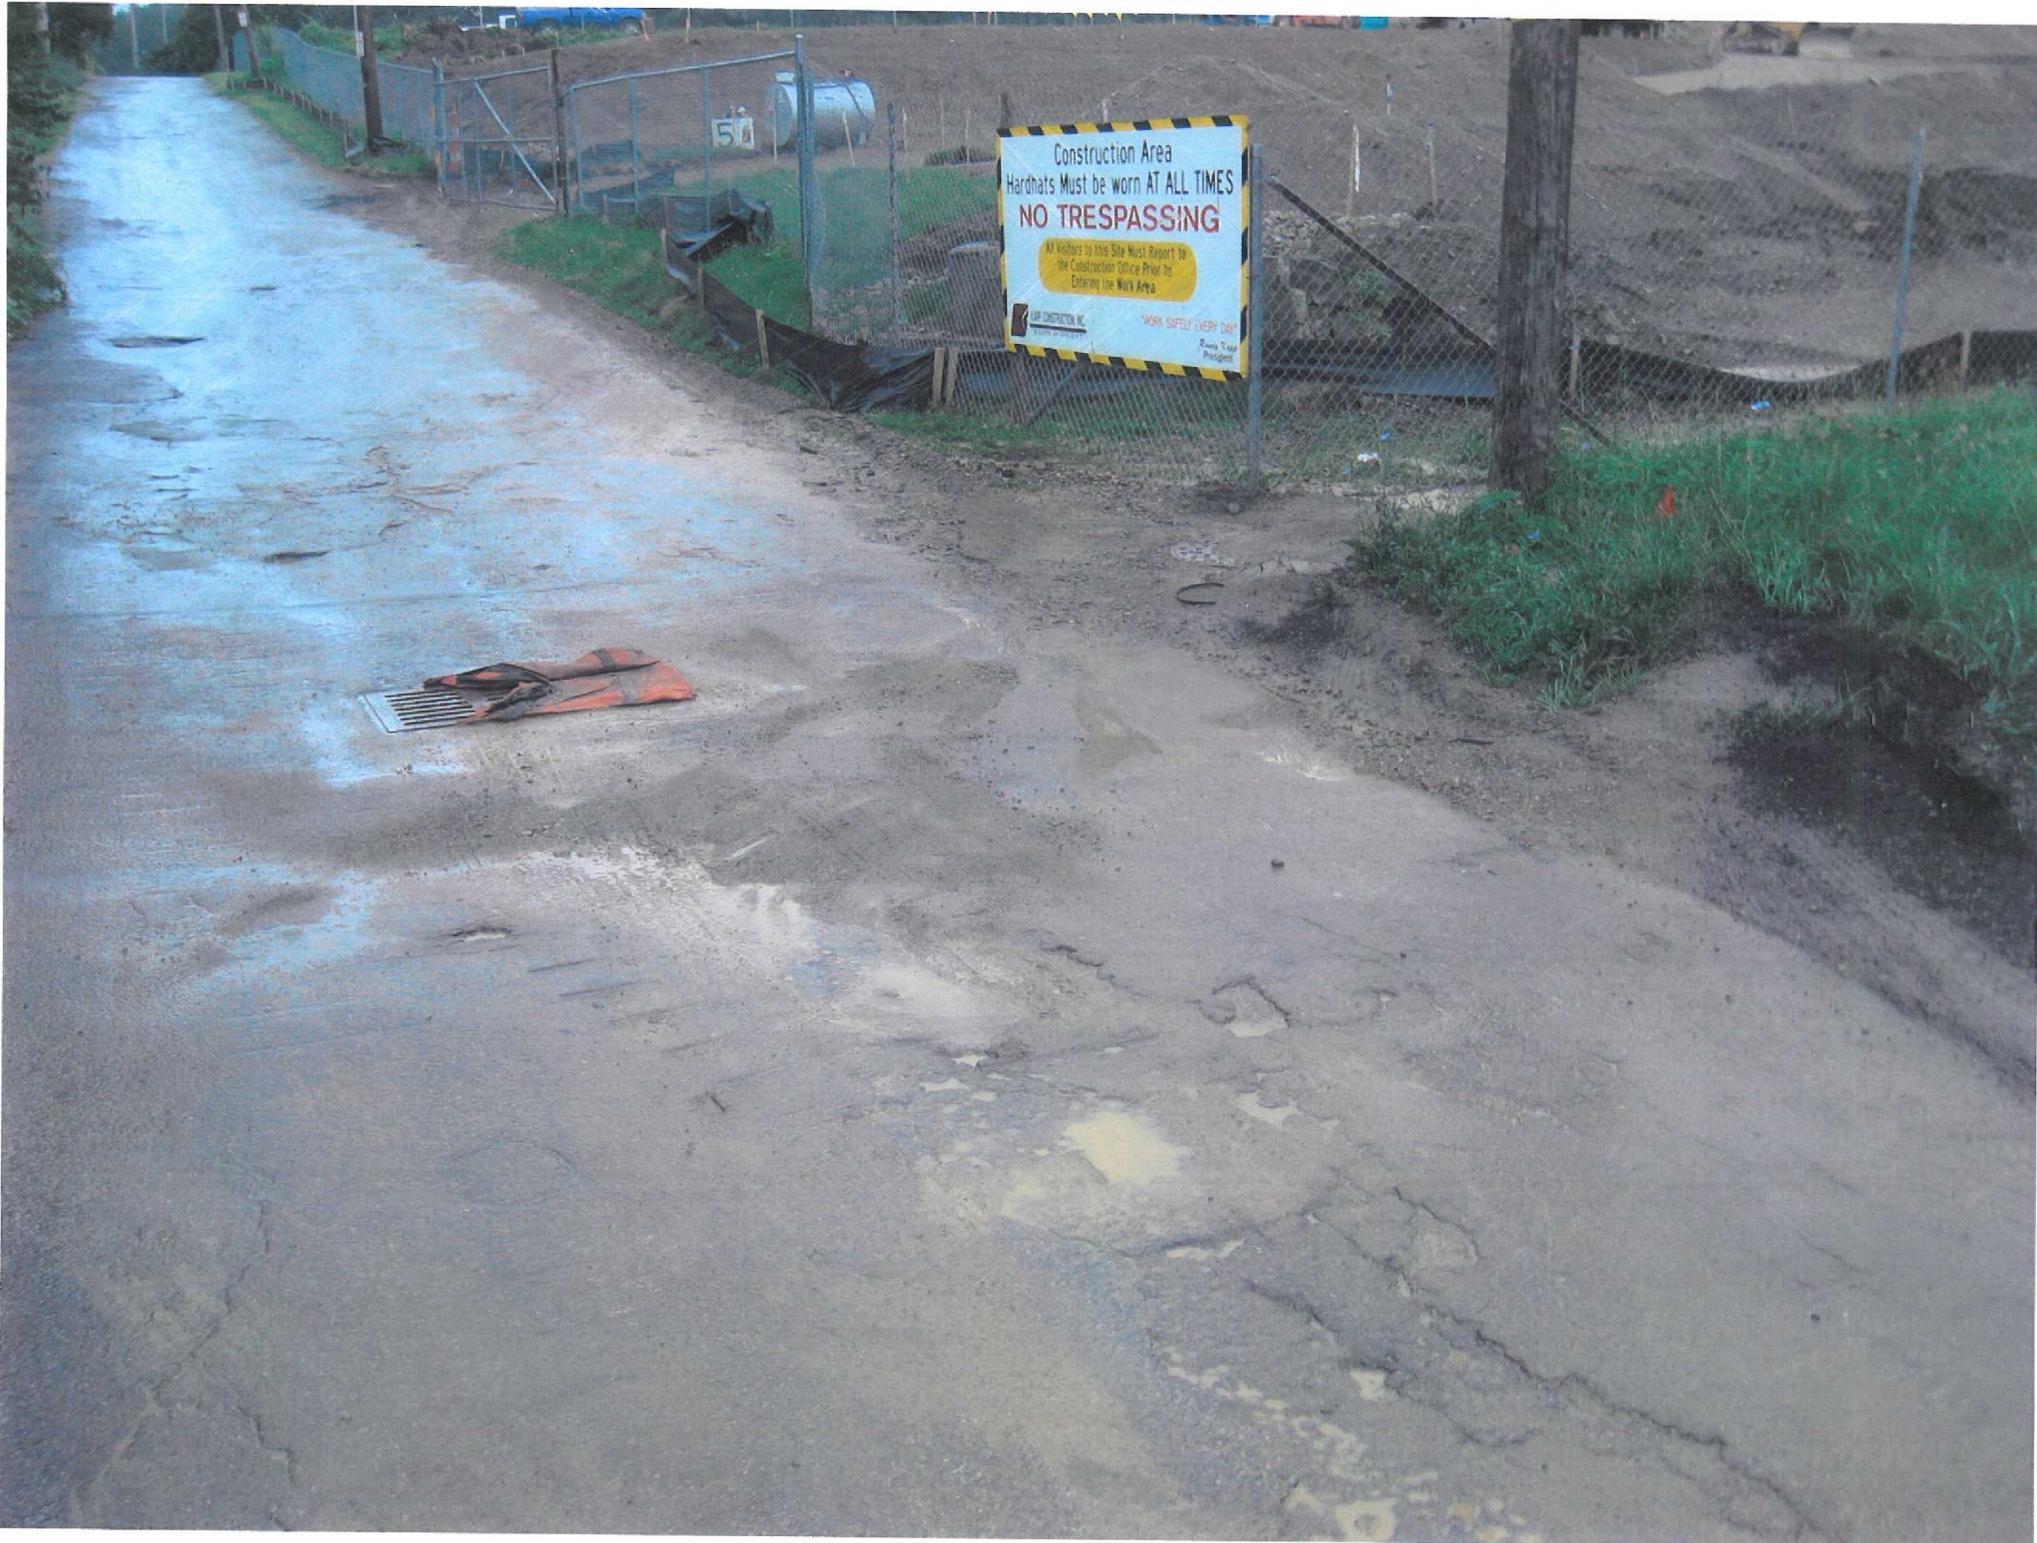
Located on McKinley Avenue there is an unprotected storm drain inlet. Sediment laden water is running from the site into this inlet. The dandy bag that was installed has been destroyed and is no longer protecting the storm drain. The photo included with this letter documents the violation. A dandy bag will minimize sediment laden water entering the city of Springfield's storm drain systems until construction activities have ceased.
