July 10, 2013

RE: LAKE COUNTY
CITY OF MENTOR
CONSTRUCTION STORM WATER
PERMIT NO: 3GC06369*AG
SHEETZ STORE

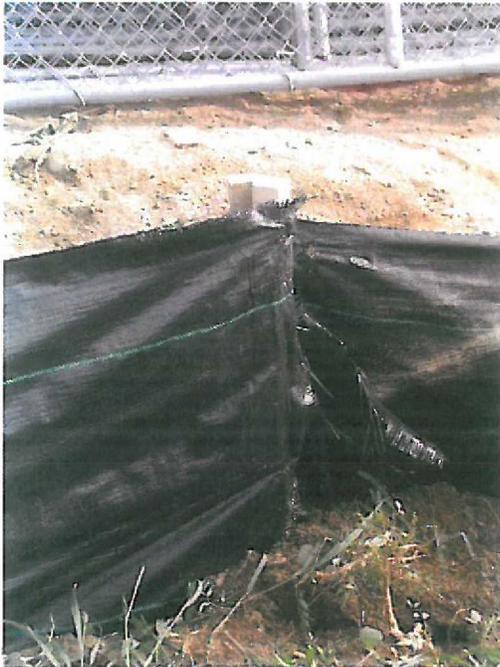
- **Silt fence has not been installed in a functional manner or has not been maintained as required by the NPDES Permit. (Figure 1)** All sediment controls, including silt fence, must be capable of ponding runoff in order to settle sediment. Silt fence must be trenched and backfilled and the joint stakes of the silt fence must be connected by twisting the stakes together prior to staking them into the ground. **Please ensure that all joints are twisted together and repair silt fence so that it is functional.** Silt fence must remain in place until the upslope contributing drainage area has reached final stabilization. (i.e., a vegetative growth density of 70% or greater has been achieved.)

Figure 1: Joints not properly tied off.

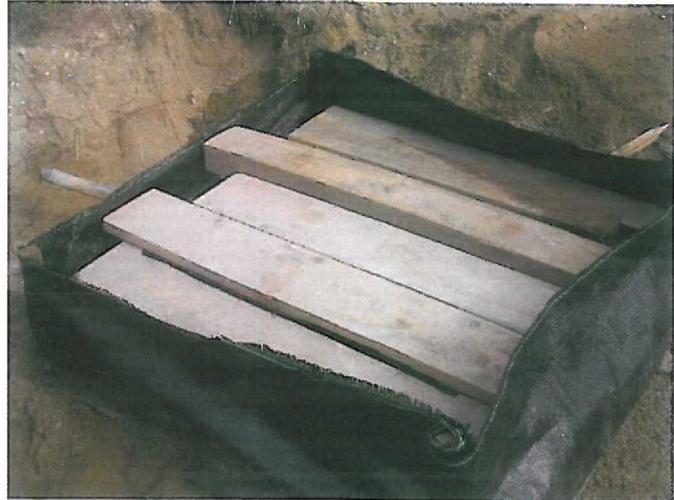
- **Storm drain inlet protection has not been constructed per specifications contained in the SWP3.** We noted inlet protection constructed by encircling drains with silt fence and placing wood over top. (Figure 2) This has resulted in failed storm drain inlet protection. Please note that geotextile is to be supported by a wooden frame and cross braces constructed of 2"x4"s as well as wire mesh. Please review the specifications contained in the SWP3 and in *Rainwater and Land Development, Ohio's Standards for Stormwater Management, Land Development and Urban Stream Protection* (Ohio Department of Natural Resources, 2006), and install/repair inlet protection to meet these standards.

Figure 2: Inlet protection not properly constructed.

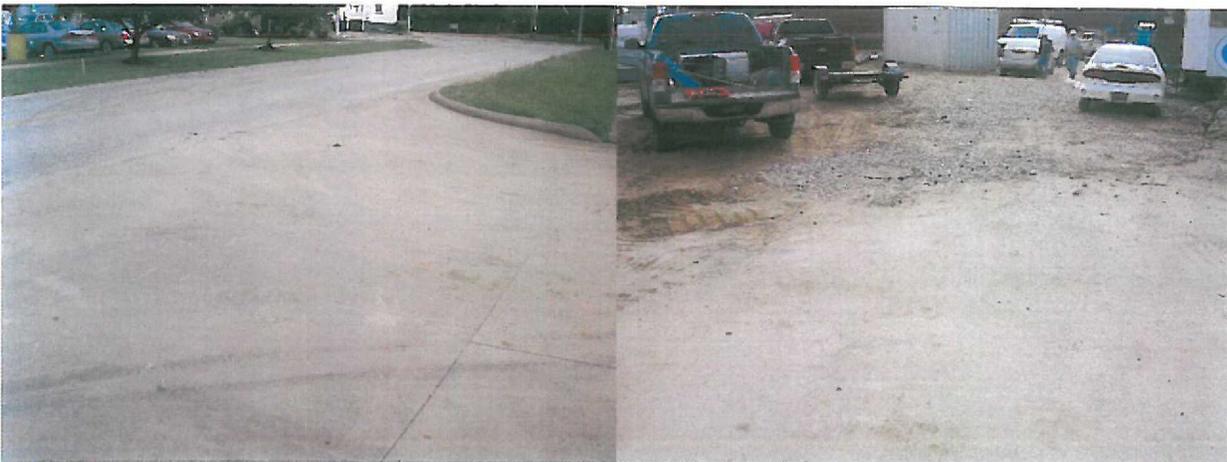
- **The Rock Construction Entrance was inadequate, resulting in sediment tracking off site. (Figures 3&4)** Specifications for a Rock Construction Entrance can be found in Chapter 7 of the *Rainwater and Land Development Manual*
- **Perry Construction Group, the day to day operator of the site, had never submitted a Co-Permittee NOI as required by the NPDES Permit.** *An e-mail from James Noble of Perry Construction dated July 8, 2013 informed that a Co-Permittee NOI had been recently submitted.*

Figures 3&4: Rock Construction Entrance fails to prevent sediment from tracking onto street.
