RE: Beacon Pointe Development; NPDES Permit # 1GC04168*AG; Compliance Inspection Findings and Notice of Violation

Ohio EPA DSW Storm Water Section, Construction Site Visit Information Form

Site Name: Beacon Pointe Phase 1 - Development

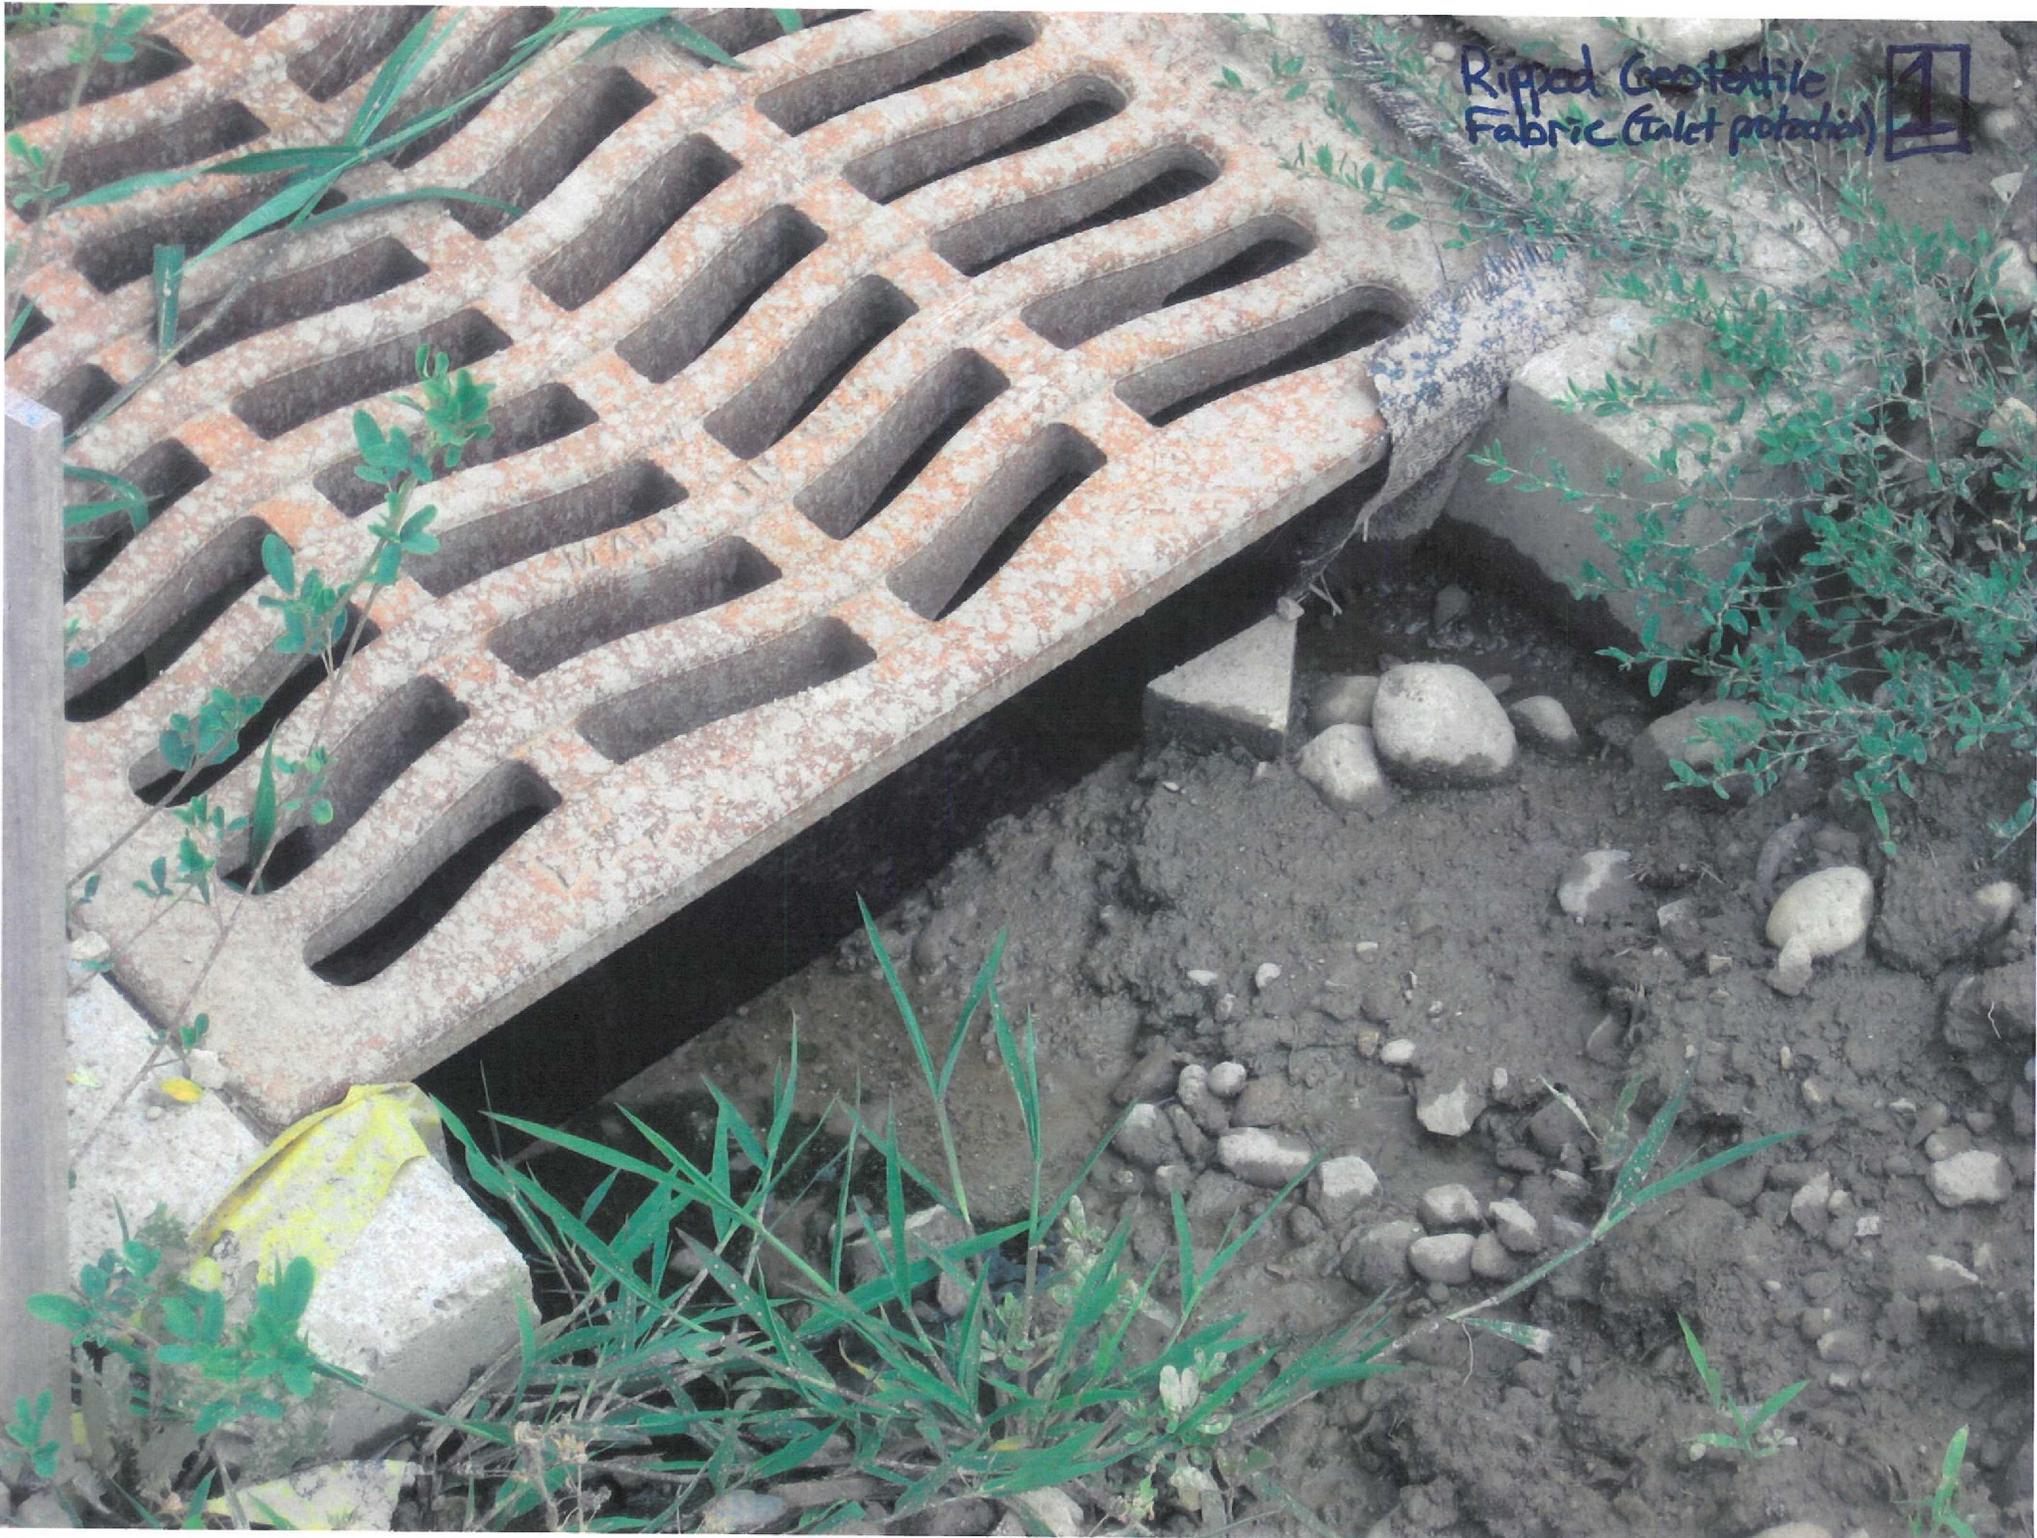
Ripped Geotextile
Fabric (talet potachin)

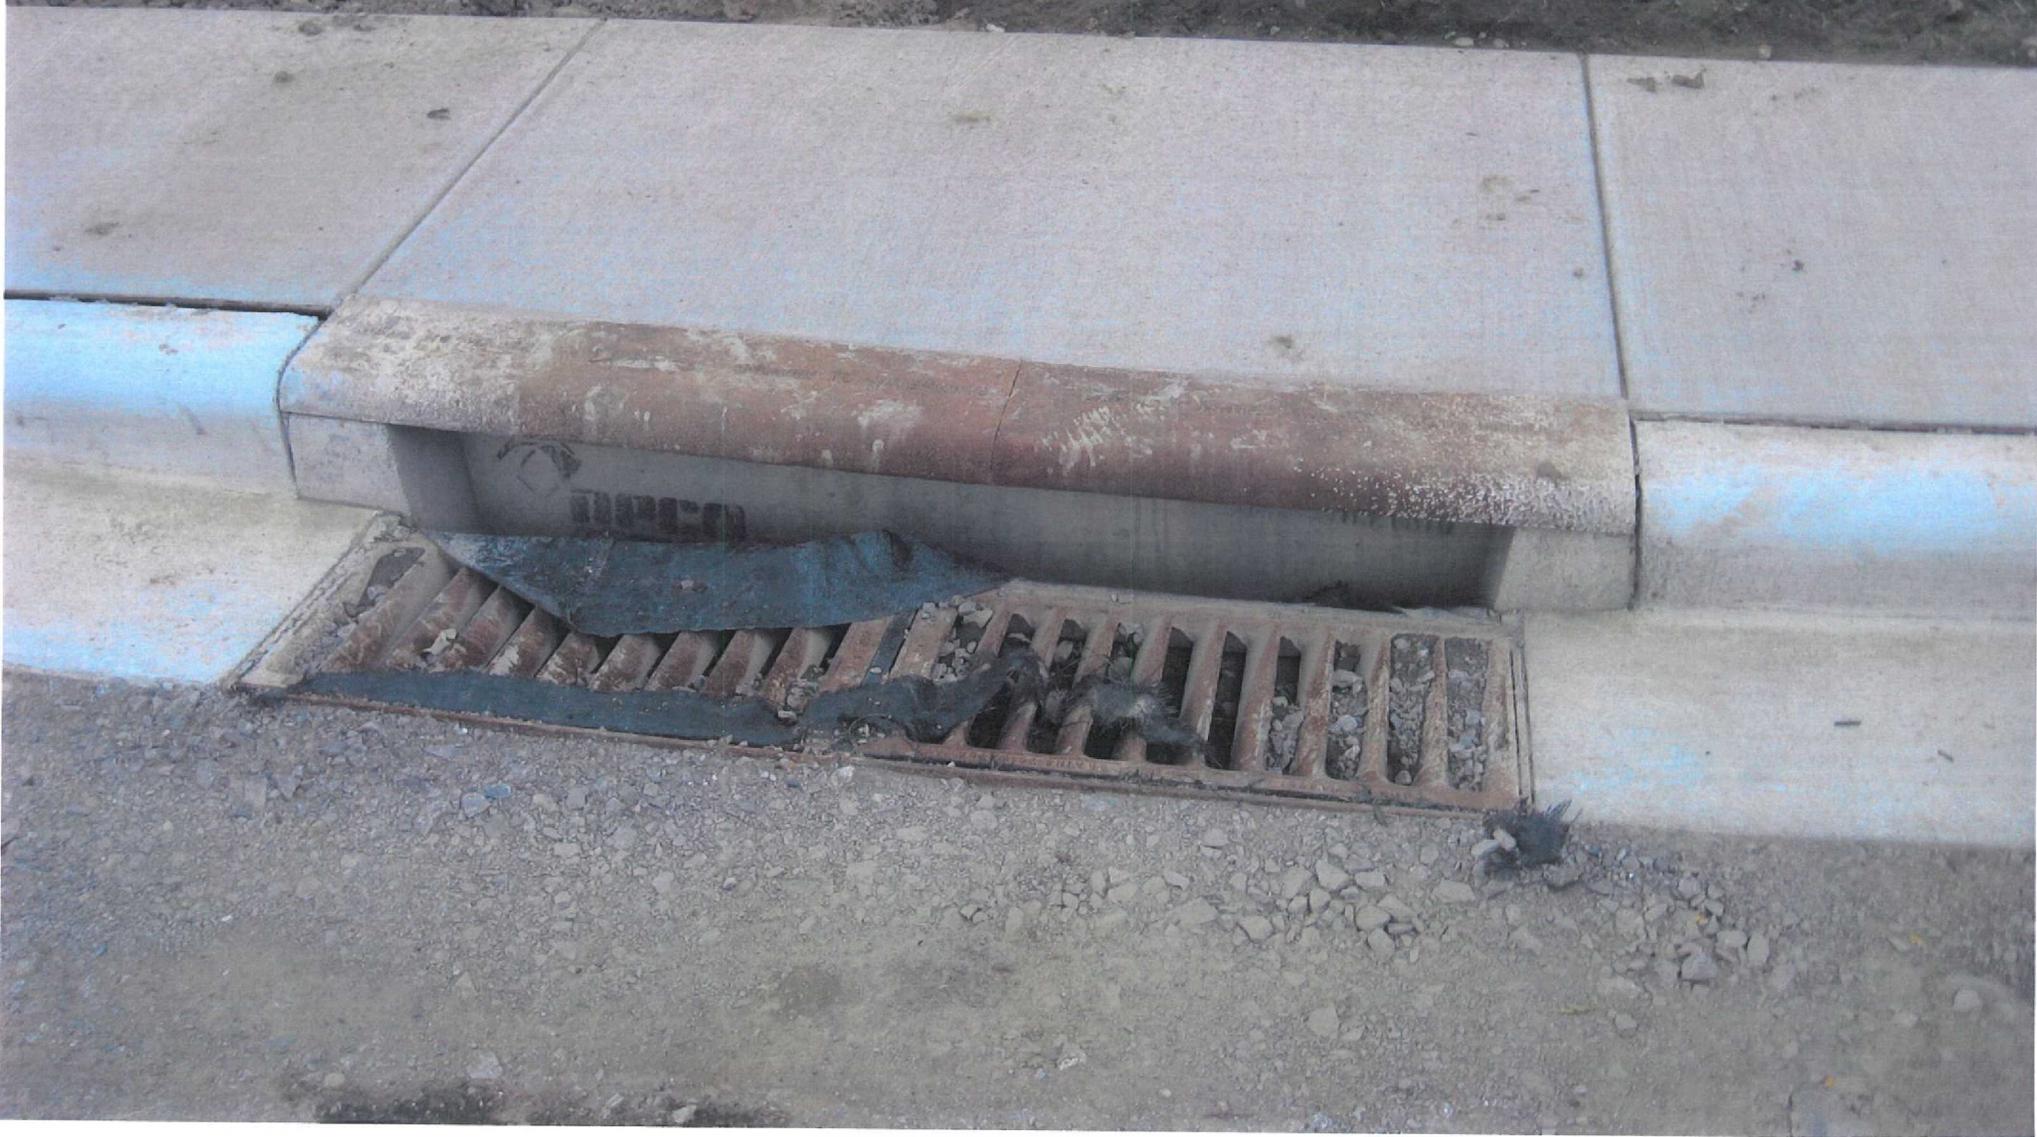
2

Not maintained/Not
Installed Properly

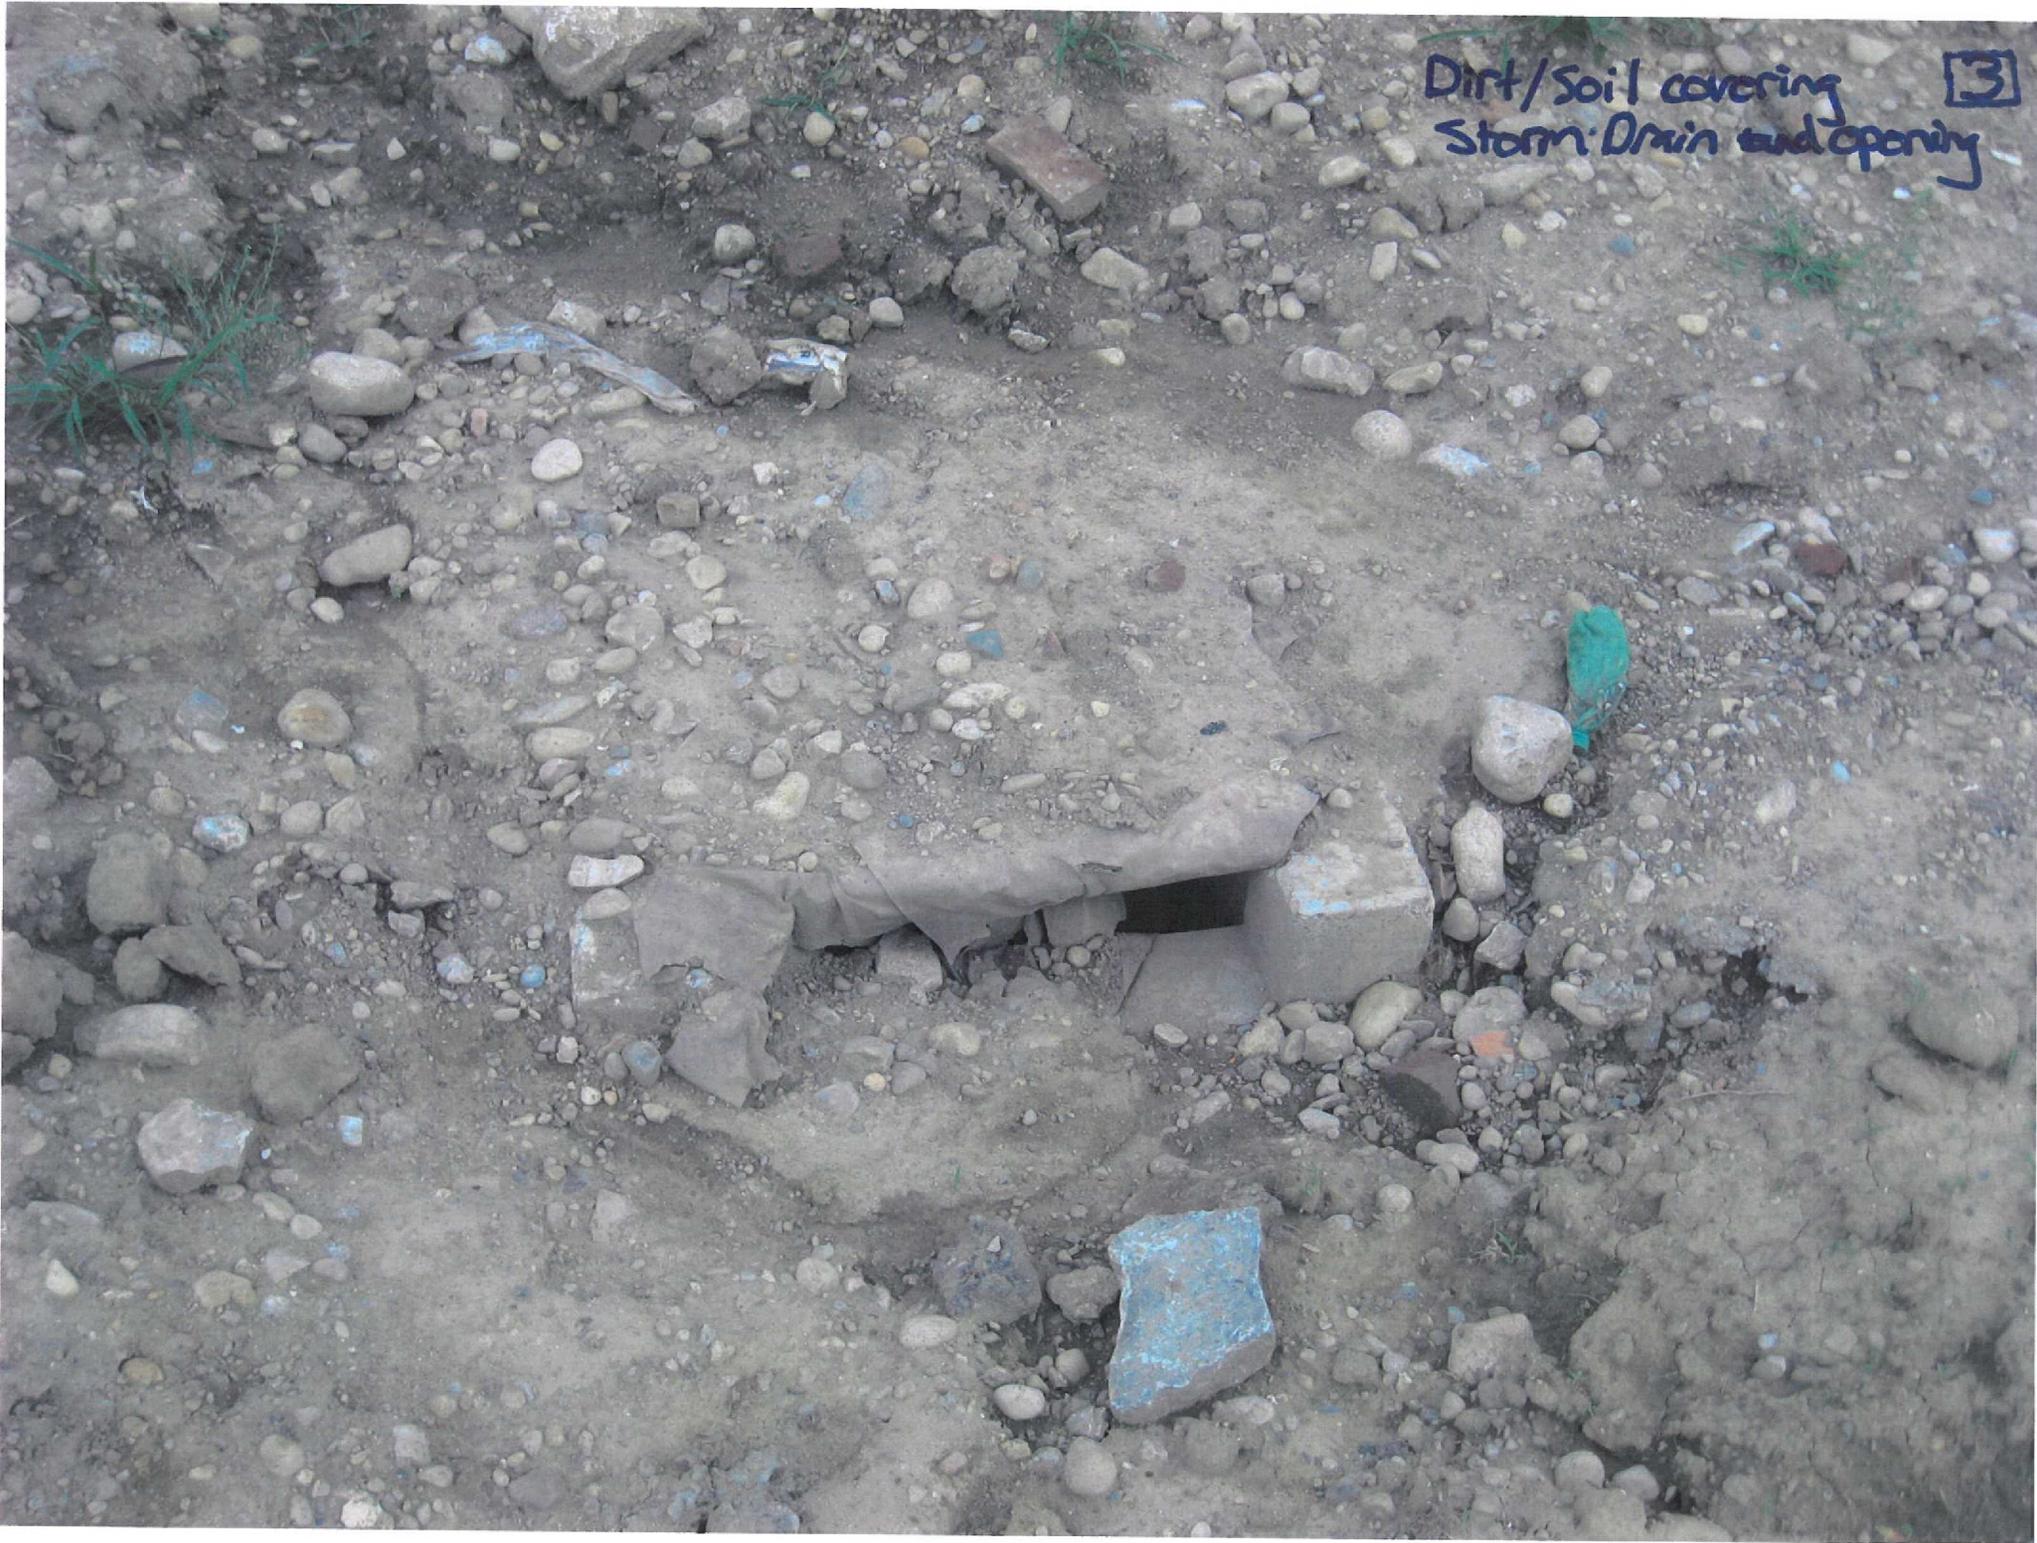
Dirt/Soil covering
Storm Drain end opening 3

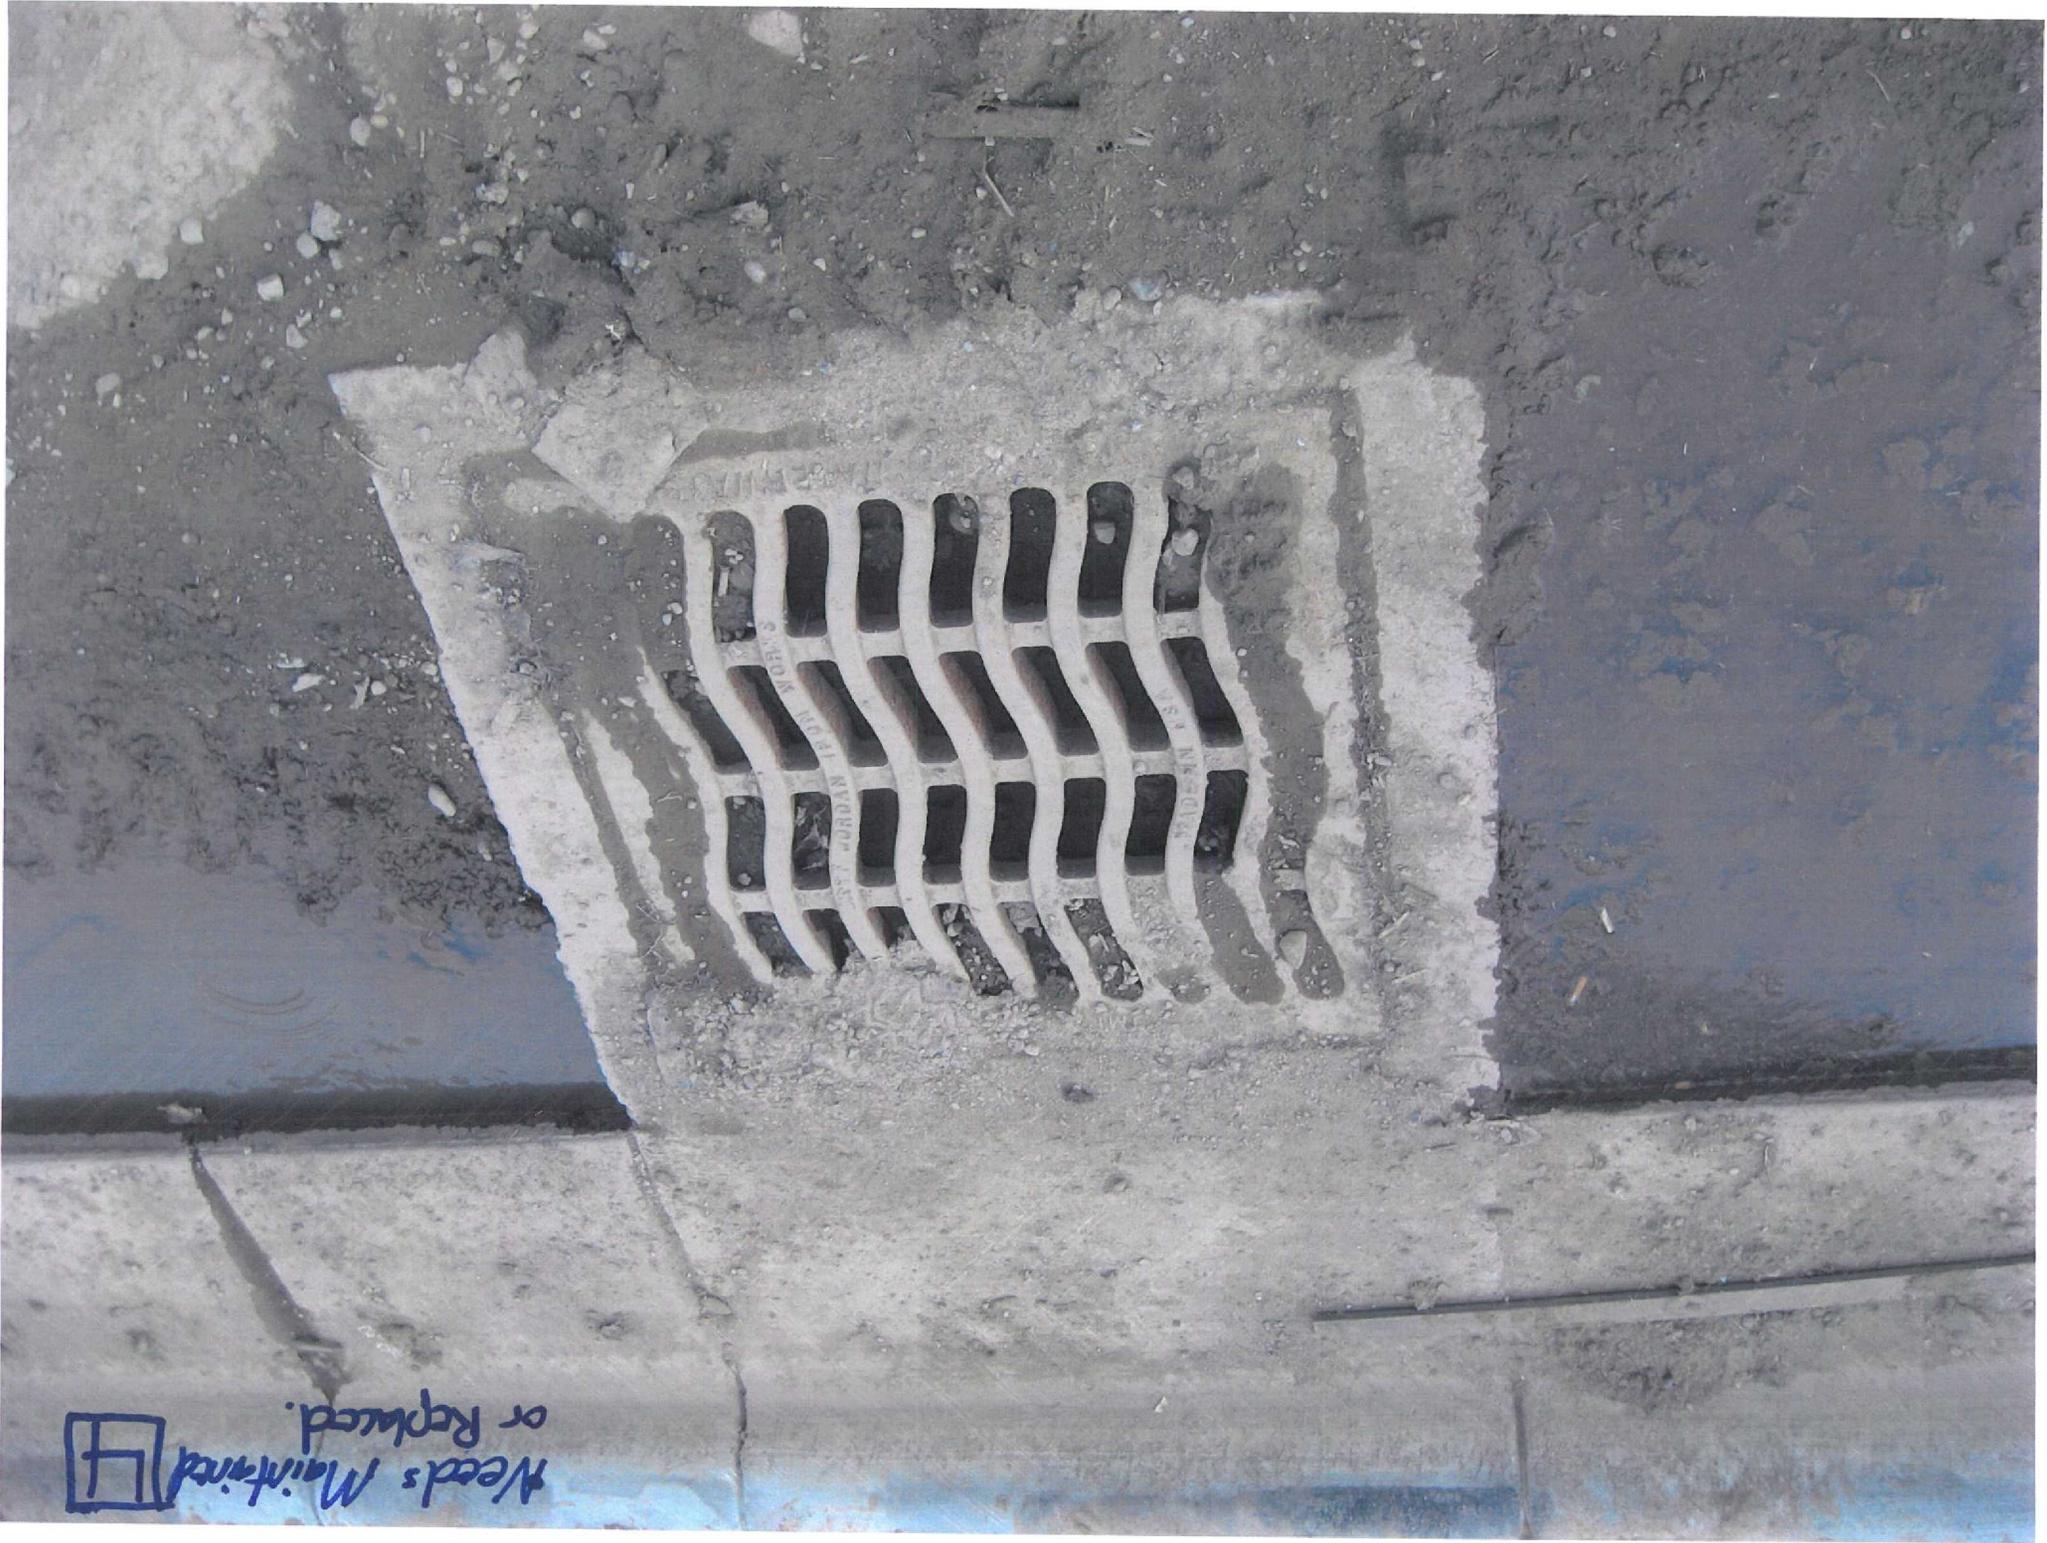
Needs Maintenance
or Replaced.

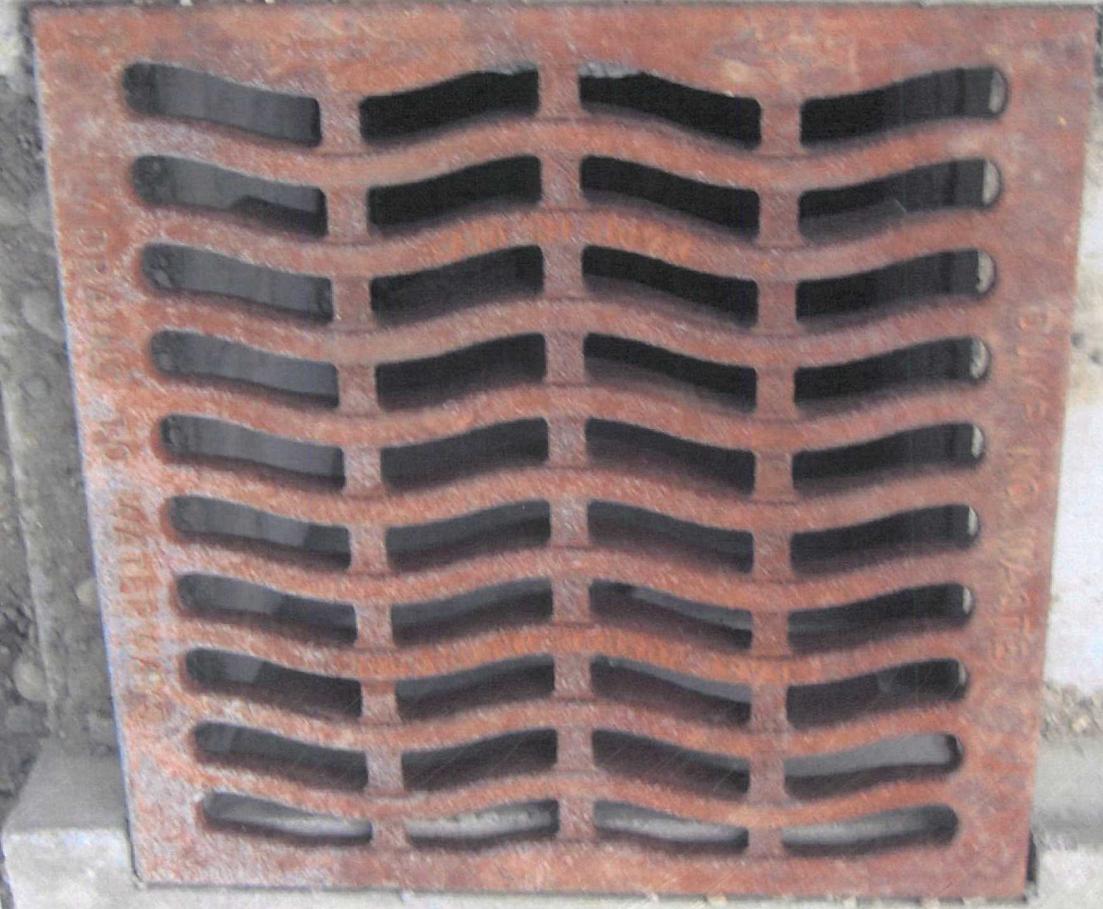
No Inlet
Protection
