July 24, 2013

RE: CUYAHOGA COUNTY
CITY OF BEACHWOOD
CONSTRUCTION STORM WATER
PERMIT NO: 3GC06128*AG
ALOFT HOTEL

NOTICE OF VIOLATION

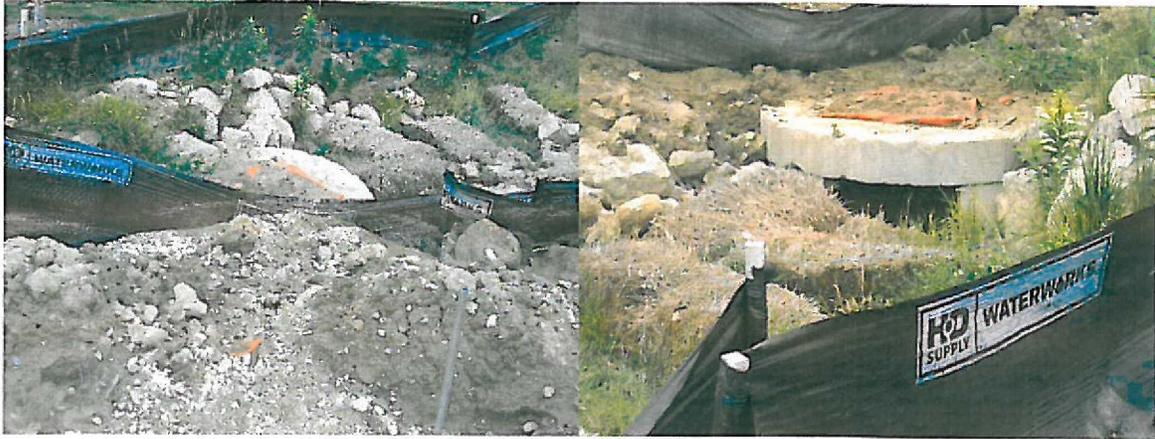
- **Silt fence has not been installed in a functional manner and has not been maintained as required by the NPDES Permit.** Silt fence must be trenched and backfilled and the joint stakes of the silt fence must be connected by twisting the stakes together prior to staking them into the ground. Silt fence on the eastern side of the site was not twisted at the stakes and parts had been trampled down by sediment (Figure 1). Please ensure that all joints are twisted together and repair silt fence so that it is functional. Silt fence must remain in place until the upslope contributing drainage area has reached final stabilization, i.e., a vegetative growth density of 70% or greater has been achieved. **Failure to install silt fence in a functional manner is a violation of Part III.G.2.d of the NPDES permit and Ohio Revised Code (ORC) 6111.04 and 6111.07. Failure to maintain silt fence is a violation of Part III.G.2.h of the NPDES permit and ORC 6111.04 and 6111.07.**

- **Storm drain inlet protection on the northeastern side of the site is insufficient.** There is an exposed window on the side of the casting (Figure 2). Straw bales have been placed in front of the window, but this is not an accepted form of inlet protection. As long as the drainage area to the eastern ditch remains disturbed, inlet protection is required. Please review the specifications in *Rainwater and Land Development, Ohio's Standards for Stormwater Management, Land Development and Urban Stream Protection* (Ohio Department of Natural Resources, 2006), repair inlet protection to meet these standards. **Failure to install storm drain inlet protection in a functional manner is a violation of Part III.G.2.d of the NPDES permit and ORC 6111.04 and 6111.07.**

Figures 1 & 2: Fence in need of repair; stakes need to be tied off together; window in catch basin needs to be covered.

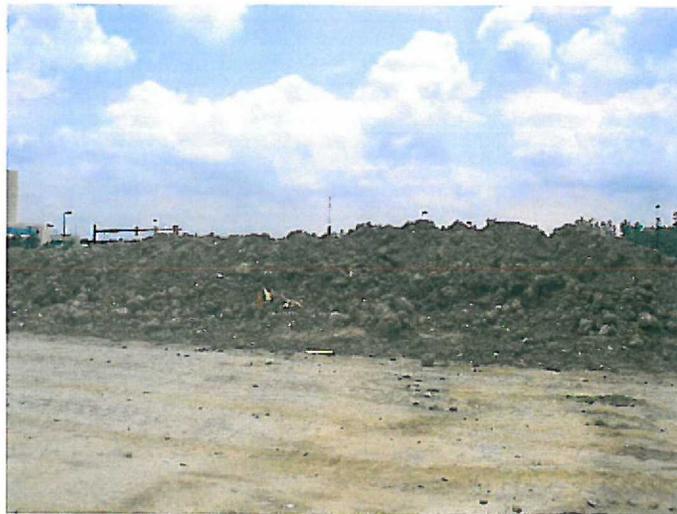
- **Stabilization, i.e., seeding and mulching, has not been initiated as required by the NPDES permit (Figure 3).** Temporary stabilization must be initiated within 7 days of last disturbance on any disturbed area of the site if it will not be further disturbed within 14 days of last disturbance. Permanent stabilization must be initiated within 7 days of reaching final grade. **Failure to initiate stabilization in these time frames is a violation of Part II.B and Part III.G.2.b.i of the NPDES permit and ORC 6111.04 and 6111.07.**

Figure 3: Earthen Berm must be stabilized if it will sit undisturbed for 14+ days.

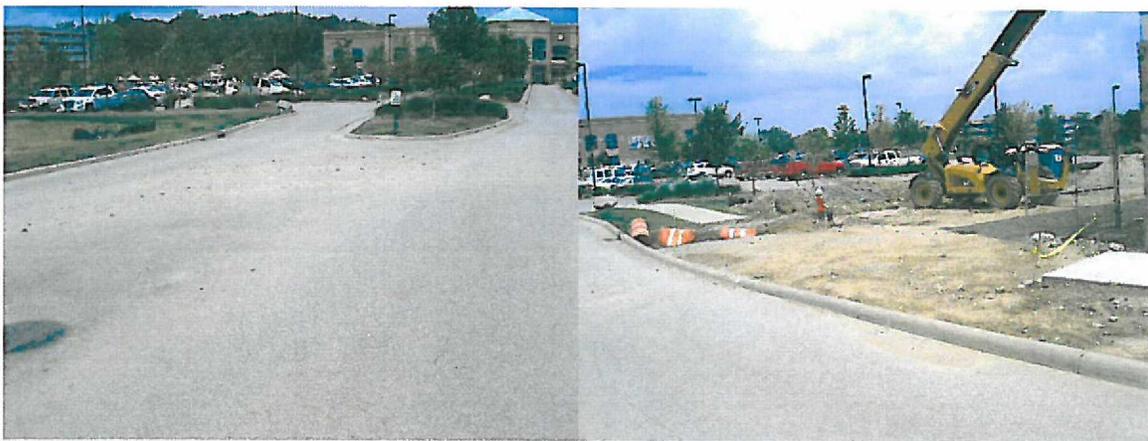
- **The northern-most rock construction entrance fails to fully prevent sediment from exiting the site (Figures 4 & 5).** Redressing the entrance with additional stone will help prevent sediments from tracking off site. **Failure to maintain rock construction entrances is a violation of Part III.G.2.h of the NPDES permit and ORC 6111.04 and 6111.07.**

Figures 4 & 5: Rock construction entrance fails to sediment from tracking off site.
