July 25, 2013

**RE: Voss Property; NPDES Permit # 1GC04441\*AG; Compliance Inspection Findings and Notice of Violation**

Site Name: Voss Property

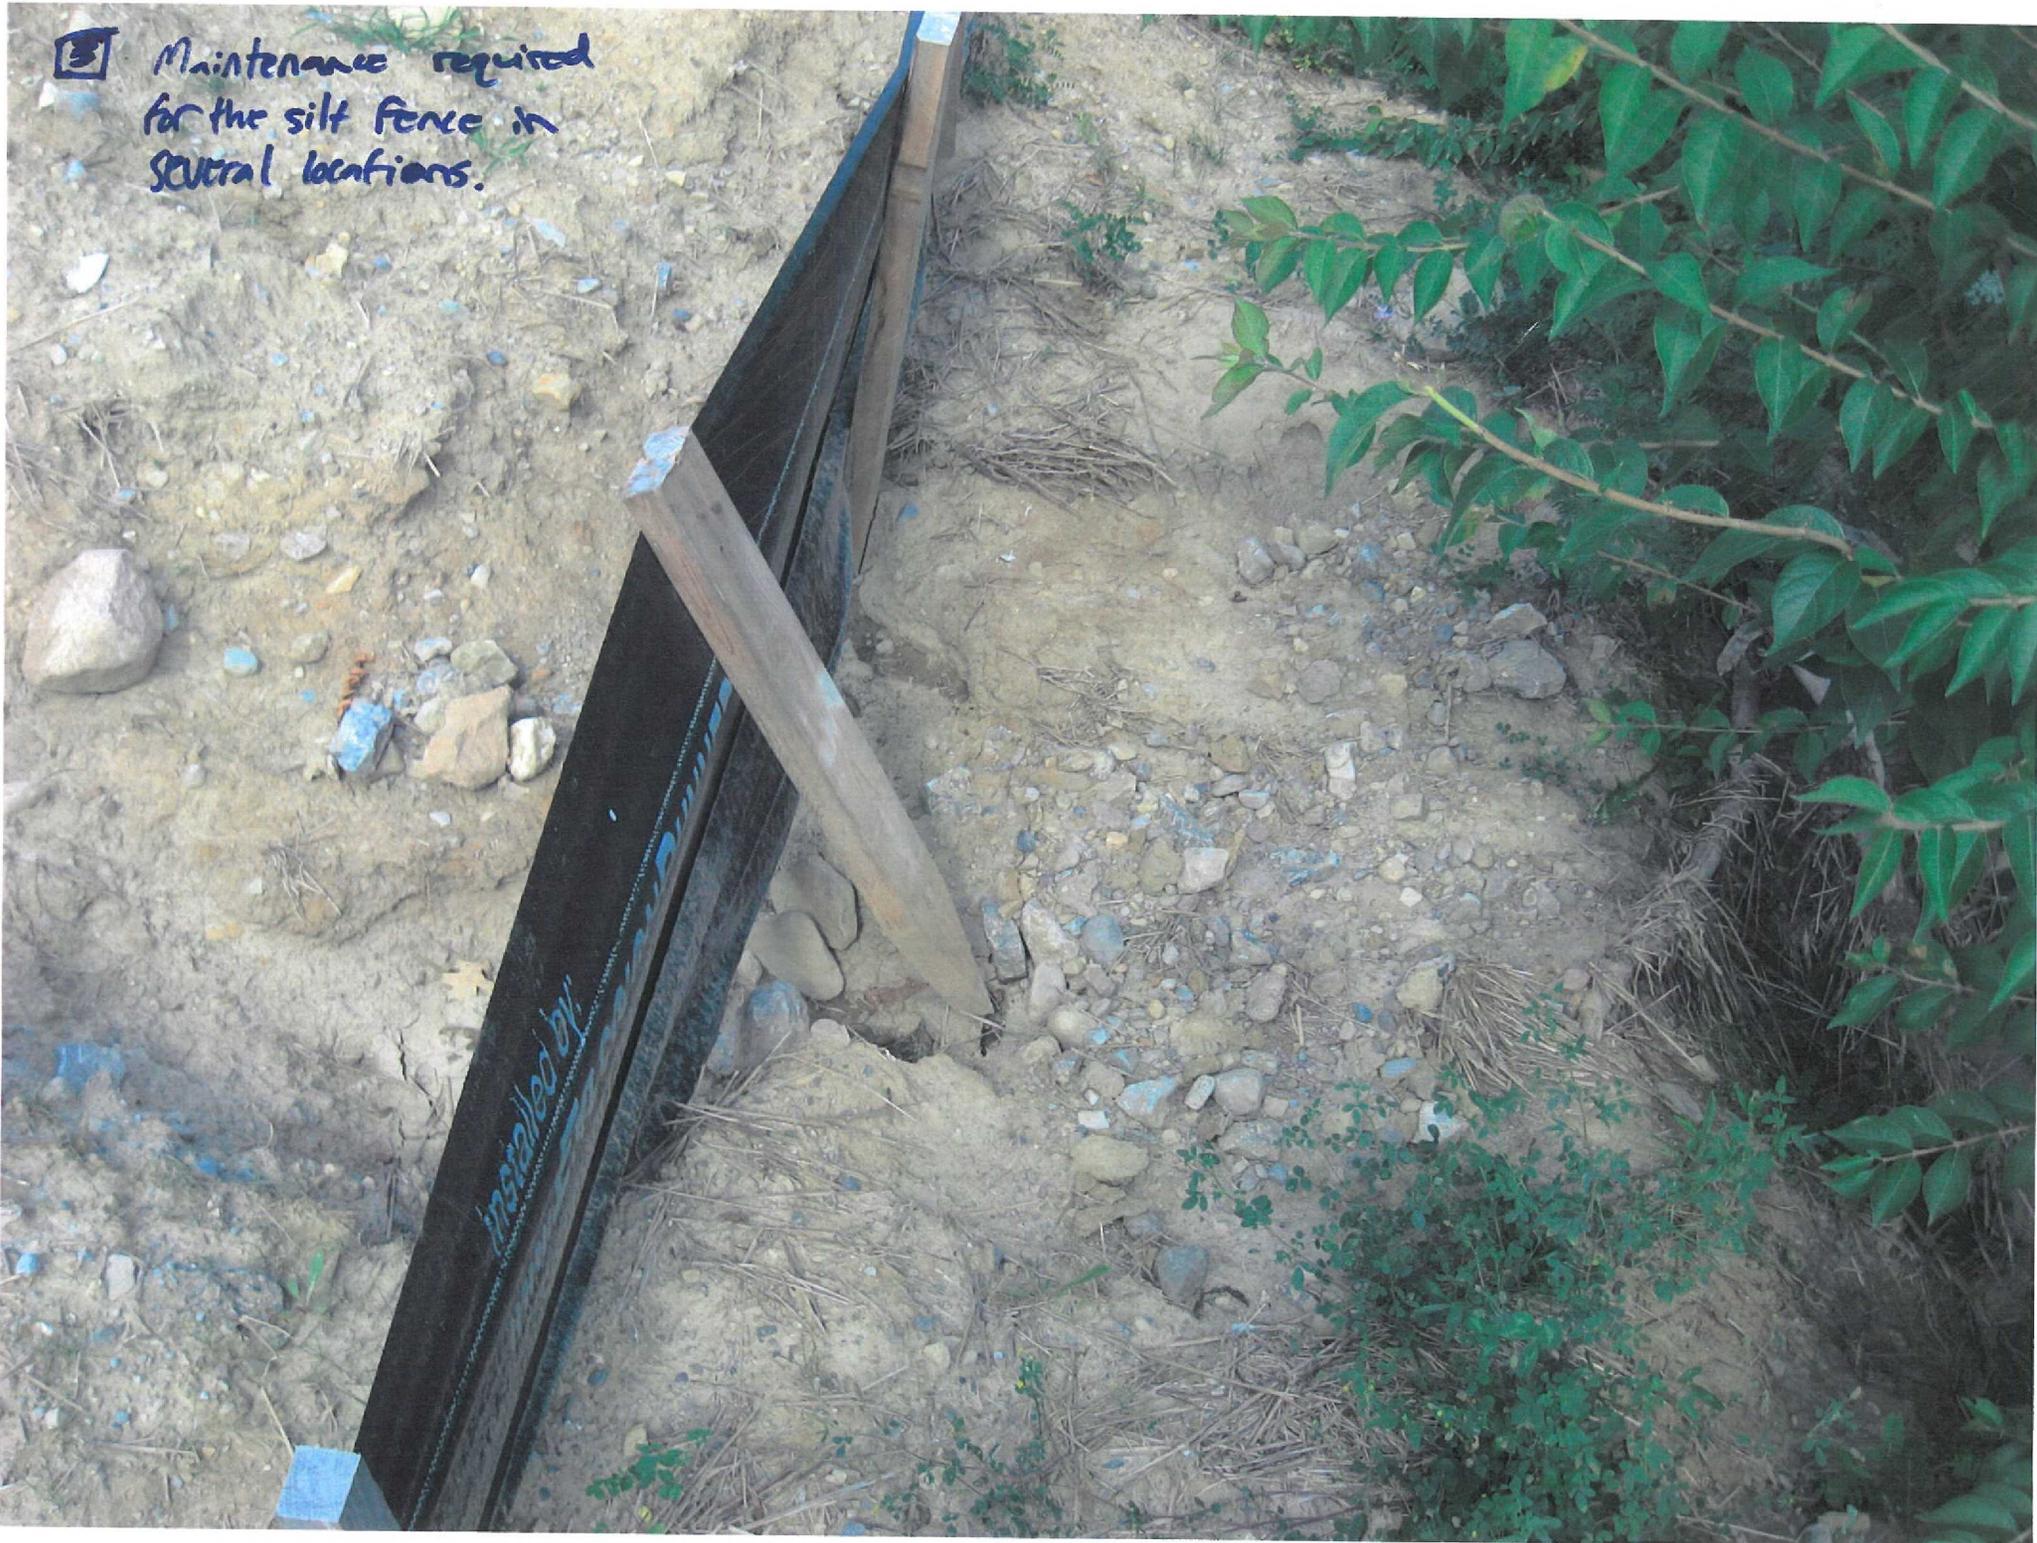
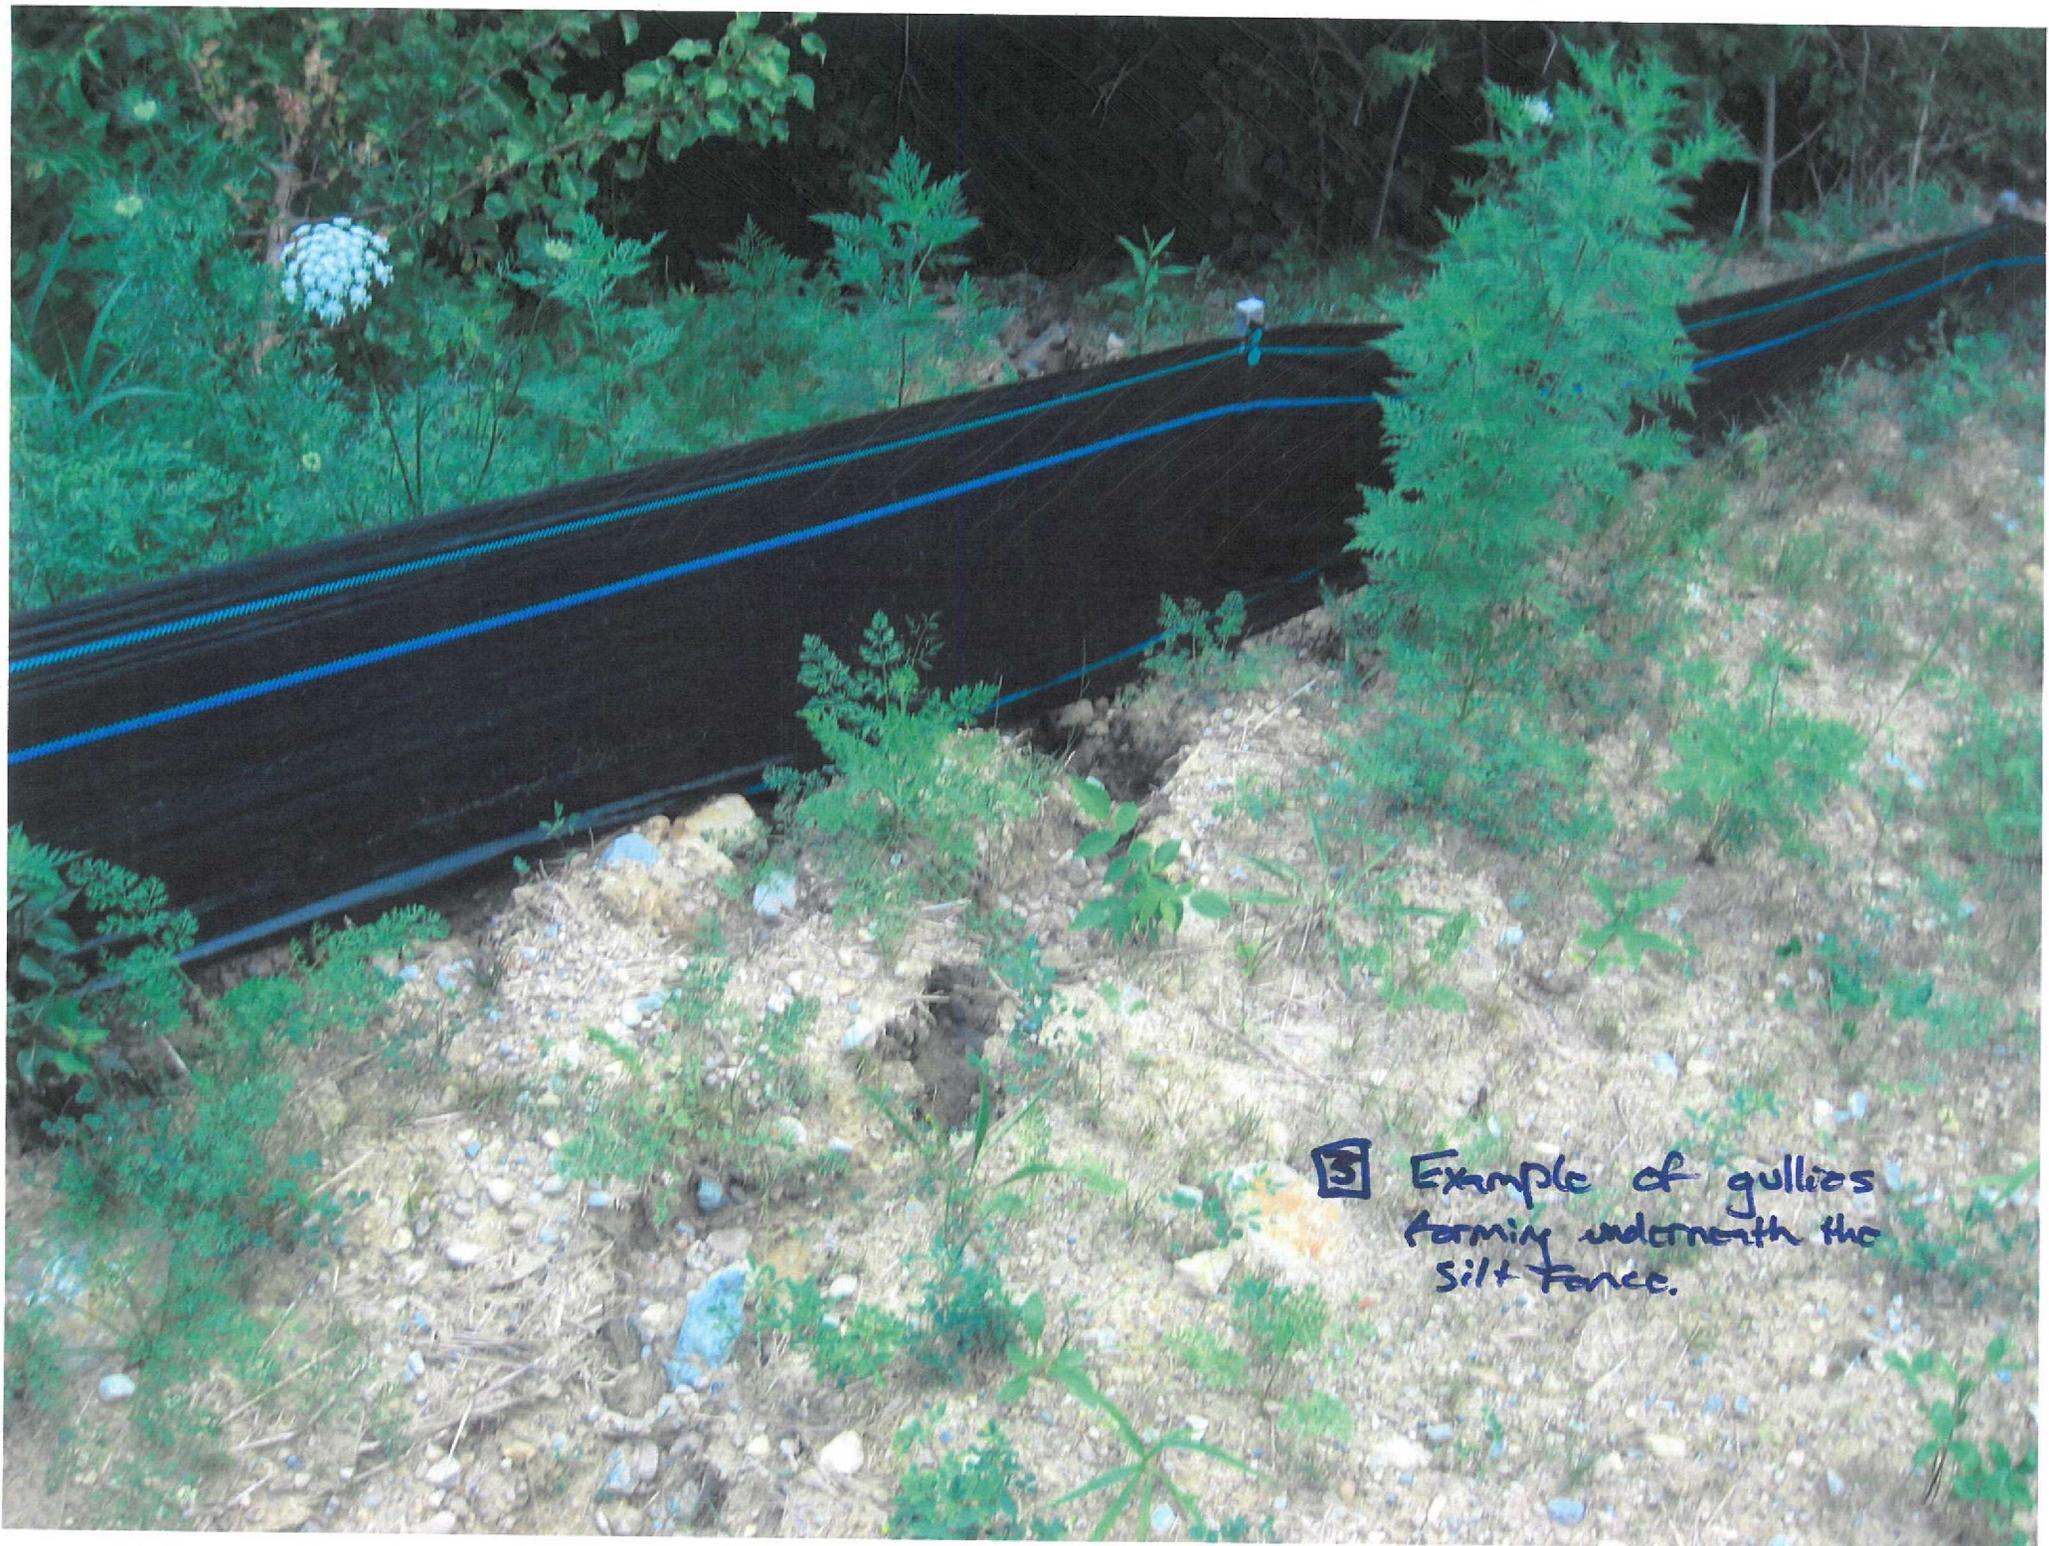
3 Example of gullies forming underneath the silt fence.
