RE: CUYAHOGA COUNTY
CITY OF BROOKLYN
MUNICIPAL STORM WATER PROGRAM
MCM #6 FOLLOW-UP INSPECTION
3GQ00047*BG

NOTICE OF VIOLATION

**Inspection Photos
Service Garage**

City of Brooklyn

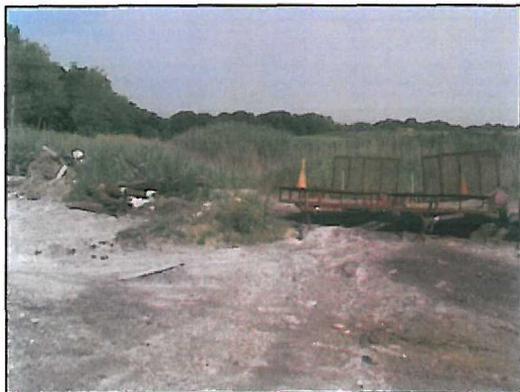
- **Salt Storage and Spill Clean-Up** – The City has not implemented best management practices (BMPs) in regards to salt storage and spill clean-up. Salt can be seen tracking north and into a possible wetland (Figure 1). A heavy concentration of salt is present outside along the north side of the salt barn (Figure 2). Salt has been heavily tracked outside the salt barn entrance, forming a thick bed of salt (Figure 3). The exposed salt must be cleaned up immediately and remain under cover. Many of these same conditions were observed during our audit in 2009.

Figure 1 (left): This photo shows evidence of salt tracking north into a possible wetland.
Figure 2 (right): This photo shows a heavy concentration of salt where a small pile may have been stored.

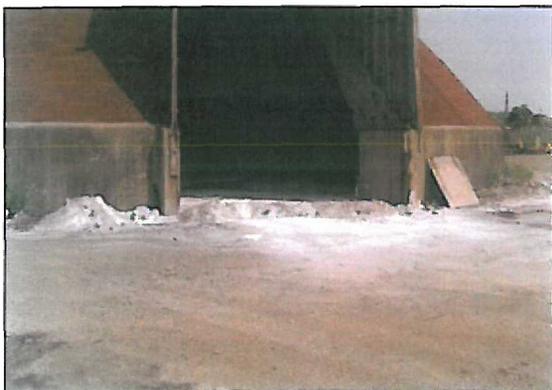
Figure 3 (left): This photo shows a small pile of salt left outside the barn along with a heavy concentration of salt that has accumulated outside the barn entrance.
Figure 4 (right): This photo shows the overhang constructed for the paint can drying area.

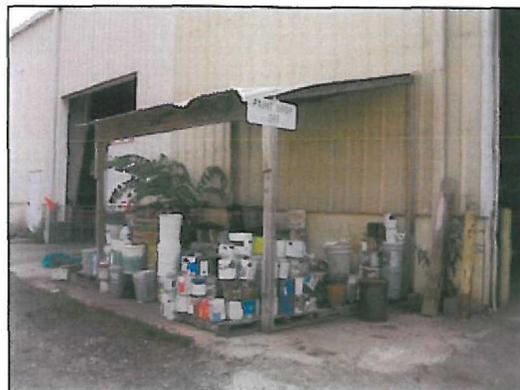
- **Paint Cans and Other Waste Storage Areas** – Our inspection in 2009 noted a violation concerning the improper storage and disposal of waste from municipal operations. Waste was stored in areas exposed to storm water without BMPs. In response, the City has constructed an overhang on the side of the Service Garage (Figure 4). Paint cans and other waste materials are stored under the overhang, but secondary containment is suggested. For paint containers, this could take the form of a cardboard box with a plastic liner. The City of Solon places cans in plastic swimming pools collected during curbside trash pick-up. In case of any leaks or spills, the materials remain contained. Also, be sure to implement spill response and remediation procedures completely. We noted that some oils have spilled and oil absorbent has been spread on that area (Figure 5), however spent absorbent must be disposed of properly and in a timely manner. Sweep up spent oil absorbent and dispose of it in the dumpster.

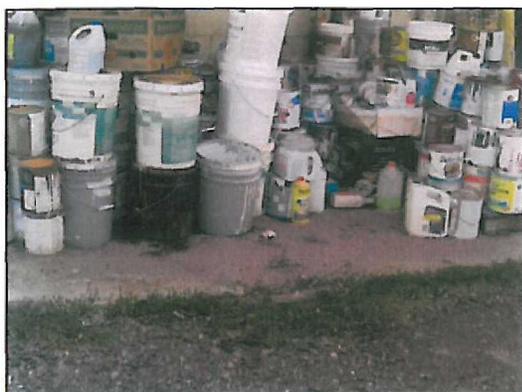
Figure 5 (left): This photo shows a spill that has been covered with oil dry.
Figure 6 (right): This photo shows a pile of miscellaneous scrap and debris.

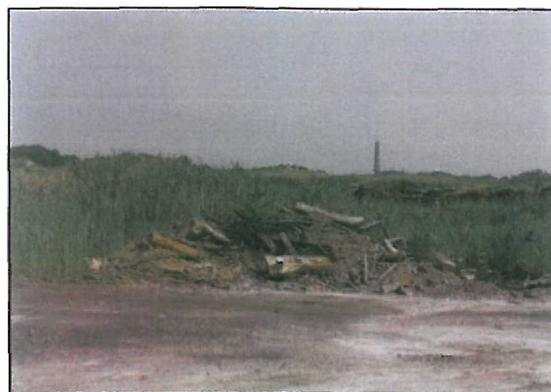
- **Soil/debris Stockpiles** – There are a few stockpiles of dirt and debris, one containing scrap materials, around the salt dome (Figure 6). The storage of scrap materials was noted in the 2009 audit. If there is no planned use for these materials, they must be properly disposed or recycled to keep the area clean. These stockpiles contain erodible soil as well. Erodible materials must be stored under cover, tarped or be stabilized to prevent the material to get washed away with the runoff during a rain event. If the debris is removed from the stockpile, leaving just loose soil, it can be seeded and mulched so as to stabilize the soil.

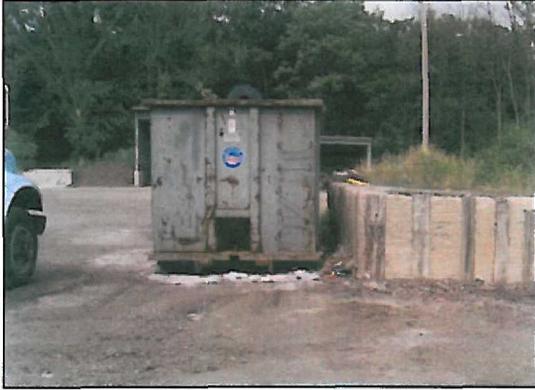
- **Waste Dumpster** – The general waste dumpster is uncovered (Figure 7). Dumpsters must be covered with a lid or tarp to prevent the collection of storm water and the formation of leachates.

Figure 7 (left): This photo shows the general waste dumpster which is uncovered.
Figure 8 (right): This photo shows a spill or leak behind the left pump box of the main gas tank.

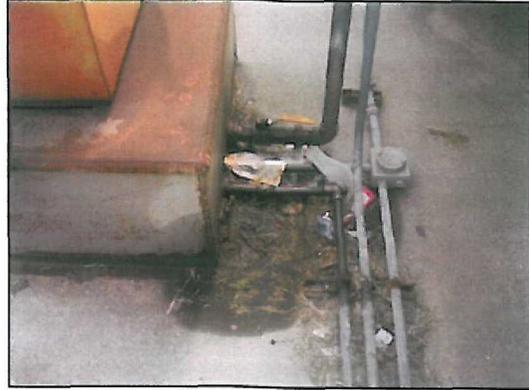
- **Main Gas Tank** – A spill kit is provided next to the gas tank. The emergency shut-off is clearly labeled. There is a leak, possibly from one of the connecting pipes, behind the left pump box (Figure 8). Use oil absorbent to clean the spill. Check for leaks. A pipe or connection piece may need to be repaired or replaced.
