August 2, 2013

RE: LORAIN COUNTY
CARLISLE TOWNSHIP
BUTTERNUT TERRACE APARTMENTS
(ROWLAND ENTERPRISES)
CEI
(NPDES NO. 3PW00038)

On July 16, 2013, a Compliance Evaluation Inspection (CEI) was conducted on the wastewater treatment plant (WWTP) serving the Butternut Terrace Apartments. The inspection was conducted by this writer, and Mr. John Sabo of the Lorain County Health Department. The Butternut Terrace Apartments are located at 38775 Butternut Ridge Road, Carlisle Township, Lorain County.

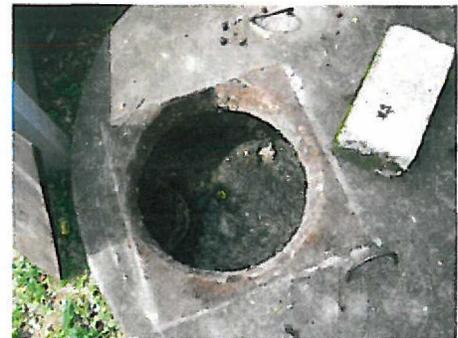
- 1) Contents of the trash trap were covered with a several inch thick mat of floating grease and solids.
- 2) The aeration tank contents were well aerated, and were a greasy looking medium brown color. The return sludge line was operating, returning medium brown liquid to the aeration tank from the settling tank.
- 3) Contents of the settling tank were relatively clear, but there was floating solids/scum on the surface of the contents. Although the skimmer was operating and returning clear water, it was adjusted too far below the surface of the water, and it was allowing the solids/scum to accumulate on the surface of the water. The settling tank effluent trough had a deposition of solids in the bottom.
- 4) Operation of the sand filter dosing pumps could not be checked, as there were no AUTO / MANUAL pump control switches in the electrical control panel for the dosing

station. The high water level alarm did not operate when the float switch was manually tripped.
