August 8, 2013

RE: CUYAHOGA COUNTY  
CITY OF CLEVELAND  
INDUSTRIAL STORM WATER  
BELLAIRE ROAD AUTO PARTS  
3GR00092\*EG

**NOTICE OF VIOLATION**

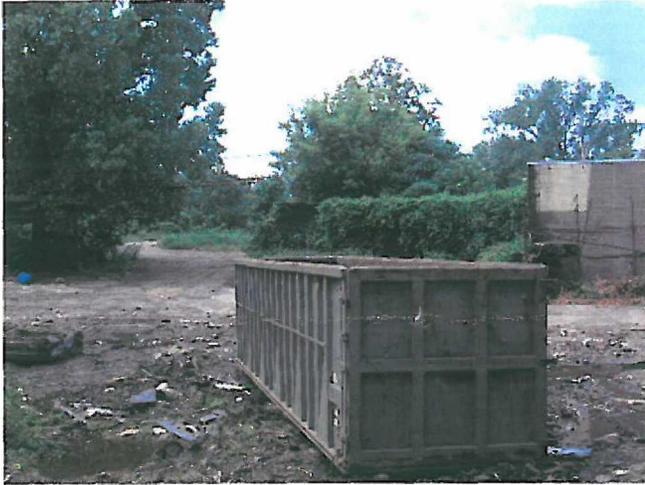
1. The dumpsters behind the building on the lot were uncovered. All dumpsters outside of the facility need to be covered with a tarp or a lid at all times to minimize the creation and discharge of leachate. (see **Fig 1 & 2**).

**Figure 1:** uncovered dumpster.

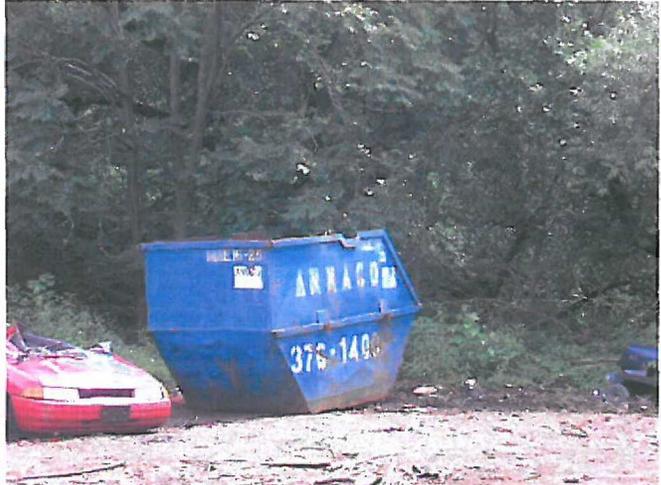
**Figure 2:** uncovered dumpster.

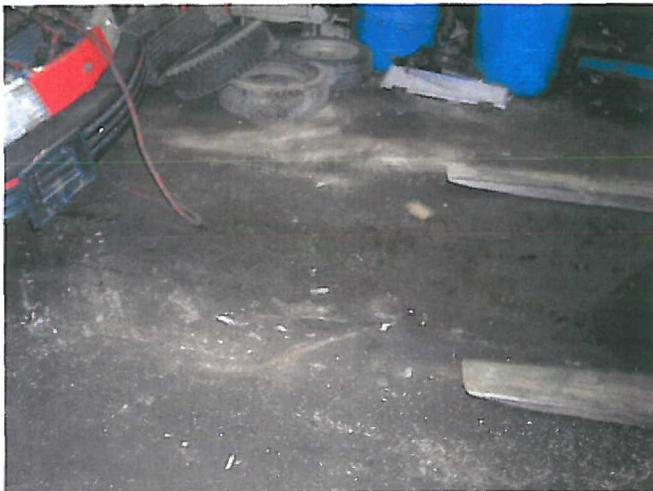
2. Inside the garage there was antifreeze spilt on the floor. These spills need to be cleaned up immediately to guarantee that they do not reach the runoff storm water. (see **Fig 3**)

**Figure 3:** antifreeze spill in the garage.

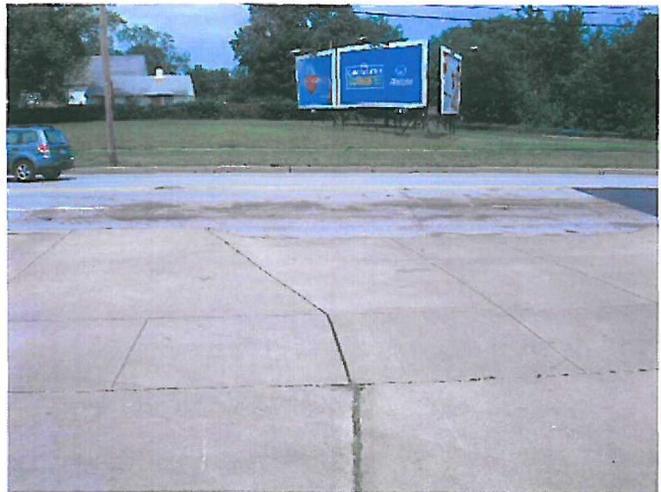
3. On the street at the main entrance there were stains and sediment getting tracked off site from the lot. Implement best management practices (BMPs) to keep everything within the lot on site. (see **Fig 4**).

**Figure 4:** Sediment that got tracked of site along with spills from cars at the main entrance.

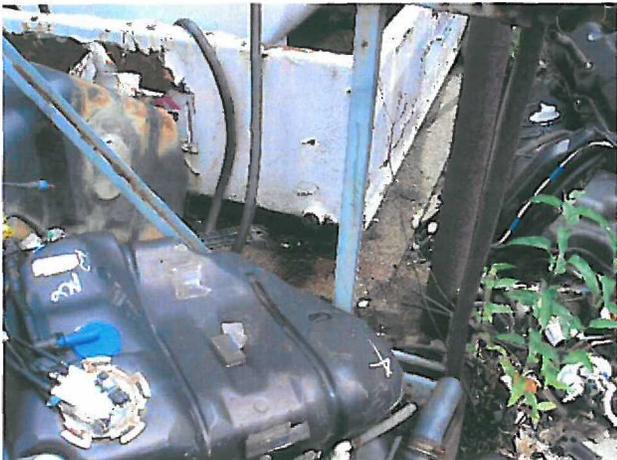
4. The gas tank on the site did have secondary containment, but the plug on the tank missing, therefore, the contaminants were leaking and escaping all controls. The spill needs to be cleaned up and the containment needs to be repaired to ensure that nothing else escapes it. (see **Fig 5**).

**Figure 6:** (left) Opened drain on the secondary containment for the gas tank. Observed spill coming from the tank below the drain.
