August 8, 2013

RE: CUYAHOGA COUNTY
CITY OF VALLEY VIEW
INDUSTRIAL STORM WATER
ANTHONY ALLEGA CEMENT
CONTRACTOR INC
3GR00263*EG

NOTICE OF VIOLATION

ANTHONY ALLEGA CEMENT CONTRACTOR INC
Valley View Cuyahoga County

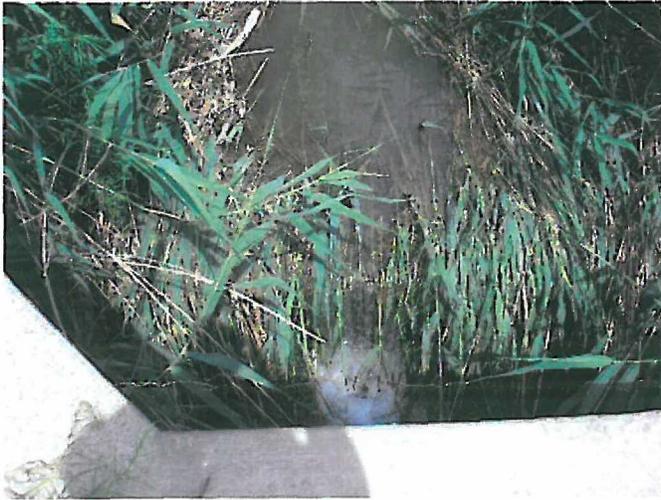
The Notice of Intent (NOI) submitted by Anthony Allega Cement Contractor, Inc. to renew coverage indicates that there is only one outfall from this facility. However, our site inspection indicates that there are three outfalls. The three outfalls are made up of the two drains on the west end of the lot, one north of the building and one south of the building closer to the I-480 bridge (See Fig 1&2), and the concentrated flow going of the south end of the property (See Fig 3). All outfalls must be identified on the NOI. To correct this error, please either submit a revised NOI or letter to our Central Office acknowledging the additional three outfalls. For each outfall, identify the SIC and subsector codes associated with the outfall as well as the latitude and longitude. There are no federal effluent limitations for storm water discharges from this facility.

Figure 1: (upper left) Outfall drain on the west end of the lot, north of the building.
Figure 2: (above) Outfall drain on the west end of the lot, under the I-480 bridge.
Figure 3: (left) Concentrated sheet flow on the south end of the lot under the bridge.

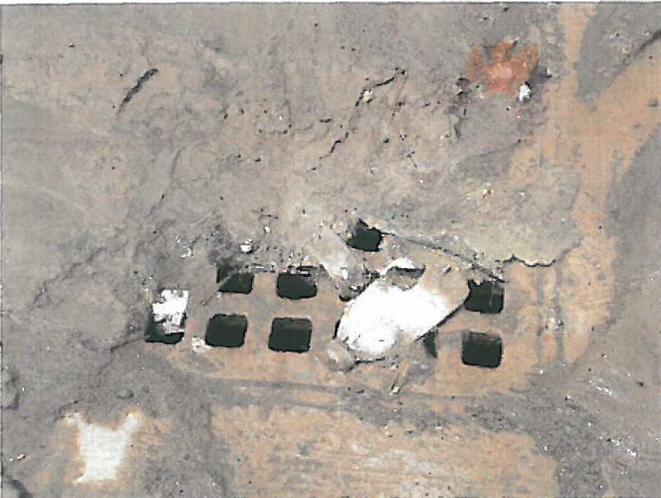
1. The stockpiles on the lot need to be covered with a tarp or stabilized to eliminate the chance of sediment pollution in the storm water.
2. During the inspection we were informed that the drains on the lot all went to storm water. In this case, they need to be properly maintained and good housekeeping needs to be set in place to keep the sediment and other pollutants out of the drains. One drain was observed to be caked over in sediment. This specific drain needs to be cleaned and control measures and/or best management practices (BMPs) need to be set in place to keep this from reoccurring in the future. **(See Fig 4)**

Figure 4: (left) Drain on lot covered in sediment and debris.
Figure 5: (above) the area of the lot that drains into Figure 4.
