August 8, 2013

RE: LORAIN COUNTY
CITY OF ELYRIA
INDUSTRIAL STORM WATER
BLUE STAR METAL RECYCLING
3GR00735*EG

NOTICE OF VIOLATION

BLUE STAR METAL RECYCLING
Elyria Lorain County

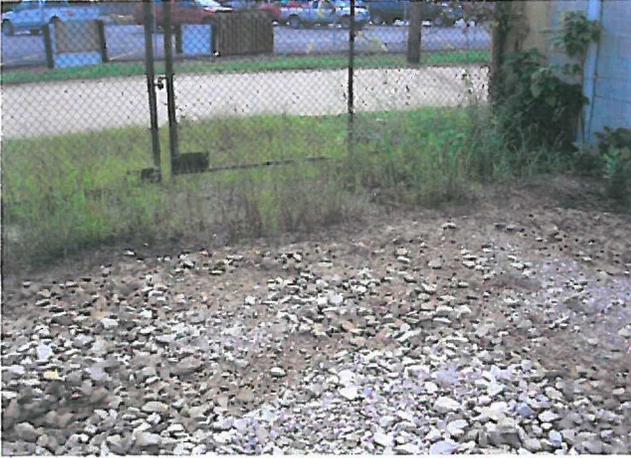
The Notice of Intent (NOI) submitted by Blue Star Metal Recycling to renew coverage and the Site Map indicate that there are only two outfalls from this facility. However, our site inspection indicates that there are eight outfalls from the site. One outfall being the sheet flow off the main entrance of the lot (**Figure 9**), two being the flow from the exit of the drive thru recycling drop off garage (**Figure 3**), three is the sheet flow off the east side over the gravel berm (**Figure 1**), four is the water that collects in the oil water separator (**Figure 2**), five is the storm drain at the weigh in station (**Figure 4**), the sixth is the roof drains that discharge into the street (**Figure 6**), outfall seven is the drain under the can crusher inside the drive thru recycling garage (**Figure 7**), and the eighth outfall is the flow off of the back of the lot by the train tracks that flows into the oil water separator (**Figure 5**). To your understanding the flow went through the oil water outfalls then discharged into the storm sewers. If this is true then it, along with the other oil water separator on the east side should be counted as on

Figure 1: (Top Left) Out fall off of the east side of the lot where water sheet flows off site. Some goes directly into the street and a percentage into the oil water separator north of the gate.

outfall. All outfalls must be identified on the NOI. To correct this error, please either submit a revised NOI or letter to our Central Office acknowledging the additional 6 outfalls. For each outfall, identify the SIC and subsector codes associated with the outfall as well as the latitude and longitude. There are no federal effluent limitations for storm water discharges from this facility. The revised NOI or letter should be sent **within 14 days** of this letter to:

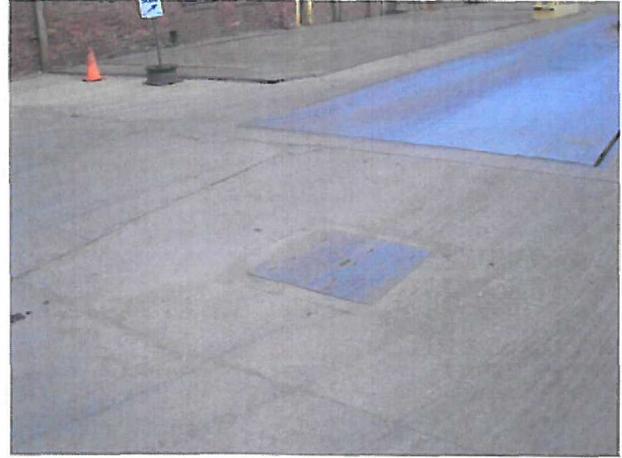
Figure 2: (Middle Left) Oil water separator north of Figure 1.

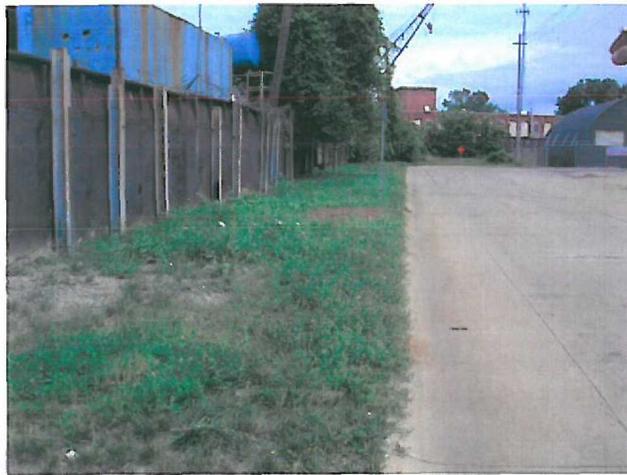
Figure 3: (Bottom Left) Exit for the drive thru recycling building.

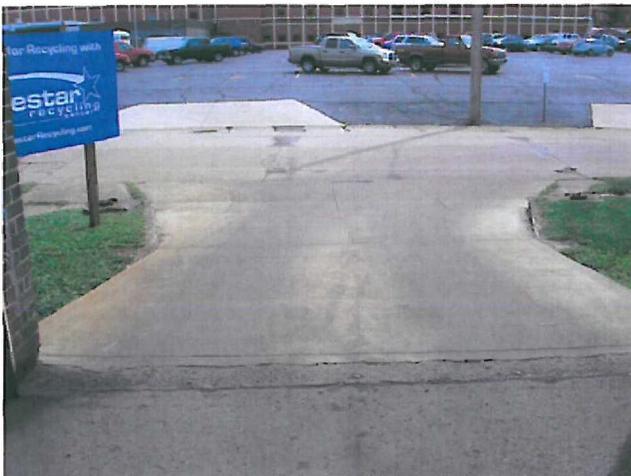
Figure 4: (Top Right) Drain in from on the weigh in station.

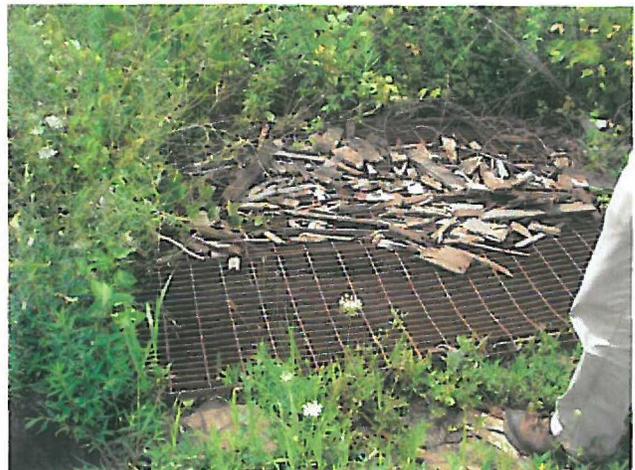
Figure 5: (Bottom Right) Second oil water separator on the north side of the lot by the rail road.

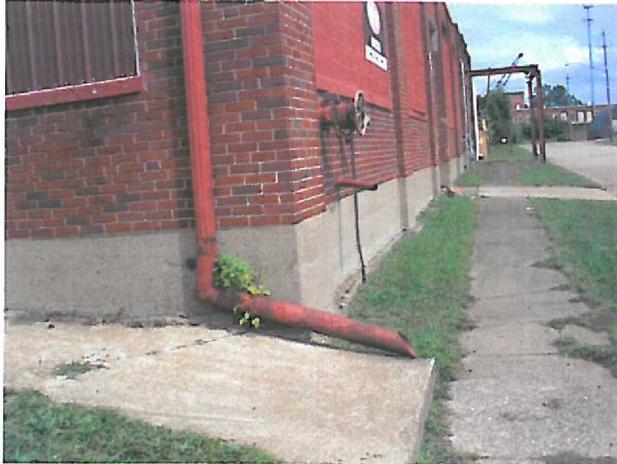
Figure 6: (Top Left) Roof Drain outfalls to the east onto the street.

While it appears that water is discharging at more spots of the site than what was recorded, many of these outfalls can be eliminated by building or renovating those areas to not allow water to discharge. If these newly identified outfalls are eliminated, then they would not need to be recorded.

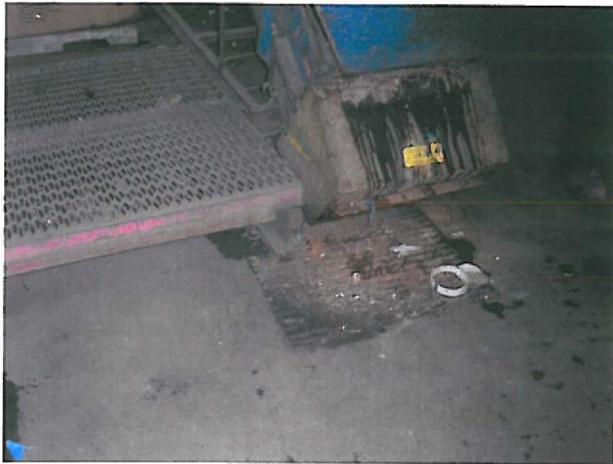
2. There were multiple areas on the site where oil stains were observed. This could be a result of the cars not being fully drained and leaking while sitting in site, the car parts that are not properly stored were leaking, or spills during the dismantling process. To prevent this from happening in the future, make sure that cars get drained upon arrival, car parts are properly stored, and dismantling happens in the designated area. These spills should be cleaned up immediately and disposed of properly. **(See Fig 8 & 10)**

Figure 8: (Bottom Left) Oil spills on site.

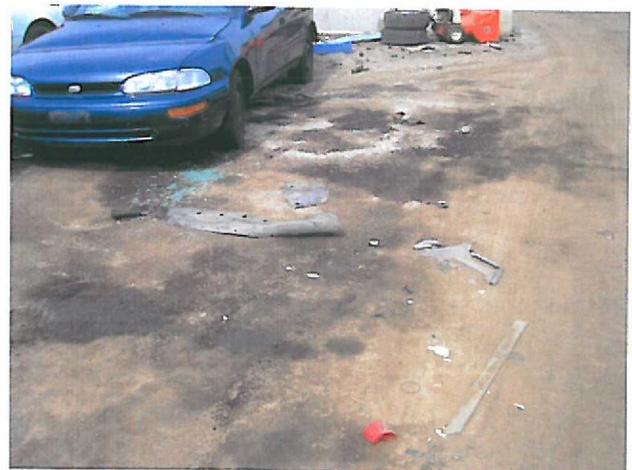
Figure 10: (Bottom Right) Oil spills on site.

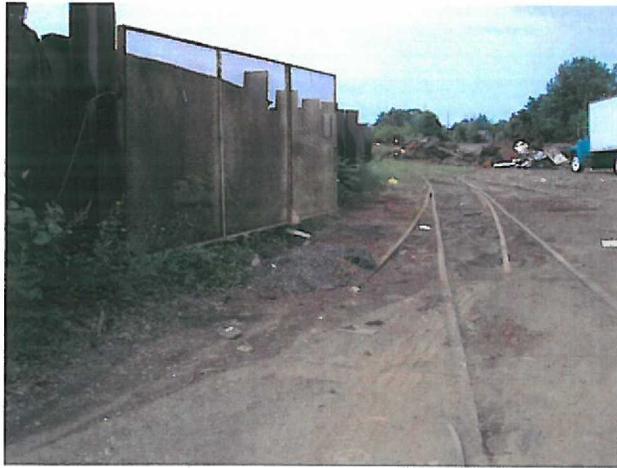
3. There were multiple piles of metal turnings all over the site. These turnings needs to be cleaned up immediately and kept within some type of containment. Not following this is a violation of Part 8.N.3.1.3 of the NPDES Permit. **(See Fig 11, 13, 17, & 19)**

Figure 11: *(Top Left \)* Turning on the ground by the railroad tracks.
Figure 12: *(Middle Left)* Piles of broken up wood pallets found around the site.
Figure 13: *(Bottom Left)* Pill of turnings by the rail road tracks.
Figure 14: *(Top Right)* Piles of rusted scrap on the north side of the site by the railroad tracks.
Figure 15: *(Bottom Right)* Car parts lying around the site.

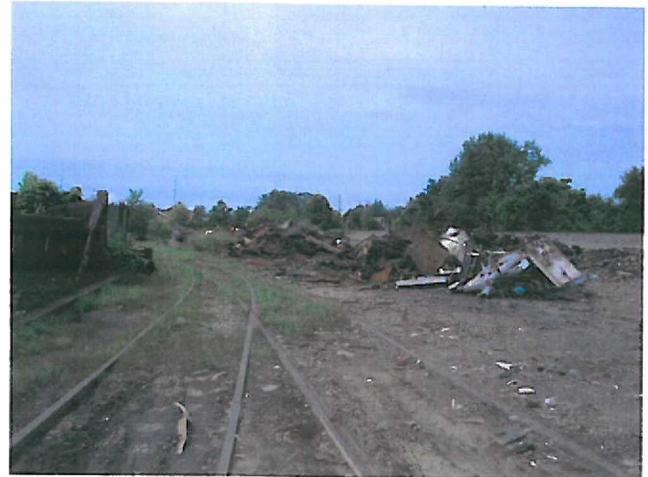
4. Good housekeeping and/or more effective Best Management Practices (BMPs) need to be implemented and achieved throughout the site. There were uncontained stock piles of rusted car parts, broken pallets, metal scrap, rotors, and other debris throughout the site. **(See Fig 8, 12, 14, 16, & 18)**

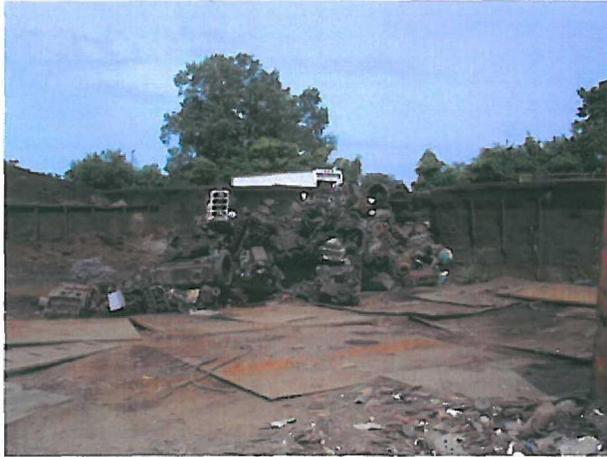
Figure 16: *(Top Left)* Stock pile of uncontained car parts.
Figure 17: *(Middle Left)* Stock piles of uncontained turnings.
Figure 18: *(Bottom Left)* Stock pile of rotors.
Figure 19: *(Top Right)* Stock pile of uncontained turnings.
Figure 20: *(Bottom Right)* Car batteries in the recycling drive thru.

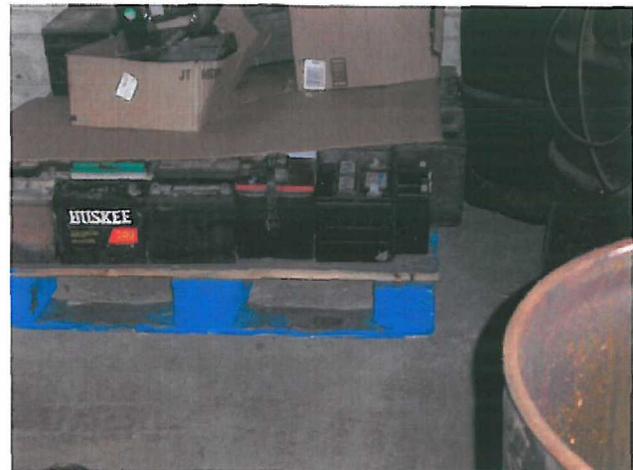
5. Car batteries can be a possible pollutant. It is strongly suggested to keep then in a contain area in case of a spill. The cardboard boxes that were used to store the other parts in the drive thru recycling garage are acceptable. **(See Fig 20)**
