August 8, 2013

RE: LORAIN COUNTY
CITY OF GRAFTON
INDUSTRIAL STORM WATER
GRAFTON READY MIX
3GR01538*EG

NOTICE OF VIOLATION

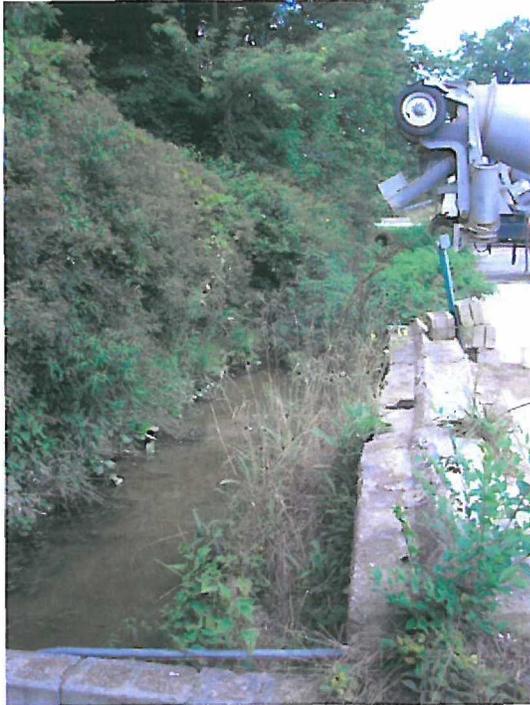
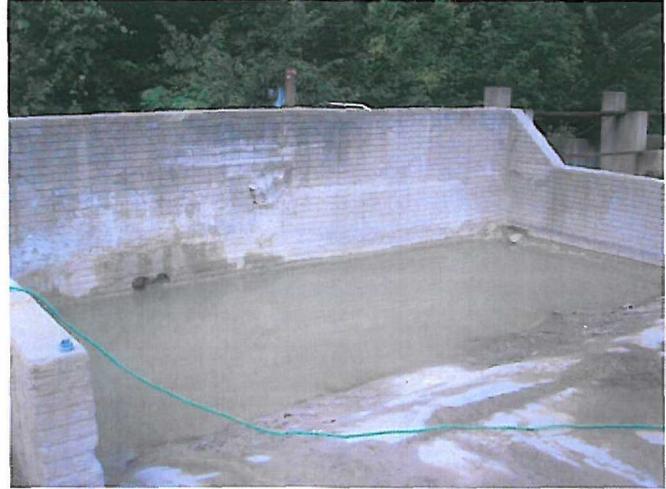
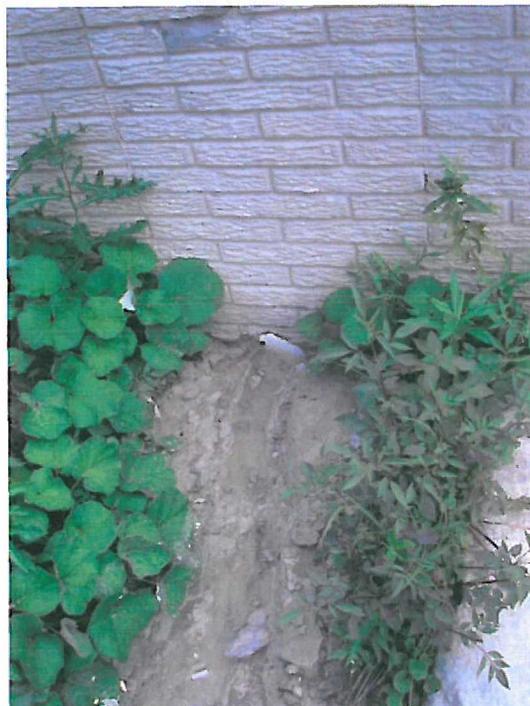
1. The concrete wash out pit on the west side of the lot discharges directly into the creek flowing behind it. This hole which allows the water to discharge needs to be capped or immediately and Best Management Practices (BMPs) need to be implemented to confirm that there will be no future discharge. **(Figure 1, 2, & 3)**

Figure 1: (*Top left*) The creek that the out falls discharge into.
Figure 2: (*Top Right*) A washout pit that discharges directly into the creek.
Figure 3: (*Bottom Left*) The hole that discharges the washout pit.
Figure 4: (*Bottom Right*) The west side of the site south of Figure 2 where sediment leaves the site in a sheet flow.

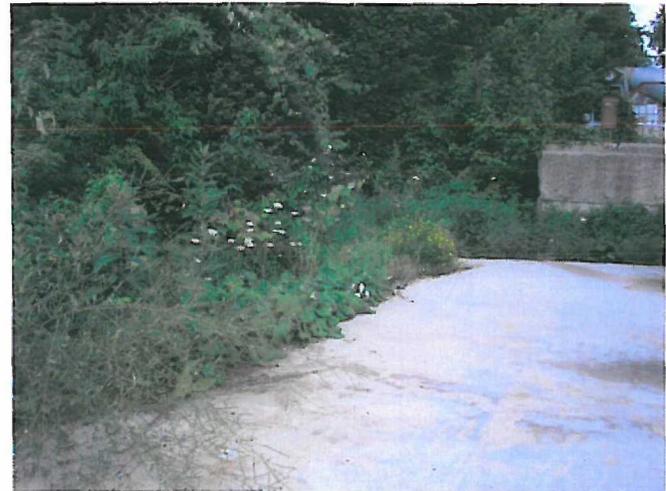
2. There were a few additional areas on the site where water and sediment were leaving the site. These areas can either have BMPs out into place such as installing a berm around the perimeter to eliminate the flow entirely or redirect it to the previously accounted for outfall. If they are left as is, they must be assessed and inspected per requirements of the permit. **(Figure 4, 5, & 7)**

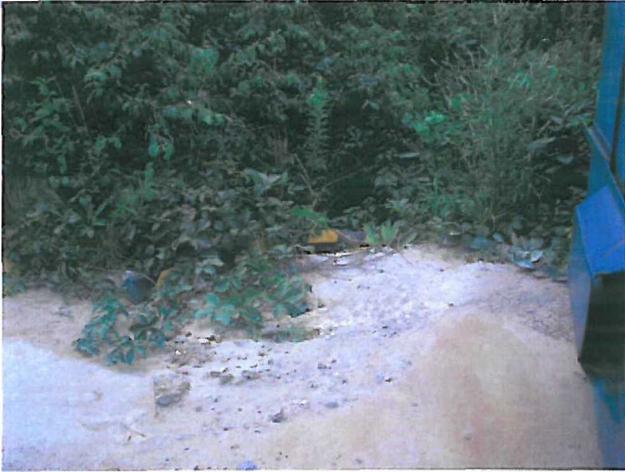
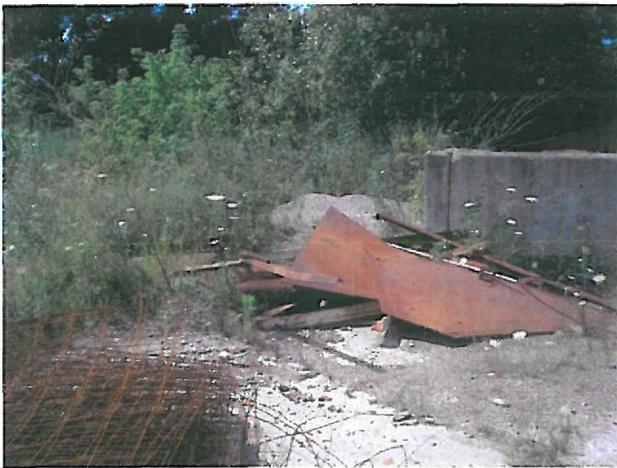
Figure 5: *(Top Left)* An undocumented outfall on the south side of the lot by the railroad tracks.
Figure 6: *(Middle Left)* Scrap metal lying around the site
Figure 7: *(Top Right)* Spot where sediment and water leave the site on the south side of the facility.
Figure 8: *(Bottom Right)* Scrap metal lying around the site.
Figure 9: *(Bottom Left)* Scrap metal lying around the site.

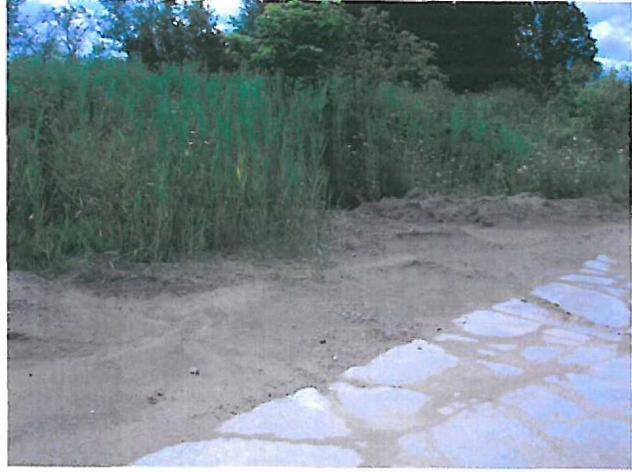
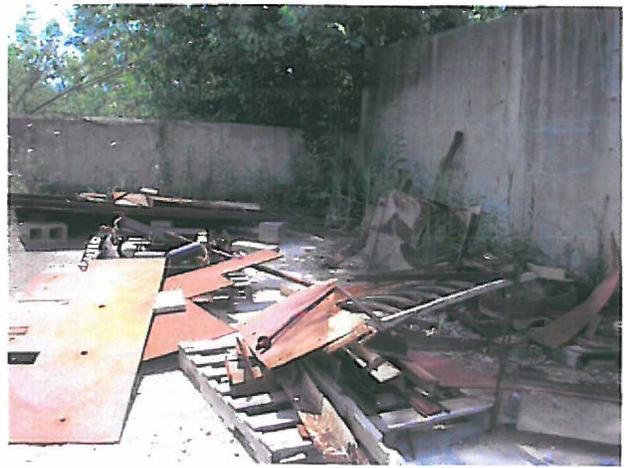
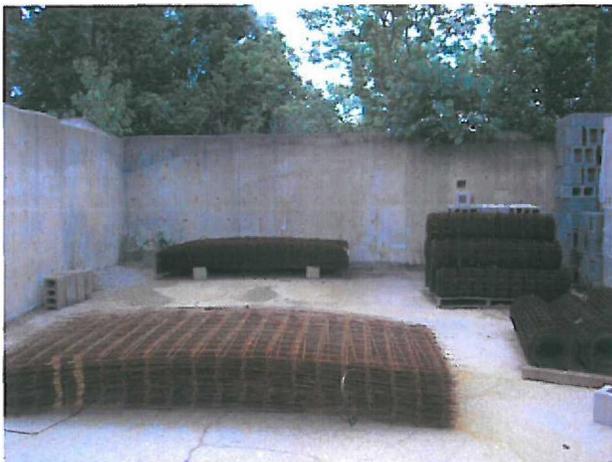
3. There were multiple piles of rusted scrap metal. These can be potential sources of pollution. It is recommended to either paint these pieces of metal or store them under covering to prevent their contact with any storm water. **(See Figure 6, 8,& 9)**

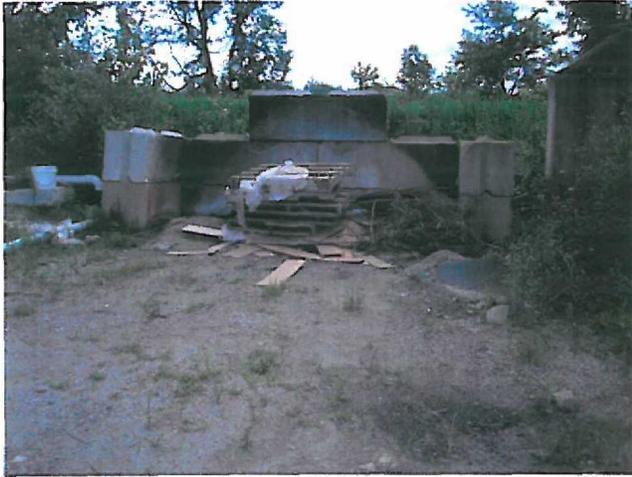
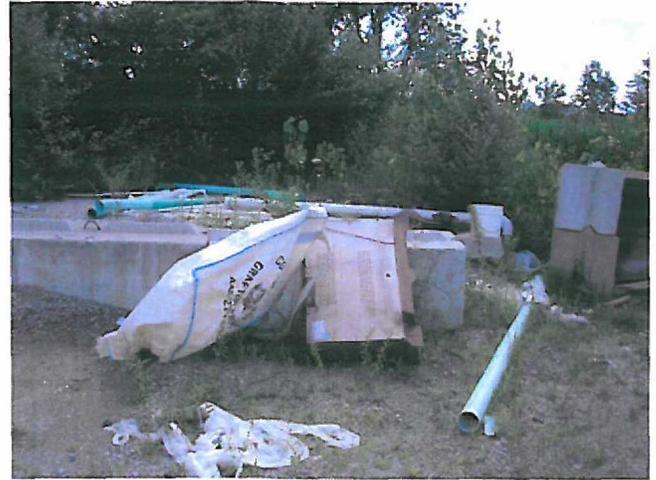
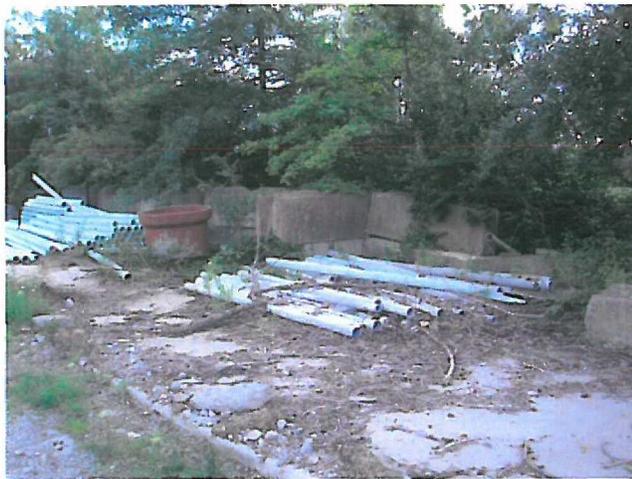
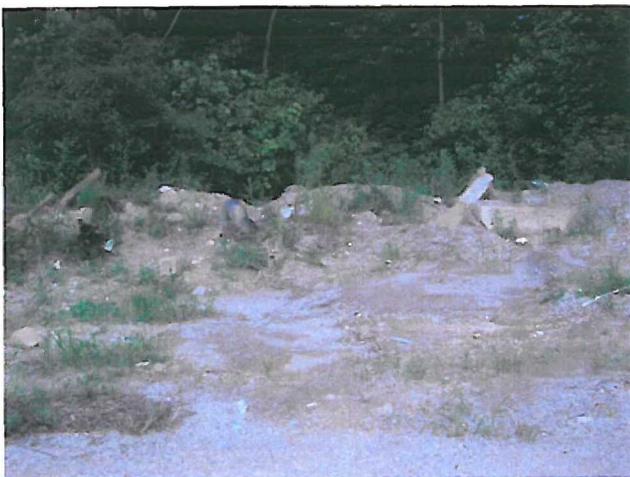
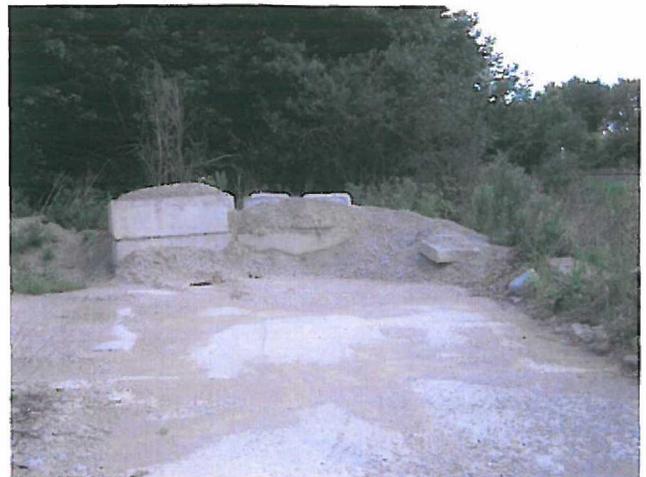
4. Good housekeeping needs to be implemented throughout the site to prevent any future pollution. This was observed in a few areas on site where trash, pallets and extra material was laying around the site. Please keep in mind that pallets can be a source of pollution because of their capabilities to hold residuals within the wood which can potentially wash off and into the receiving stream. To eliminate this chance, it is suggested to keep pallets under covering. Good housekeeping is also needed in areas where piles of material are not in any sort of containment and/or are flowing over their containment walls. These materials need to be contained to prevent them from flowing into and polluting the receiving stream. This was observed on the east side of the site. **(See Figure 10, 11, 13, & 14)**

5. Stabilization is needed in the areas of the site that are not being used. Sediment is a pollutant to water and it cannot be leaving the site. This was observed on the east side of the lot where it looked as if the area was previously used for storage, but is not currently. If the area is planned to remain unused for some time, it should be stabilized to prevent and future pollution. **(See Figure 12)**

Figure 10: (Top Left) Area where good housekeeping is needed
Figure 11: (Middle Left) Area on site where good housekeeping is needed
Figure 12: (Bottom Left) Unstable area on site where sediment and run off leave the site
Figure 13: (Top Right) Area on site where good housekeeping is needed
Figure 14: (Bottom Right) Sediment that needs to be contained and prevented from leaving the site.

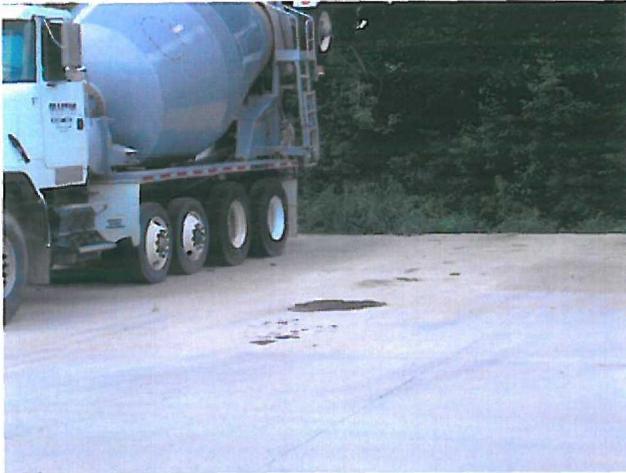
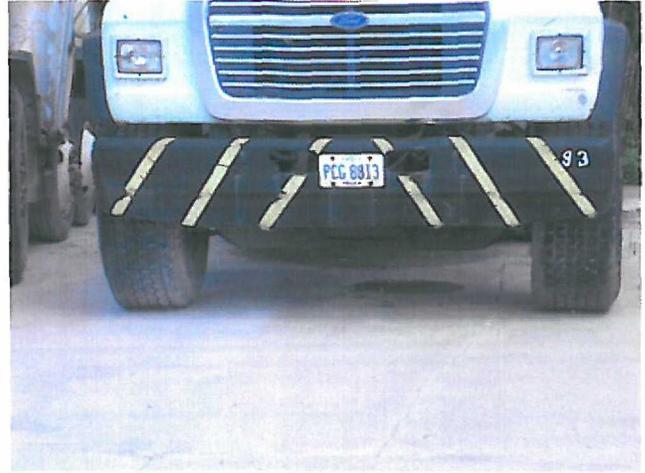
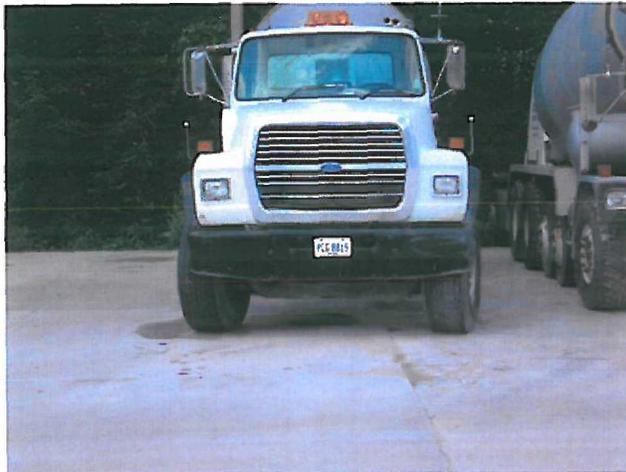
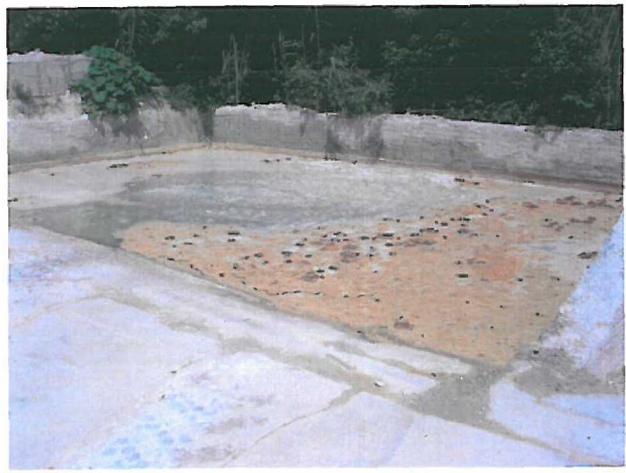
6. There were multiple oil stains on the cement from the company's trucks. When these spills occur, they need to be cleaned up immediately using the proper spill procedure. **(See Figure 15, 16, & 18)**

7. The two other cement wash out pits on the north edge of the property were near capacity. Be sure to have these pits pumped out so any overflow is prevented. Make sure to never discharge this water to the storm drains of the waters of the state. **(See Figure 17)**

Figure 15: *(Top Left)* Oil spill on site from trucks
Figure 16: *(Middle Left)* Oil spill on site from trucks
Figure 17: *(Bottom Left)* Cement washout pit
Figure 18: *(Top Right)* Oil spill on site from trucks
Figure 19: *(Bottom Right)* Retention Pond in the northeast corner of the site.

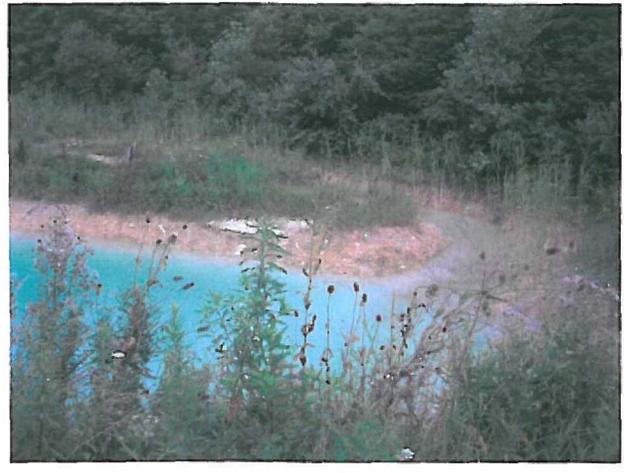
8. There was a retention pond on the northeast corner of the lot. It appeared as if the pond was treated with some sort of chemical since the pond appeared a bright aqua color. Be sure that the pond meets the water quality values for a retention pond. These specifications can be found at the following link:
