August 8, 2013

RE: CUYAHOGA COUNTY  
CITY OF HIGHLAND HEIGHTS  
CONSTRUCTION STORM WATER  
PERMIT NO: 3GC06063\*AG  
GODDARD SCHOOL

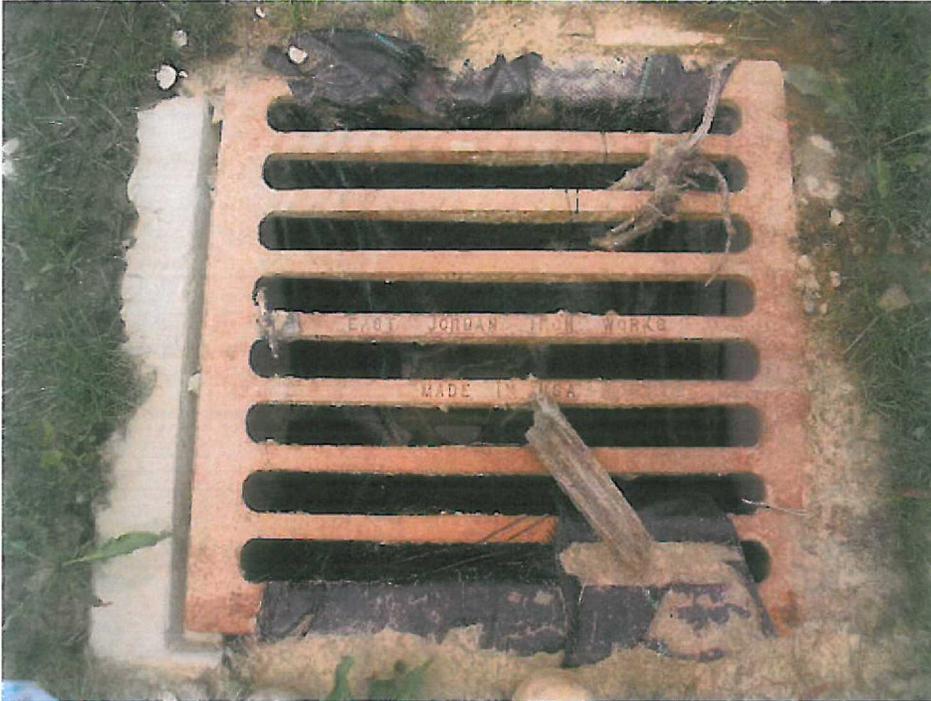
- **Storm drain inlet protection is in need of repair. (Figure 1)** Please review the specifications contained in the SWP3 and in *Rainwater and Land Development, Ohio's Standards for Stormwater Management, Land Development and Urban Stream Protection* (Ohio Department of Natural Resources, 2006), and install/repair inlet protection to meet these standards.
- **(Figure 2)** The entire site is yet to achieve final stabilization, a vegetative growth density of 70%. Final stabilization must be reached before the NPDES permit can be terminated.

**Figure 1:** Inlet protection is insufficient and in need of repair.

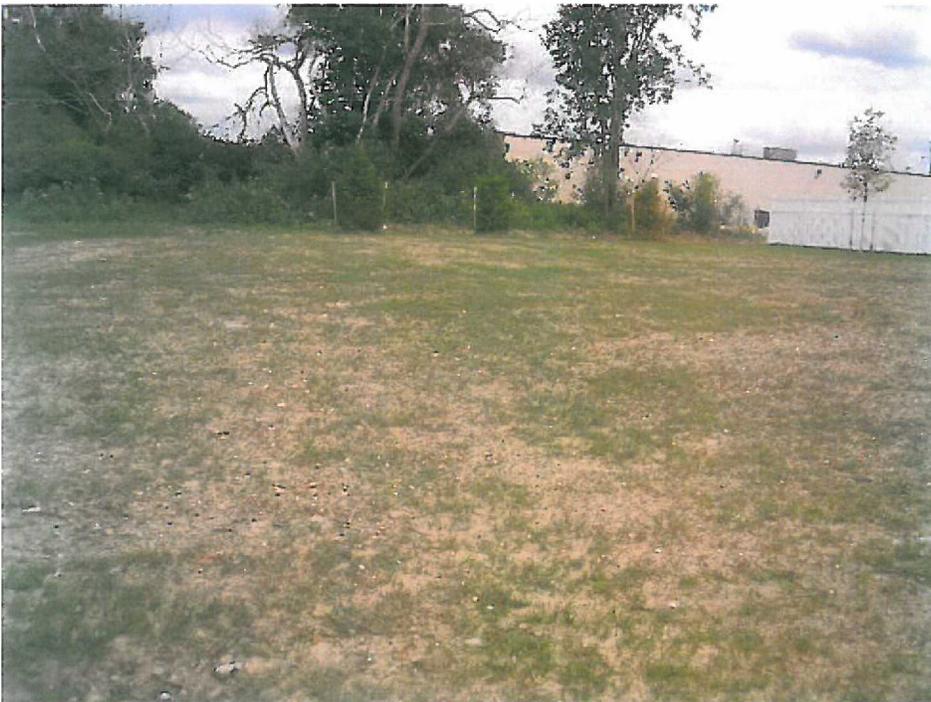
**Figure 2:** Stabilization has yet to achieve a 70% growth density.
