August 8, 2013

RE: CUYAHOGA COUNTY  
CITY OF CLEVELAND  
INDUSTRIAL STORM WATER  
PSC METALS, INC.  
3GR00867\*EG  
**NOTICE OF VIOLATION**

On July 3, 2013, Ohio EPA conducted an inspection at the PSC Metals, Inc. facility located at 4250 East 68<sup>th</sup> Street. Our inspection's purpose was to determine compliance with the Ohio EPA General Storm Water National Pollutant Discharge Elimination System (NPDES) Permit for Industrial Activity #OH000005. The site's industrial activities are categorized by the Standard Industrial Classification (SIC) Code 3363: Scrap Recycling & Waste Recycling Facilities except Source-Separated Recycling. This corresponds to Subsector N1 in Part 8 of the NPDES permit. We agreed on site that your facility's industrial activities would also correspond to Subsector M1 (Automobile Salvage Yard) in Part 8 of the NPDES Permit. Make sure you are in compliance with both sectors. During the inspection, James R. Murray Jr. and you represented PSC Metals, Inc. Dan Bogoevski, Tamara Girard, and I represented the Ohio EPA.

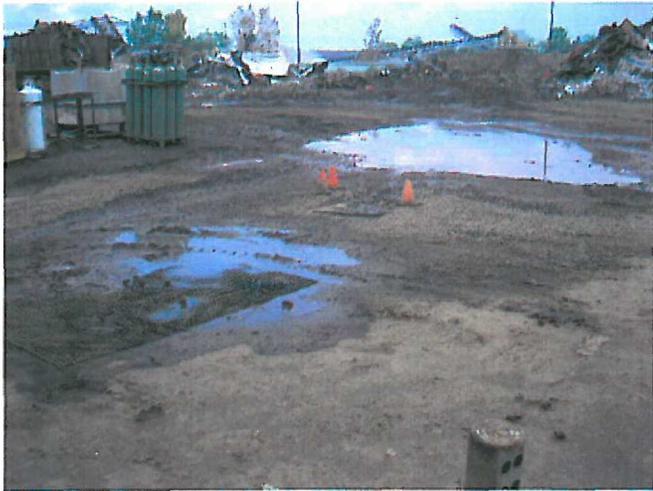
1. The area on the south side of the lot needs stabilized. One way this can be accomplished is with vegetation.
2. The heavy equipment maintenance and washing, according to you, is done outside the maintenance garage. This is a very strong source of pollution, especially since it is done adjacent to a drain. This cannot be done in this area without the proper Best Management Practices (BMPs) put into place. All machine wash runoff must drain to sanitary. If maintenance is going to remain in this spot, a good preventative action would be to cap the drain. **(See Fig 1)**

**Figure 1:** (left) The drainage going into the drain outside the maintenance garage.  
**Figure 2:** (middle left) The broken part of the fence that allowed runoff and debris to escape.

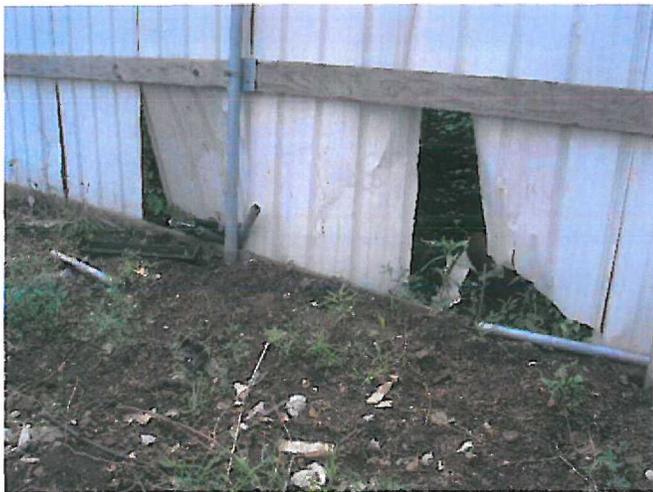
10. There was a spot of the fence on the south side of the site that was broken. Material was spilling out here and it allowed water from the site to flow into the channel. The fence should be repaired to prevent any water from leaving the site. **(See Fig 2)**

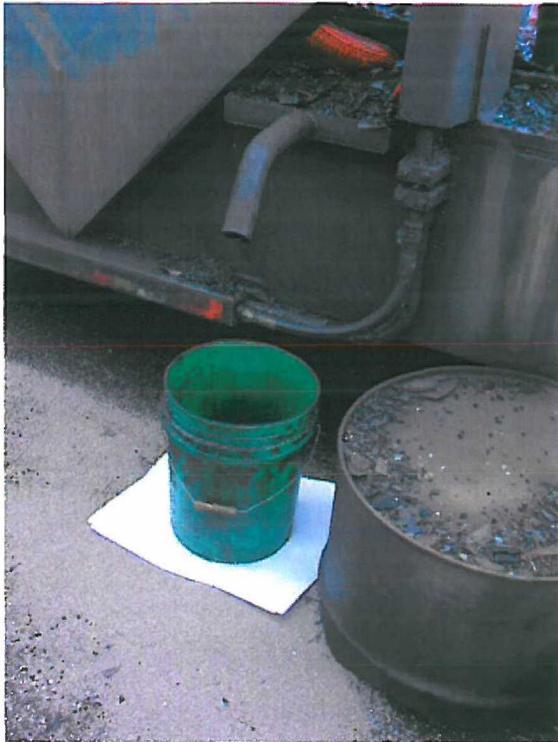
12. The metal turnings had spilled out of the roll off box that they were supposed to be contained in. This roll off was also observed to be leaking. The turnings are a very strong source of pollution and need to be maintained properly. It is required by Part 8.N.3.1.3 that all stockpiles of turning are kept under some form of permanent or semi-permanent cover in an established containment area. Storm water runoff can only be discharged after making contact with the turning if it runs through an oil water separator. Since your site does not currently have an oil water separator all runoff from the turnings is prohibited. **(See Fig 3)**

**Figure 3:** (left) One of the many uncovered and unmaintained dumpsters. Metal turnings have spilled over and the dumpster is leaking.  
**Figure 4:** (above) Car crushing area is over flowing with broken pieces of glass and plastic. More frequent clean outs may need to be set into action.

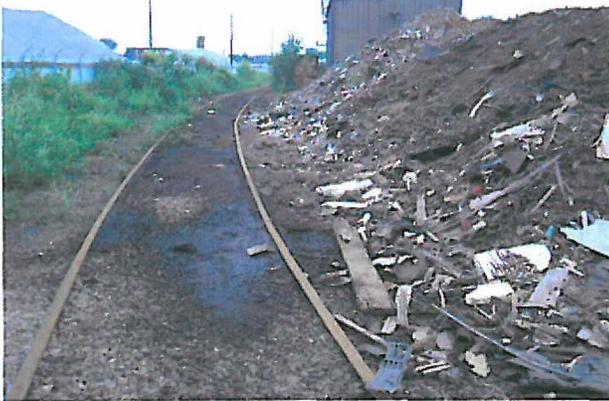
3. There was numerous oil spills observed throughout the lot. This includes all the smaller spills and the area of accumulated spills behind the bailer along the railroad tracks. These spills need to be cleaned up immediately and Best Management Practices (BMPs) need to be put into place to prevent it from happening in the future. There was also an abundant amount of a powder observed on the site that was a result of accepted pipes that broke. This specific spill

is a good example of how better surveillance and enforced limits on what gets accepted can prevent future issues. **(See Fig 5)**

Figure 5: (left) Accumulation of oil spills along the tracks behind the bailer house.

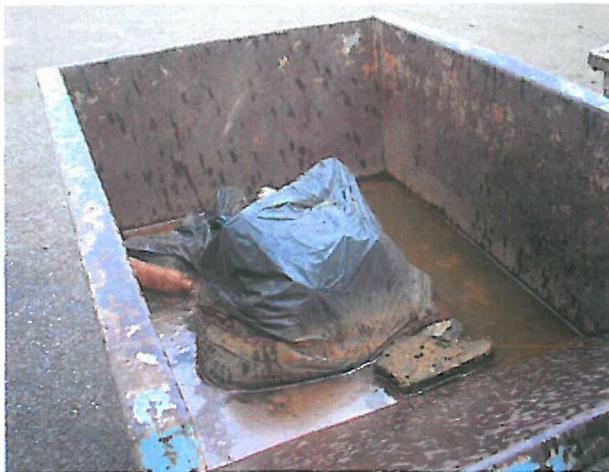
13. There were several dumpsters on site that were not covered, leaking and in overall poor condition. All dumpsters must be intact and sealed to make sure they do not have any washout leaving the container and getting into the storm water. All dumpsters must also be covered with either a tarp or a lid. They can also be stored under some sort of roof. This includes but is not limited to the dumpsters/trashcans containing:

Figure 6: (middle left) Uncovered bin storing miscellaneous trash.

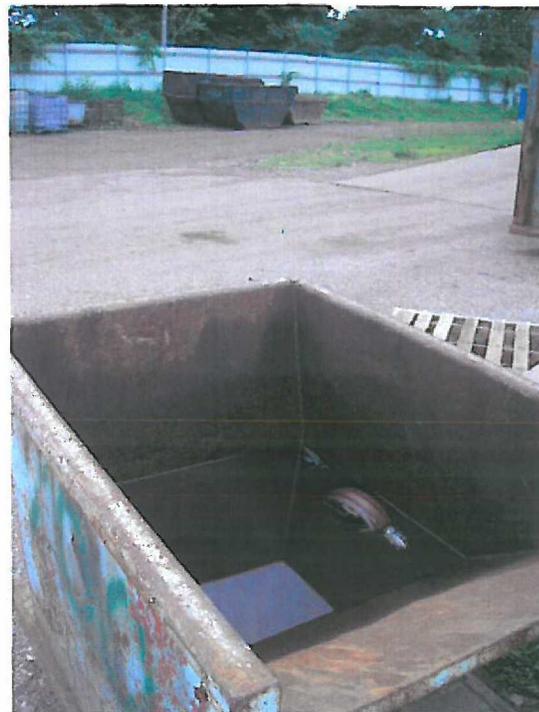
Figure 7: (below) Uncovered bin filled with transmission fluid.

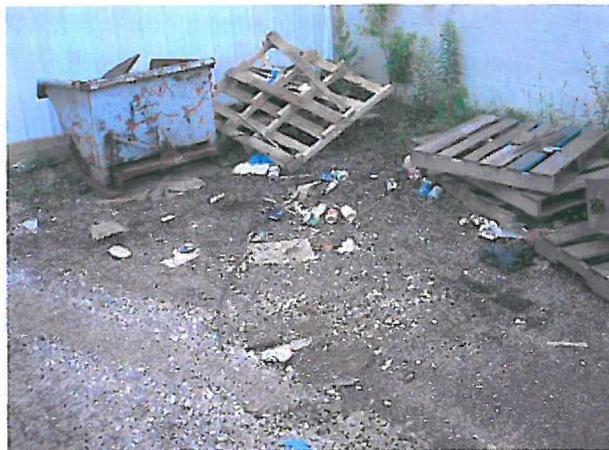
16. Good housekeeping needs to be implemented in the scrap receiving area specifically the areas around outfall #005 and #006. It was suggested to try a new system so the stockpile does not need to be on the ground for a long period of time therefore increasing the chance of pollution. It was also suggested in this area to maintain better surveillance, such as a fulltime inspector, so there is no dumping of unwanted material. **(See Fig 8)**

Figure 8: (above) Area in need of good housekeeping by the by the customer entrance for the scrap receiving yard.

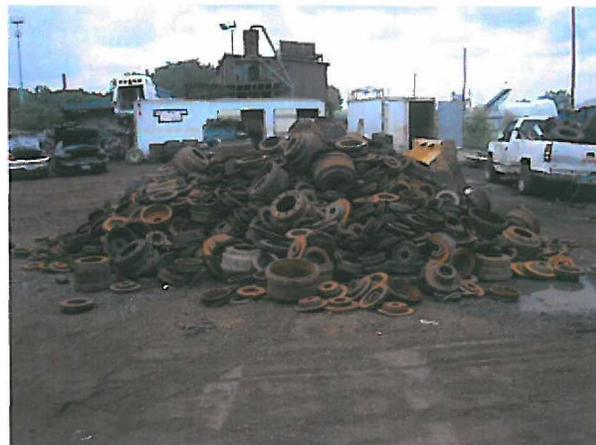
14. The stock pile of rotors on the ground close to the “weigh in” station needs to be cleaned up and stored in some sort of containment to eliminate the possibility of the storm water that hits it reaching the waterways. This also needs to happen for the stock pile of electric motors. **(See Fig 9)**

Figure 9: (right) stock pile of rotors on the ground.
