August 12, 2013

RE: State Route 235; NPDES Permit # 1GC03966*AG; Compliance Inspection Findings and Notice of Violation

Site Name: State Route 235 - New Carlisle, OH

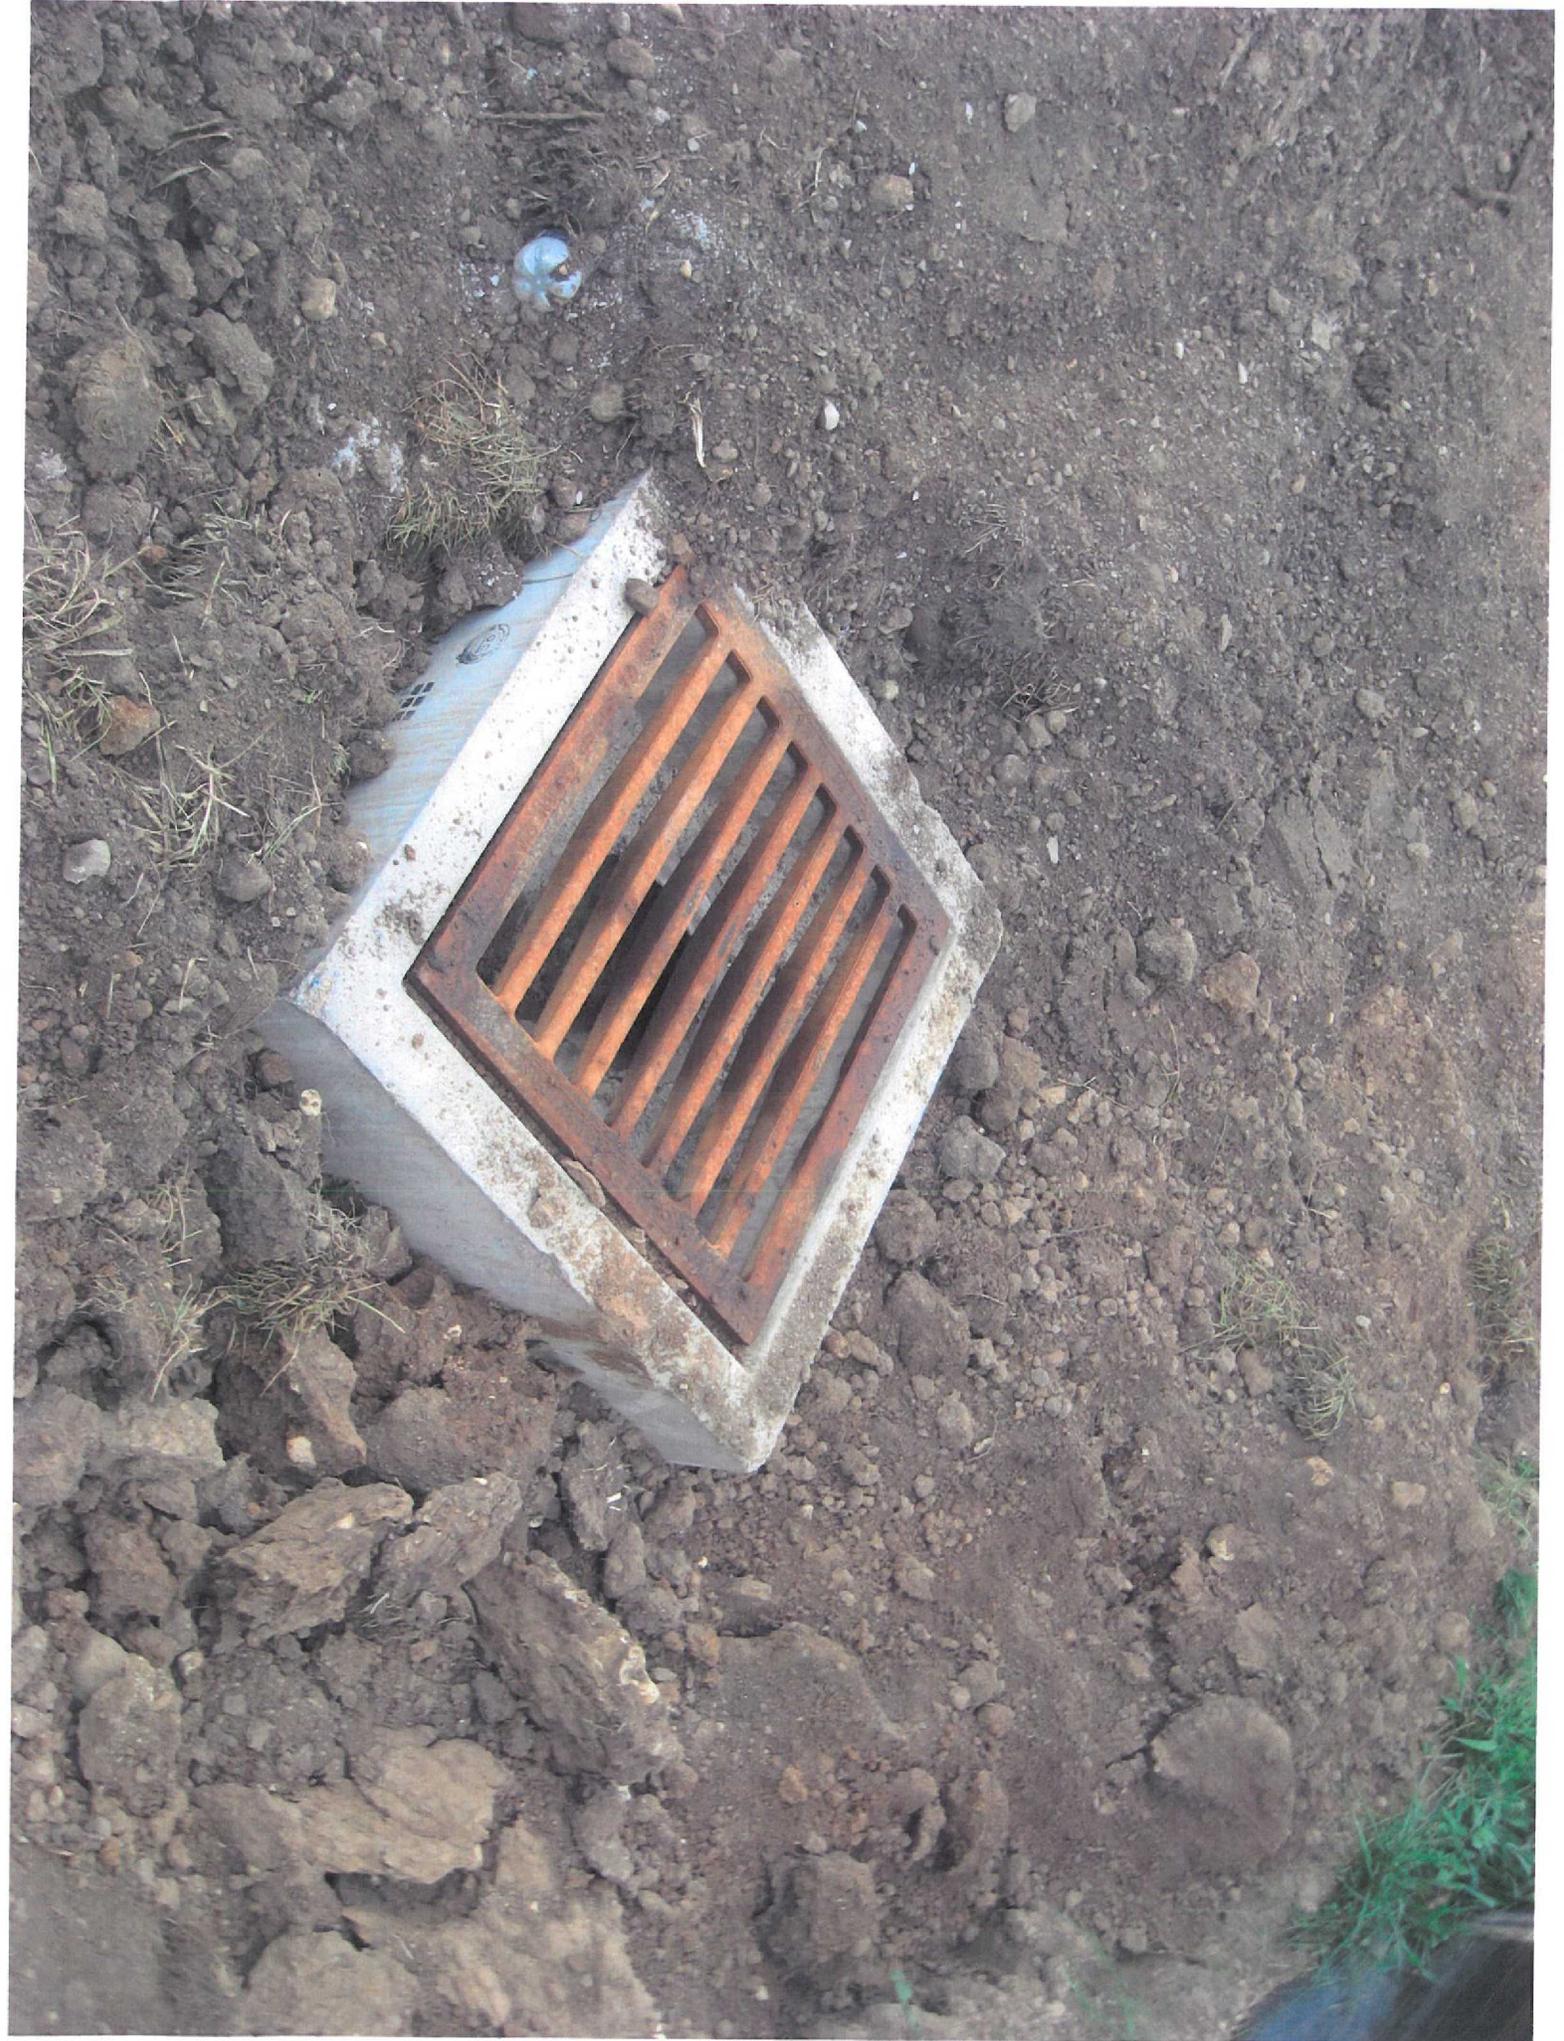
The site has failed to install effective sediment controls to minimize sediment laden water entering active storm drain systems. The intent of the permit is to minimize the off-site loss of eroded sediments into waters of the state.

Specifically, this is referring to a field inlet located along State Route 235 near the Ag Re Plan business building. The photograph included with this letter documents the violation. The unprotected inlet could allow sediment laden water to drain into an active storm sewer system which discharges into Honey Creek. Inlet protection devices should be installed based on the specifications described in Chapter 6.4 of the Ohio DNR's Rainwater and Land Development Manual. Here is the web link: <http://www.dnr.state.oh.us/tabid/9186/default.aspx>. Controls to minimize loss of eroded sediments are expected to remain in place until all disturbed areas at the project have been permanently stabilized.

Explain: 2x4 wood Board, geotextile devices on field inlets effective, One field inlet below grade not protected

- Field ^{Drain} Inlet near Ag Re Plan unprotected.
- Road Construction (widening + New storm sewer system) / Minimal Disturbance

Explain in a written response to this letter what measures will be taken to correct this violation. Please provide this response to our office within 14 days of receipt of this letter.
