August 12, 2013

RE: Construction Storm Water Inspection at Sunbury Meadows Sections 5A and 5B / Delaware County. Permit Number: 4GC04198*AG

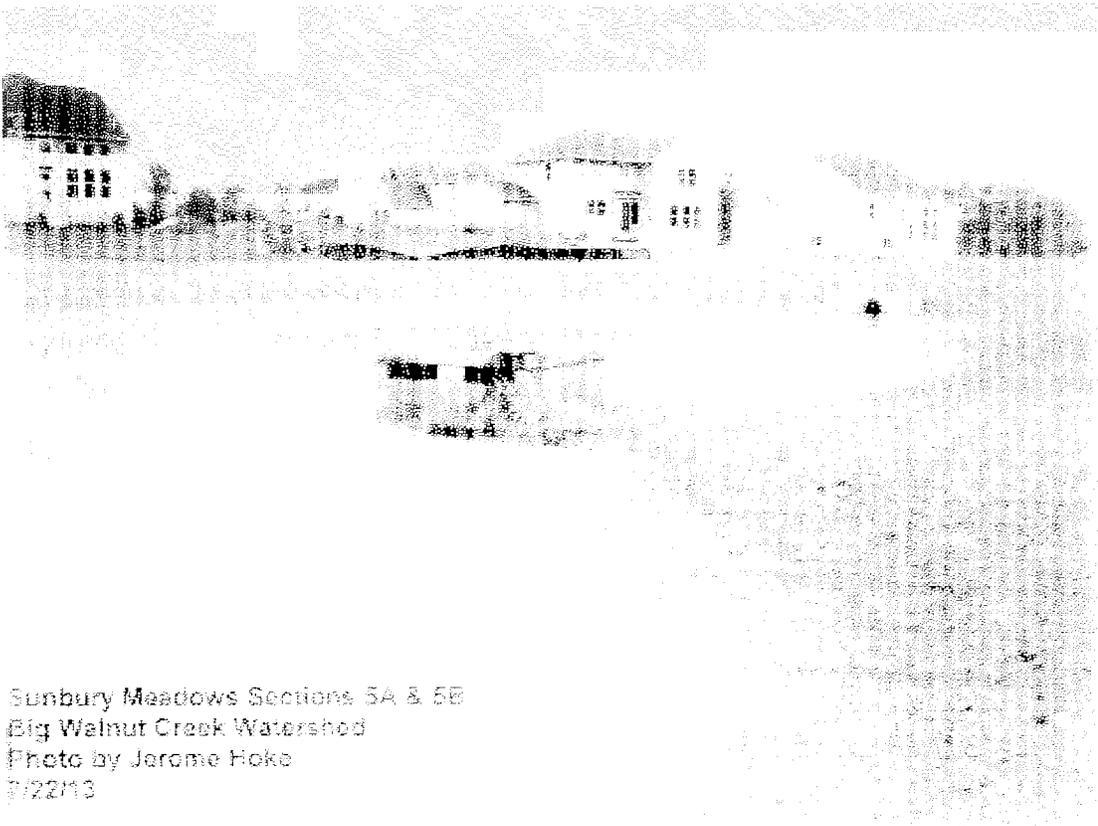
Figure 6: Sediment basin requires a riser and/or skimmer.
