September 10, 2013

RE: ROUND UP LAKE
FORMERLY JELLYSTONE PARK
PERMIT NO. 3PR00090*ED
PORTAGE COUNTY
MANTUA TOWNSHIP

On August 29, 2013, an inspection of the above referenced facility's wastewater treatment system was conducted. The facility was represented by Mr. Mark Rhoades, Class "A" Waste Water Treatment Plant Operator. The purpose of the inspection was to: (1) evaluate the performance of the wastewater treatment system along with the facility's compliance status with respect to the terms and conditions of the above-referenced National Pollutant Discharge Elimination System (NPDES) permit and (2) determine required additional actions to be undertaken as part of the permit renewal process.

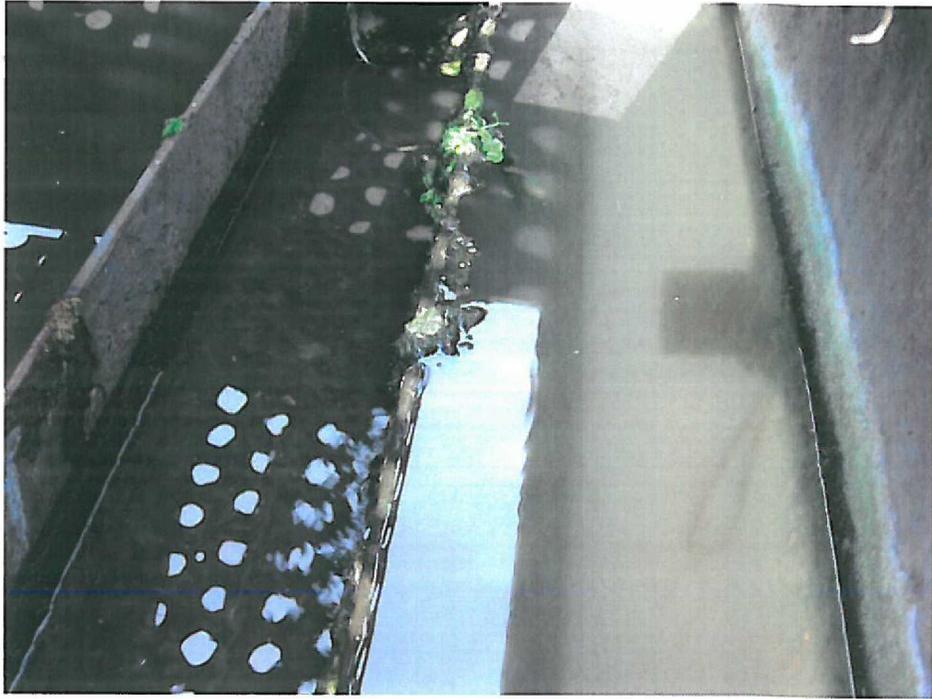
Figure 1

25. The weirs and trough in the settling tank were covered with vegetation and moss. See Figure 1. The weirs and trough should be scraped down or hosed off on a regular basis.

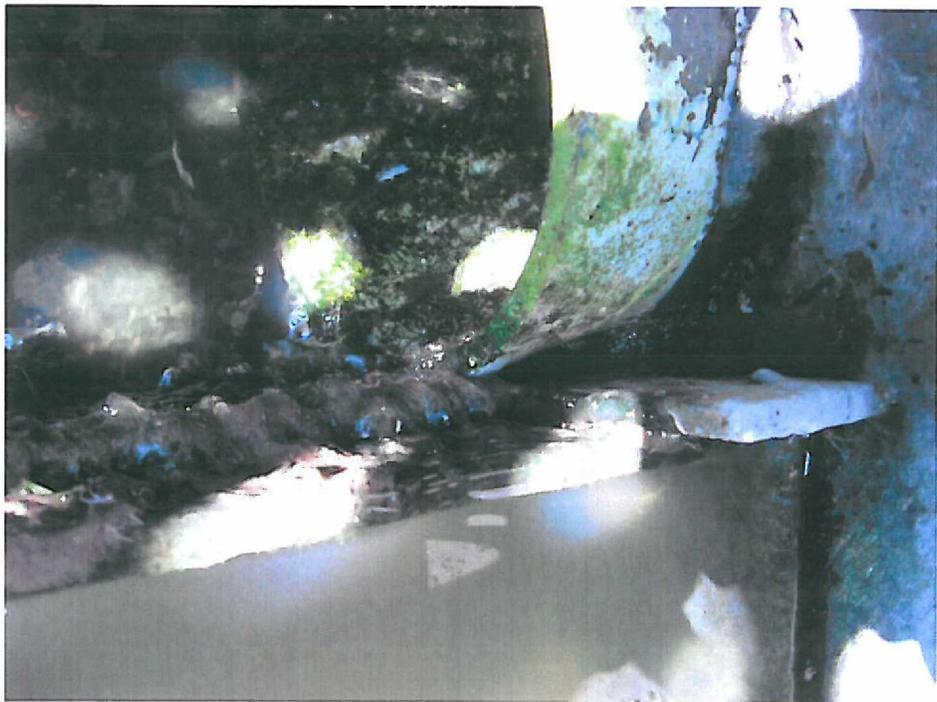
Figure 2

26. The weir is leaking between the plates near the outlet. See Figure 2. Also, it appears that the weir needs to be leveled. The water is only flowing over the weir on the west side near the outlet. This needs to be corrected immediately.
