**RE: ConAgra Foods, Inc.  
Storm Water Compliance Inspection  
Permit 1GR01005\*EG**

# Industrial Storm Water Reconnaissance Inspection Report

Name of facility: *ConAgra Foods*

Date of visit: *September 4, 2013*

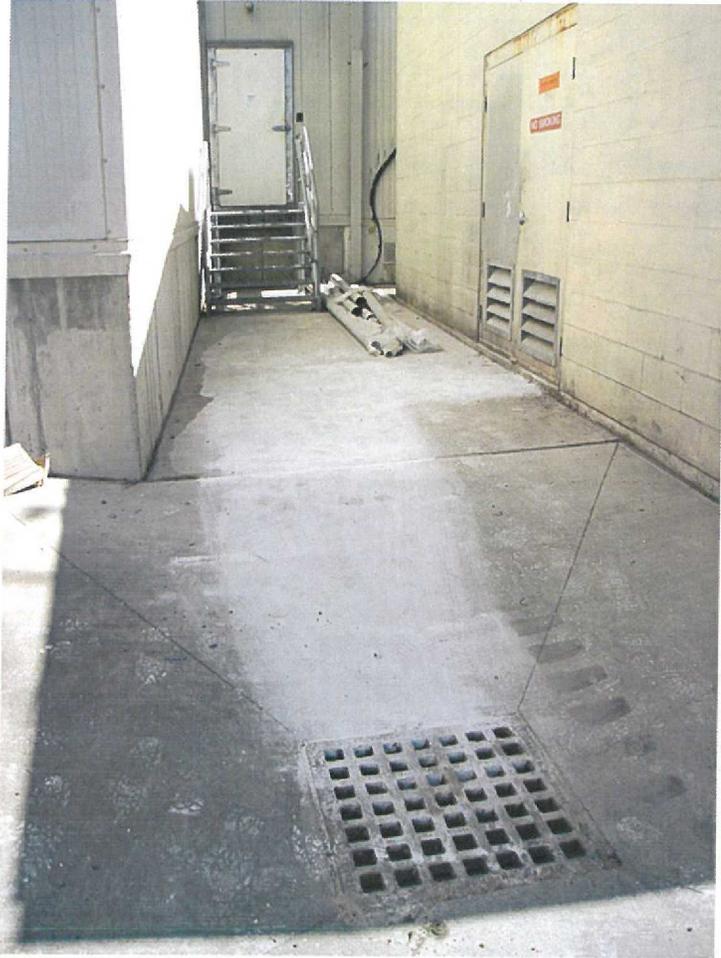
***Food ingredients are not compatible with exposure to stormwater. There was evidence of fugitive flour from the sifter building getting into a catch basin and the retention pond was septic with what ConAgra now believes was flour (see pictures)***

If yes, describe: ***Flour from sifter building (see picture). Also, water in detention basin was septic.***

*Catch basin next to flour sifter building*

Most notable from the inspection was the septic condition of the storm water detention basin that receives runoff from ConAgra's facility. It appeared that the cause of this condition was flour from the sifter building entering an adjacent storm sewer catch basin. You informed me that you have since had the contents of the detention basin pumped out and hauled off-site for disposal by Mike's Sanitation. Although you indicated that this condition was likely the result of an isolated mismanagement of flour, I believe it will be important for you to review operations associated with the sifter building to ensure flour does not enter the storm sewer. Signage or placarding notifying employees and contractors not to dispose of flour to the storm sewer would seem warranted and reasonable.

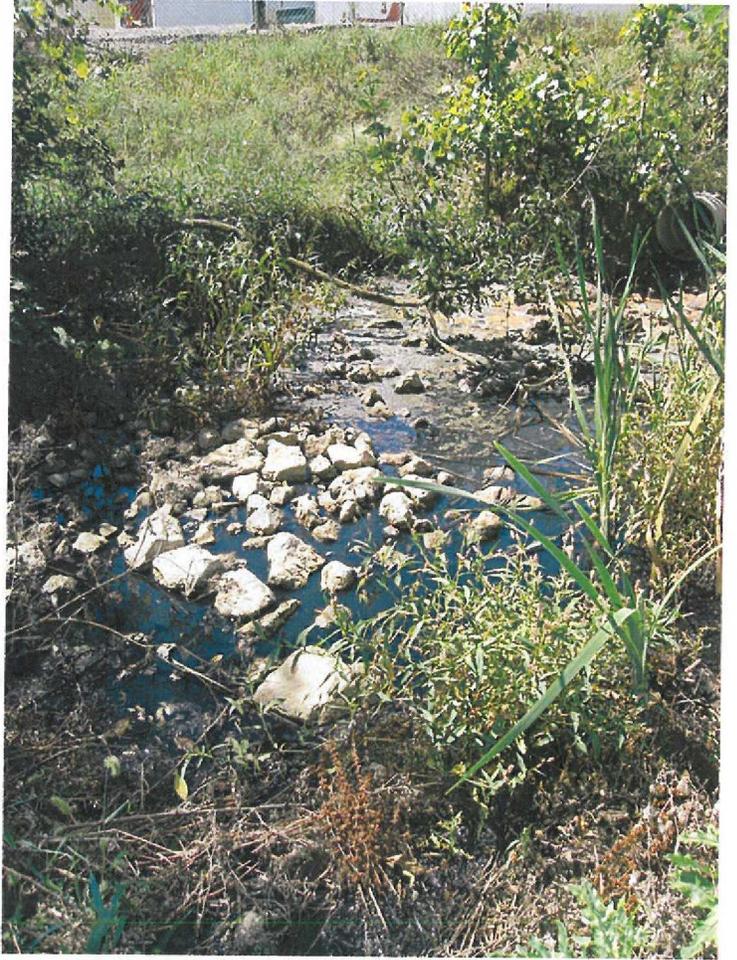
***The detention pond did not appear to be designed to manage stormwater. Any treatment would likely be incidental.***

*Detention basin on northeast side of site  
outside the security fence.*

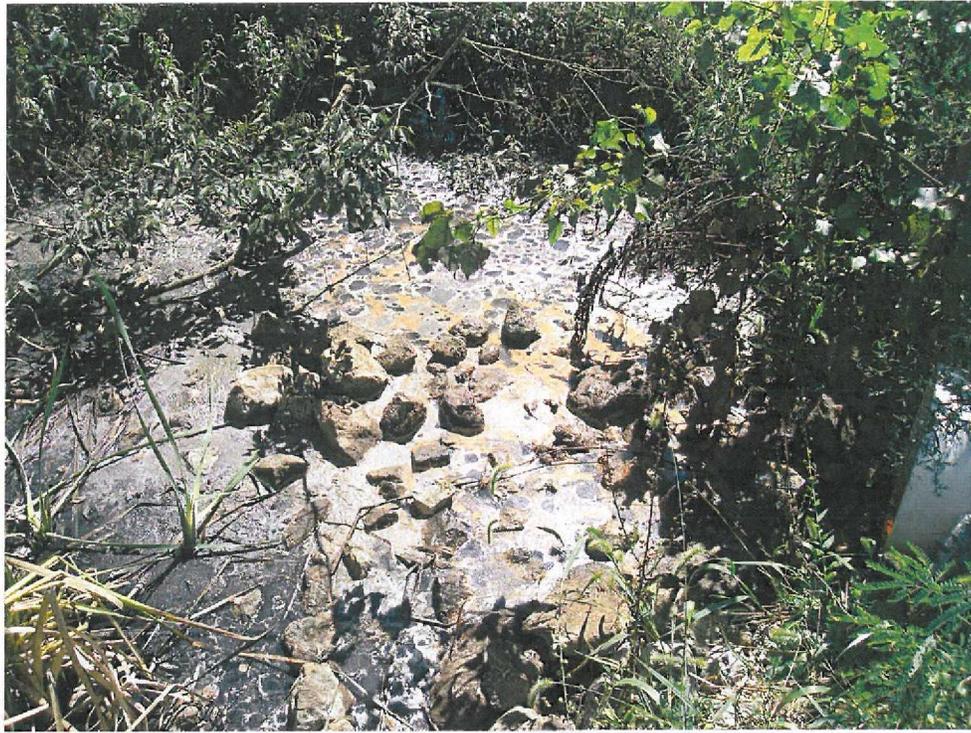
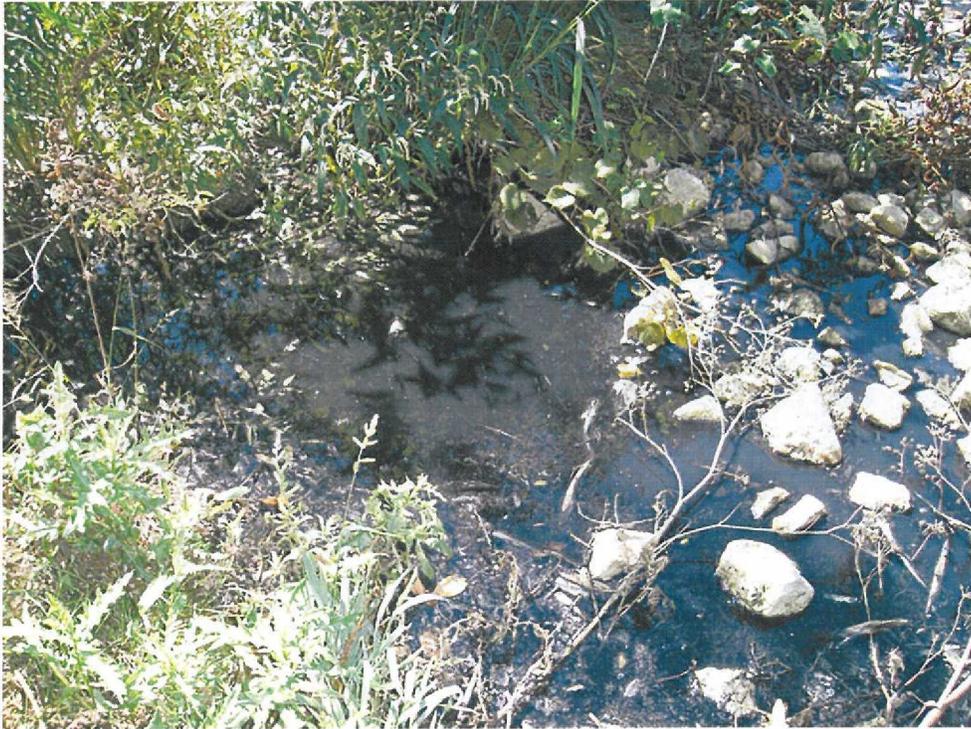
***Black stagnant water in detention basin  
(no flow into basin at the time)***
