October 2, 2013

**RE: Construction Storm Water Inspection at Franklin Station/ Franklin County
Permit Number: 4GC03741*AG**

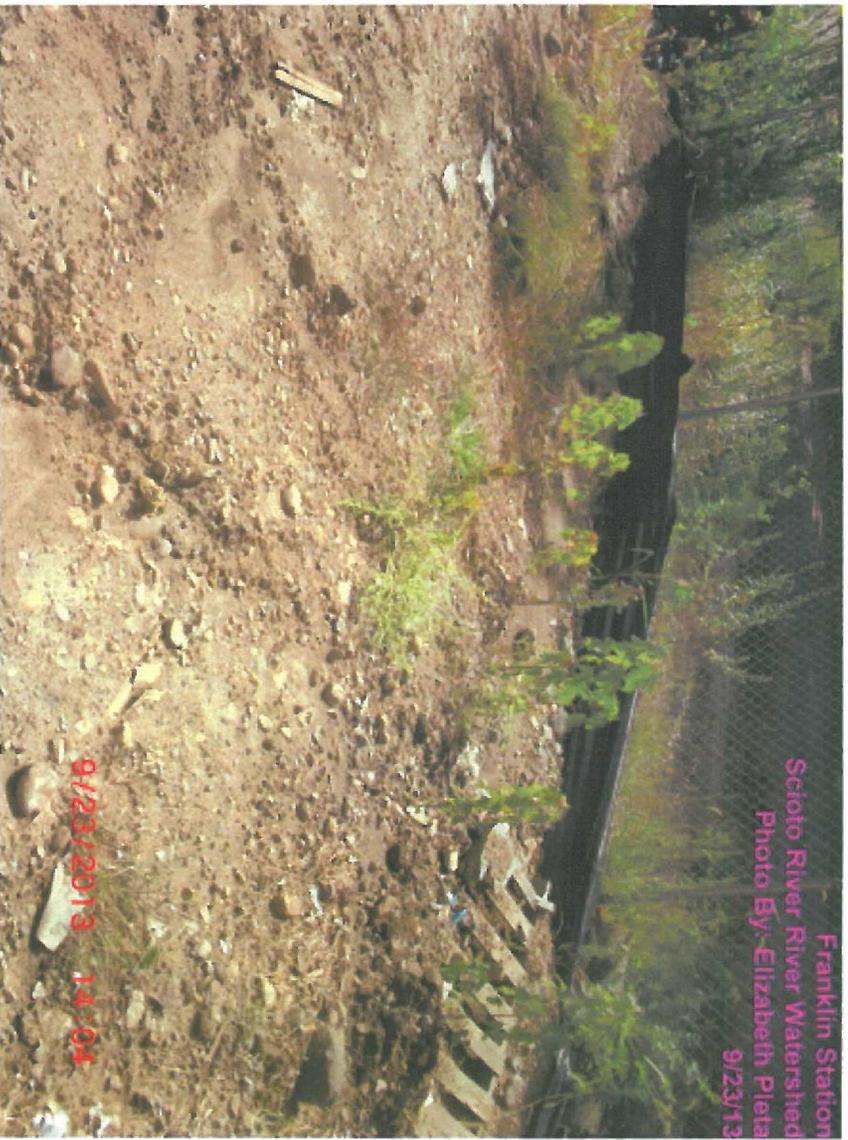
- As noted in a previous inspection, the silt fence in the northwest corner of the site has failed (See Figure 1).
- In addition the perimeter along the southeast side of the site is still void of any sediment controls, directly resulting in sedimentation off-site (See Figure 2).
- Moreover, the integrity of inlet protections on site has further degraded since our last inspection (See Figure 3). Maintenance of silt fencing and inlet protections is expected within three (3) days from receipt of this letter or further compliance measures may have to be taken on behalf of the Ohio EPA.
- At a minimum, all barren areas which are intended to remain idle to through the winter must be protected with a crimped straw mulch or equivalent. Please be aware that this site will be reevaluated to ensure this minimum requirement is

Figure 1: Silt fencing on the northwest corner of site requires maintenance.

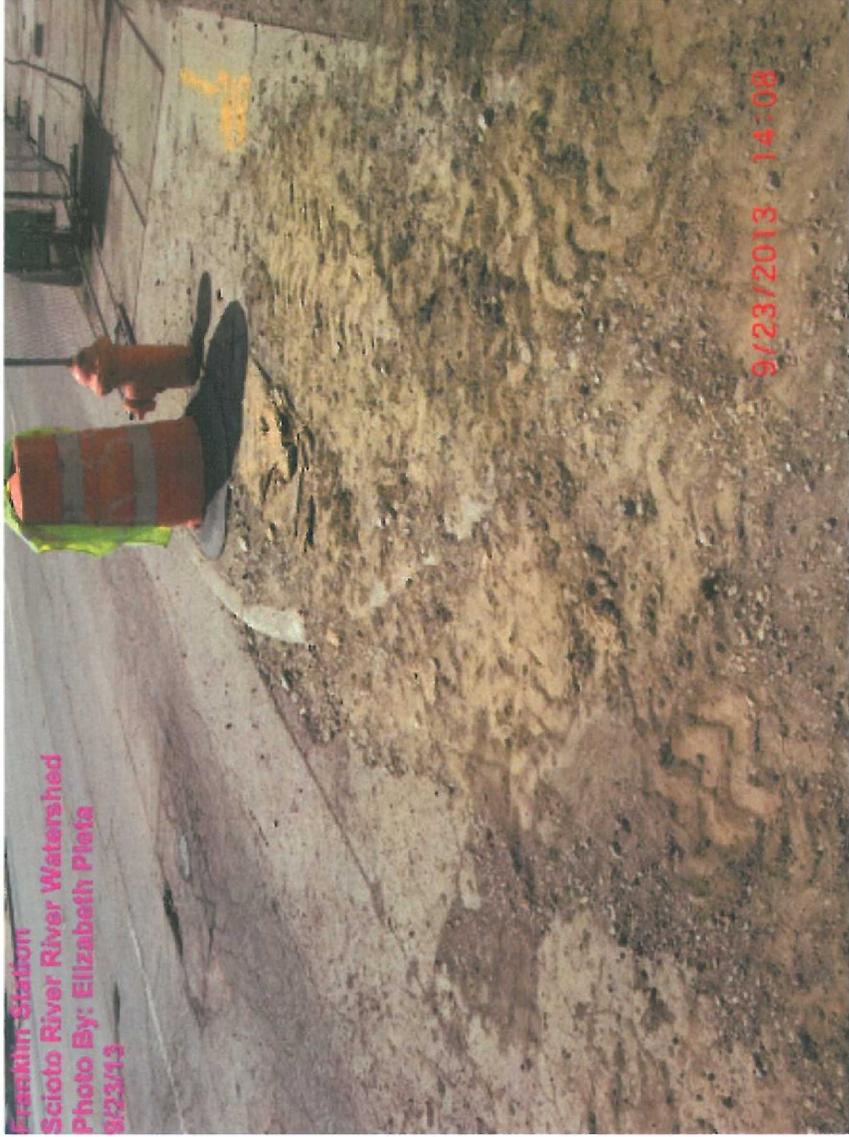
Figure 2: Controls are required on the southeast corner of the site.

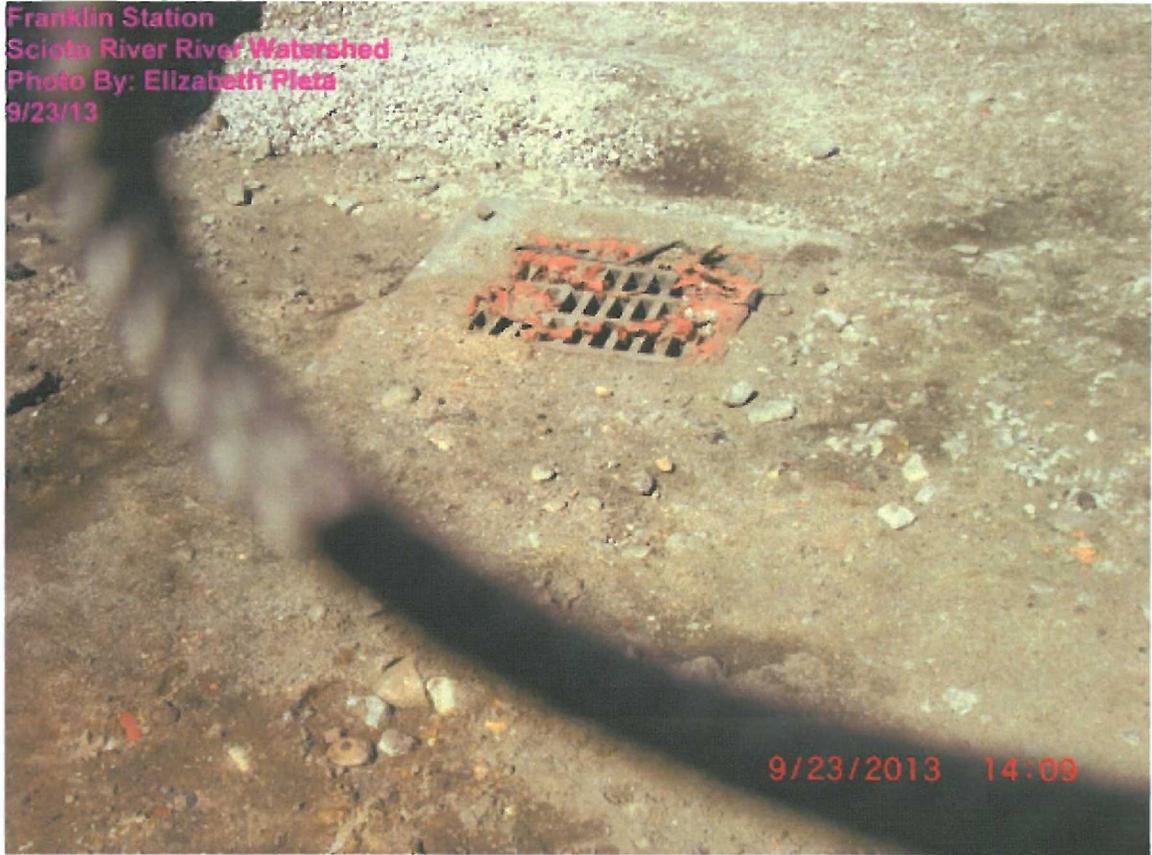
Figure 3: Inlet protections on site require maintenance.
