October 2, 2013

RE: Storm Water Inspection at Hunters Ridge/ Fairfield County, Permit Number: 4GC04148*AG

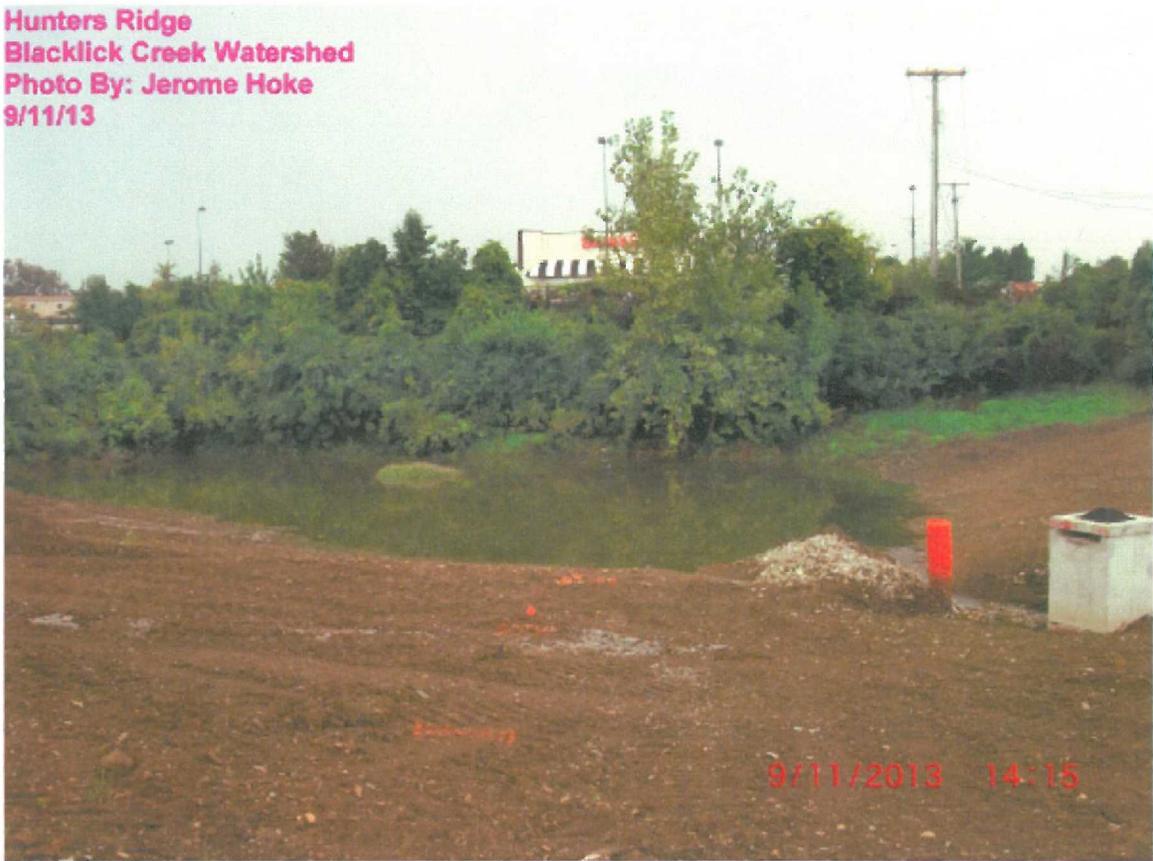
- Our staff noted that the sediment pond located on the southeast side of the site was failing to work as intended (See Figure 1). In direct observations with a rain event, water was short circuiting the temporary riser, resulting in ineffective elimination of sediment storage. Corrective measures must be taken to ensure that water is properly being circuited to the riser within seven (7) days of receipt of this letter.
- Concrete washout activities were noted on site. A washout containment area must be established to ensure compliance with the Ohio EPA's General Storm Water Permit (see Figure 2).
- The entrance of the site must be stabilized with non-erodible fill to minimize off site vehicle tracking (See Figure 3).

Figure 1 Southeast sediment basin with riser that is being short circuited.

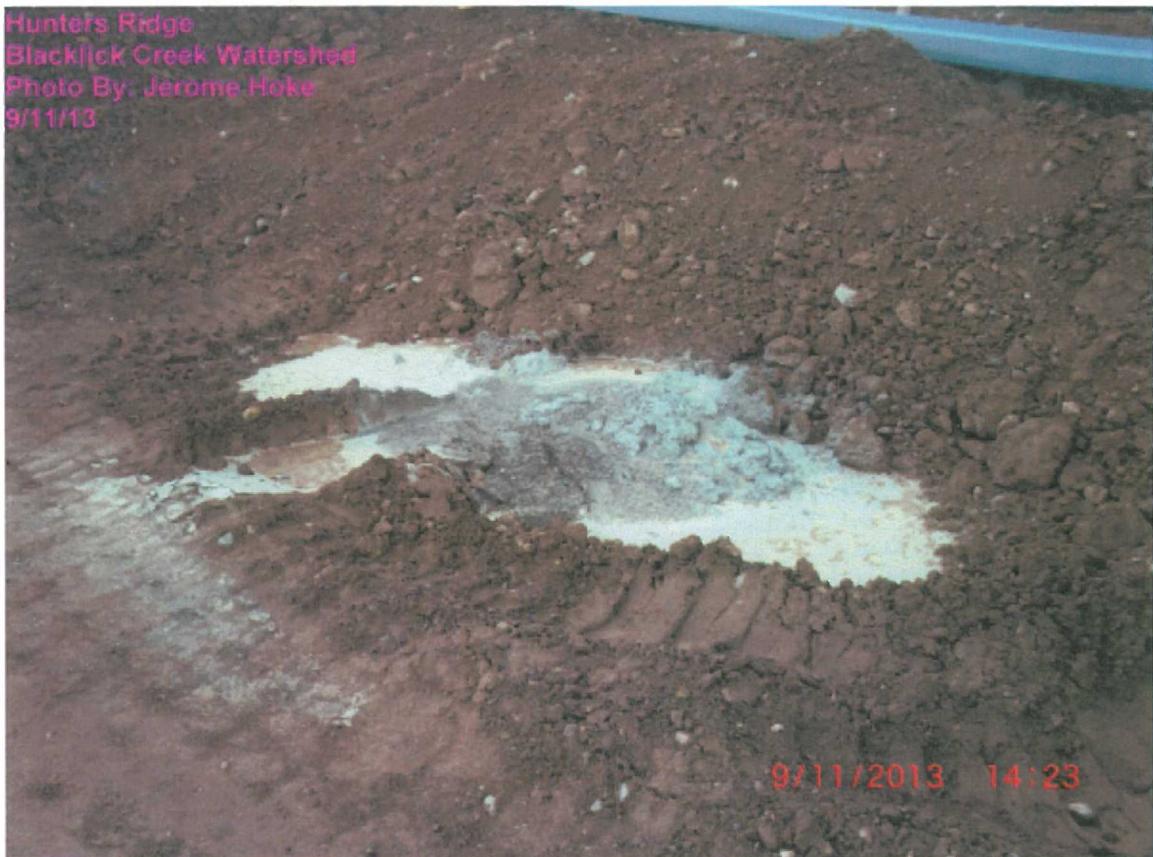
Figure 2 Evidence of concrete washout. Washout activities must be contained.

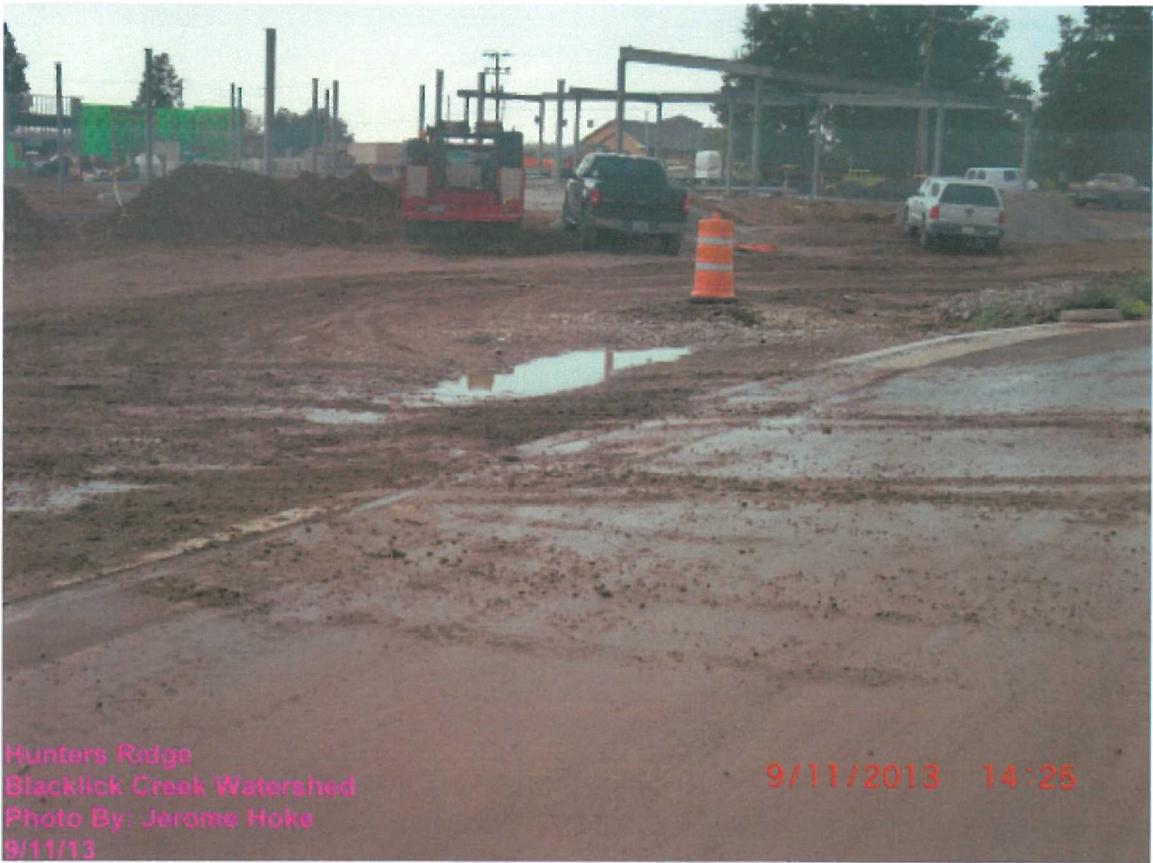
Figure 3 Site entrance requiring stabilization.
