**RE: Construction Storm Water Inspection at Dublin Alzheimers Special Care Center/ Franklin County, Permit Number: 4GC04225\*AG**

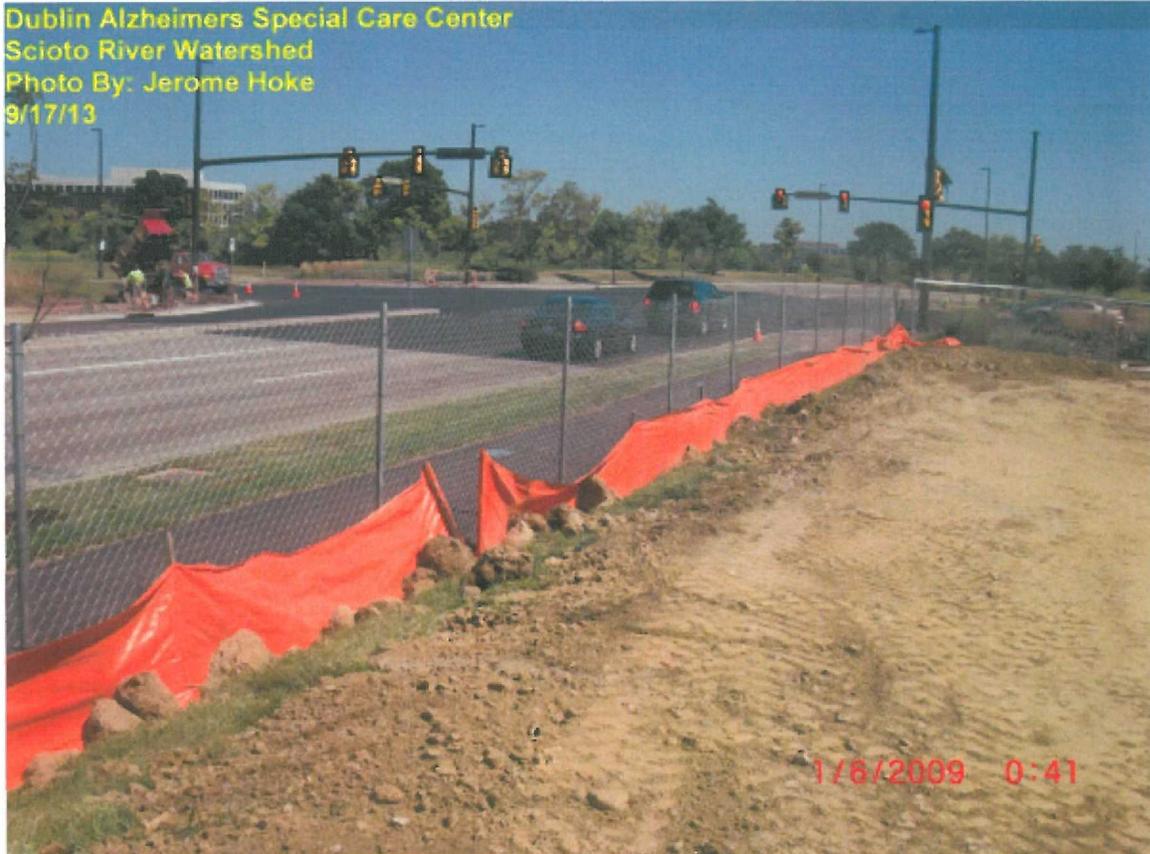
- It was noted upon inspection that there was a gap in a section of silt fence on the north side. This area of silt fence is not properly installed and will require maintenance within three (3) days of receipt of this letter (See Figure 1). Please note sediment controls implemented on this site will require maintenance to ensure a proper functioning condition. This general permit states that all sediment controls will be inspected and maintained every seven days or within 24 hours of a precipitation event equal to or greater than 0.5 inches. A log of inspection must be maintained on site for the agency to review. An example of this log can be found at: [http://www.epa.ohio.gov/portals/35/storm/cgp\\_ins1.pdf](http://www.epa.ohio.gov/portals/35/storm/cgp_ins1.pdf)

**Figure 1 North side of site, adjacent to Woerner Temple Road, has failed and requires maintenance.**

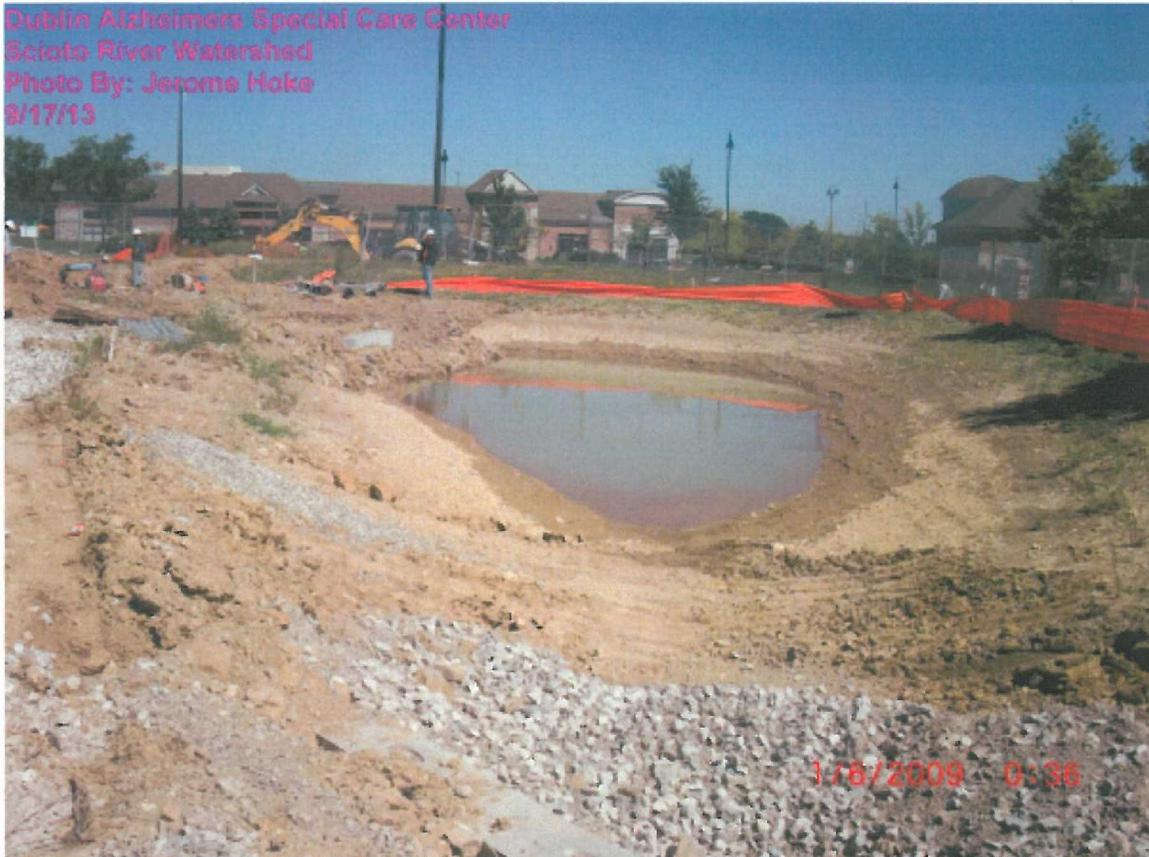
- Please maintain positive drainage to the apparent impoundment intended for sediment control noted in Figure 2
- The entrance adjacent to Woerner Temple Road must be stabilized with non-erodible fill to minimize off site vehicle tracking (See Figure 3).

**Figure 2 Maintain positive drainage to sediment impoundment.**

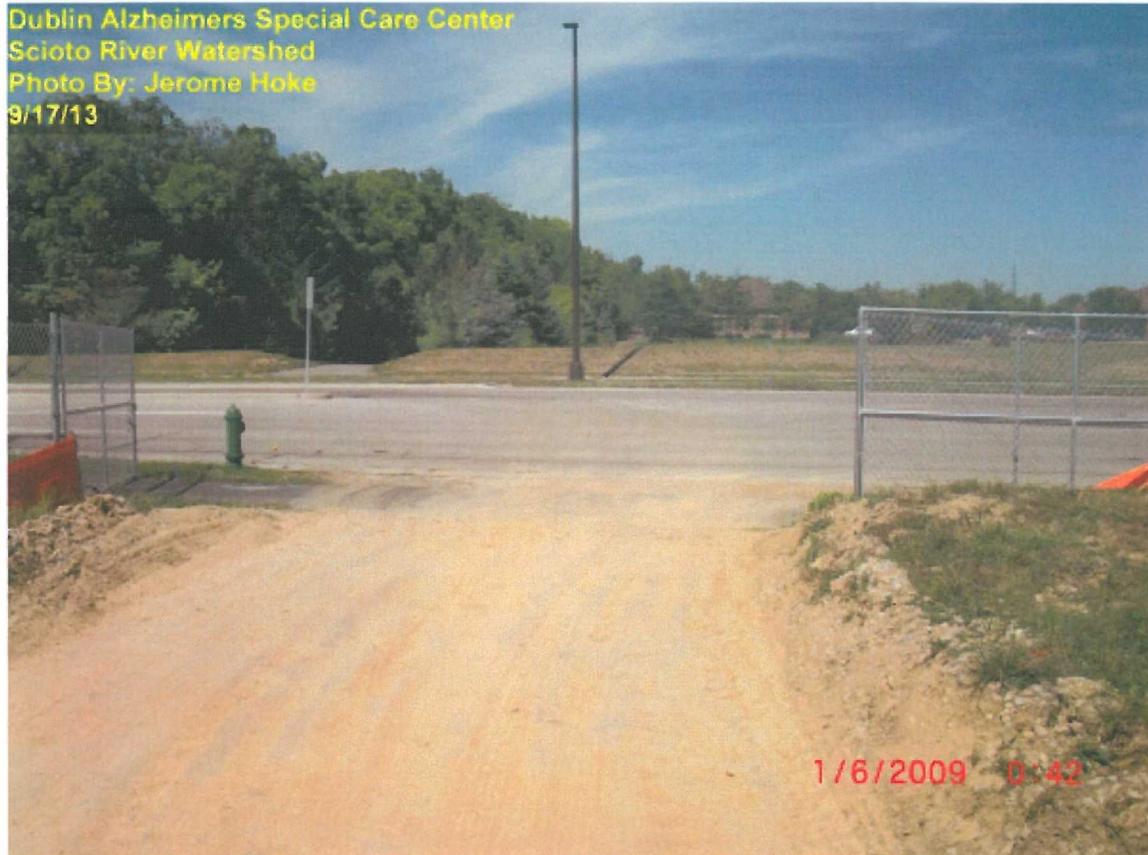
Figure 3 North entrance adjacent to Woerner Temple Road requiring stabilization.

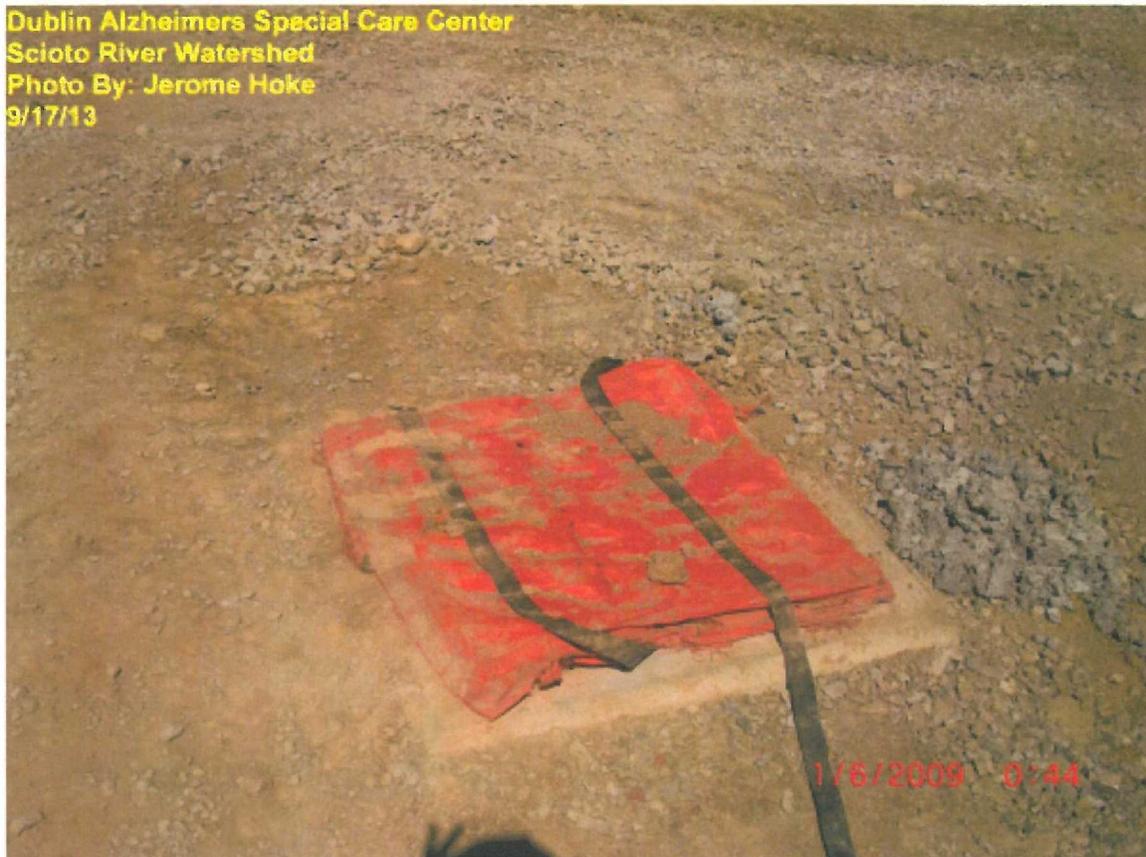
- The inlet protections noted on site have become worn and will require maintenance at this time (See Figure 4). In addition, please ensure that inlet protections that are below grade do not become overburdened with sediment (see Figure 5). If overburdening occurs please ensure maintenance to these inlets.

Figure 4 inlet protection requiring maintenance.

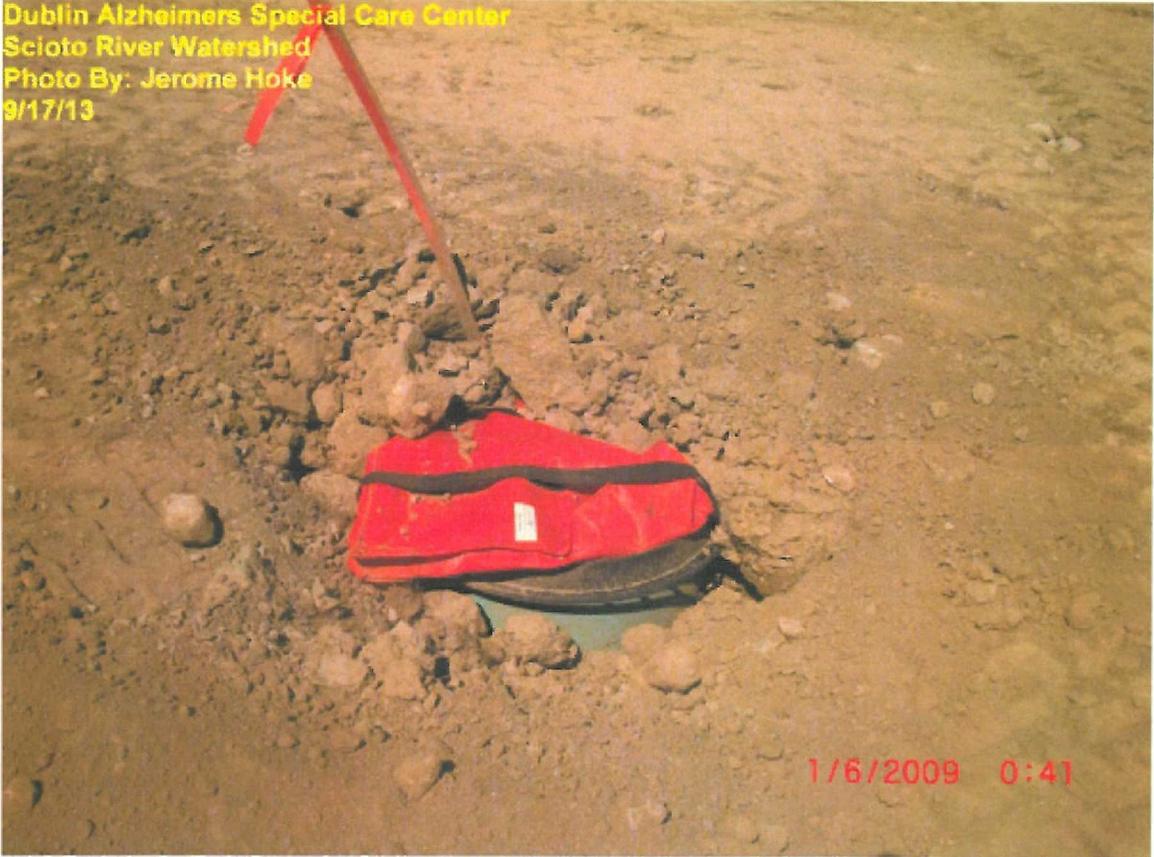
**Figure 5 Please ensure inlets do not become overburdened with sediment or dirt. This will cause them to become ineffective for sediment control.**
