October 2, 2013

**RE: Construction Storm Water Inspection at Links at Ballantrae/ Franklin County. Permit Number:  
4GC04249\*AG**

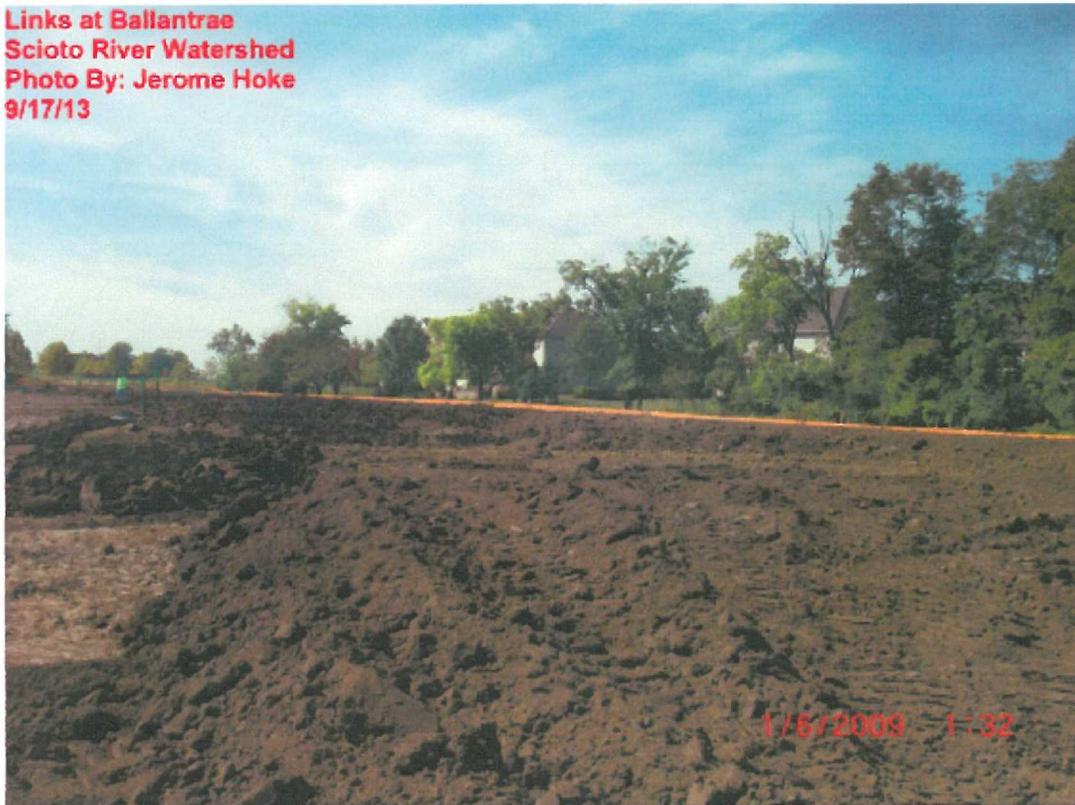
- It appeared that the northeast sediment basin was nearing completion (See Figure 1). The installation of a temporary riser and/or skimmer is expected within ten (10) days from installation of a storm water system. The riser must be set to an elevation to accommodate the required storage of 67 cubic yards per acre of drainage for the dewatering zone and thirty seven (37) cubic yards per acre of disturbance for the sediment settling zone. Please refer to the following link for assistance:  
<http://www.dnr.state.oh.us/water/rainwater/default/tabid/9186/default.aspx>
- It appeared that a small tree had fallen down on a section of silt fence on the west side of the site (See Figure 2). Maintenance of this section of silt fence is expected within three (3) days from receipt of this letter.

Figure 1: Sediment basin requires a temporary riser and/or skimmer before major earth moving activities can commence.

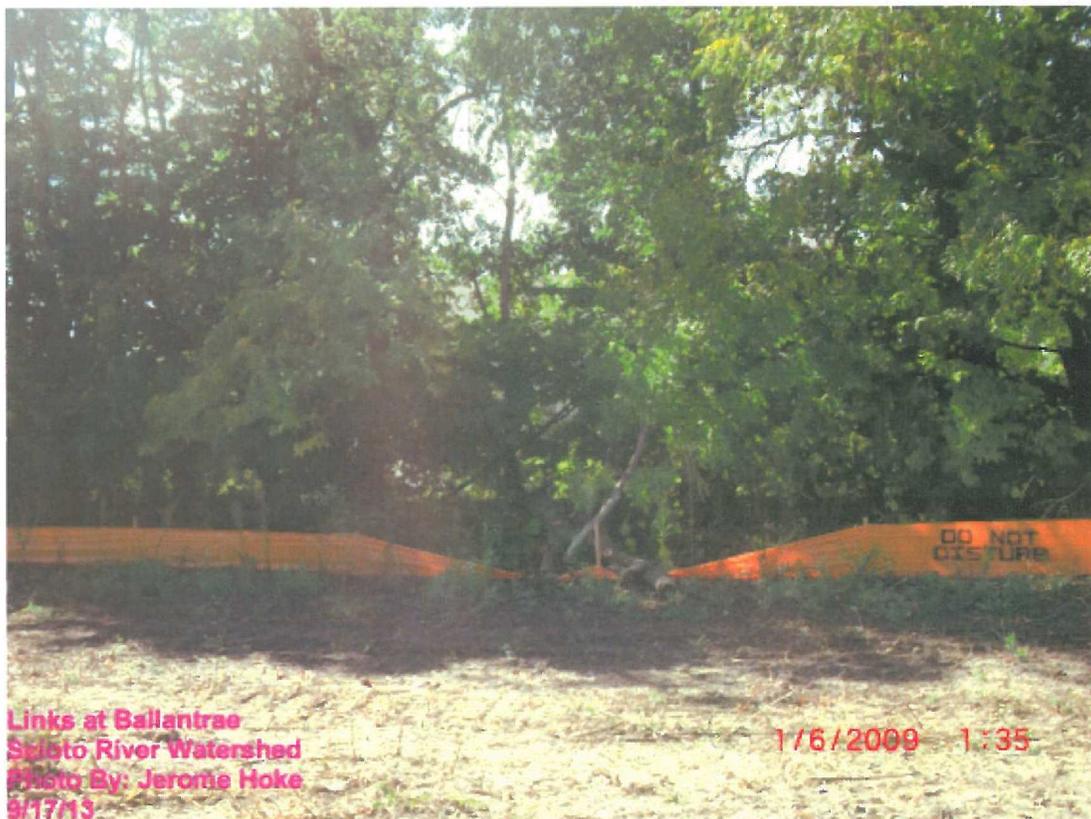
Figure 2: Downed tree has caused silt fence on west side to fail. Maintenance is required.
