October 2, 2013

**RE: Construction Storm Water Inspection at Delaware Place Senior Apartments
Delaware County. Permit Number: 4GCO00086*AG**

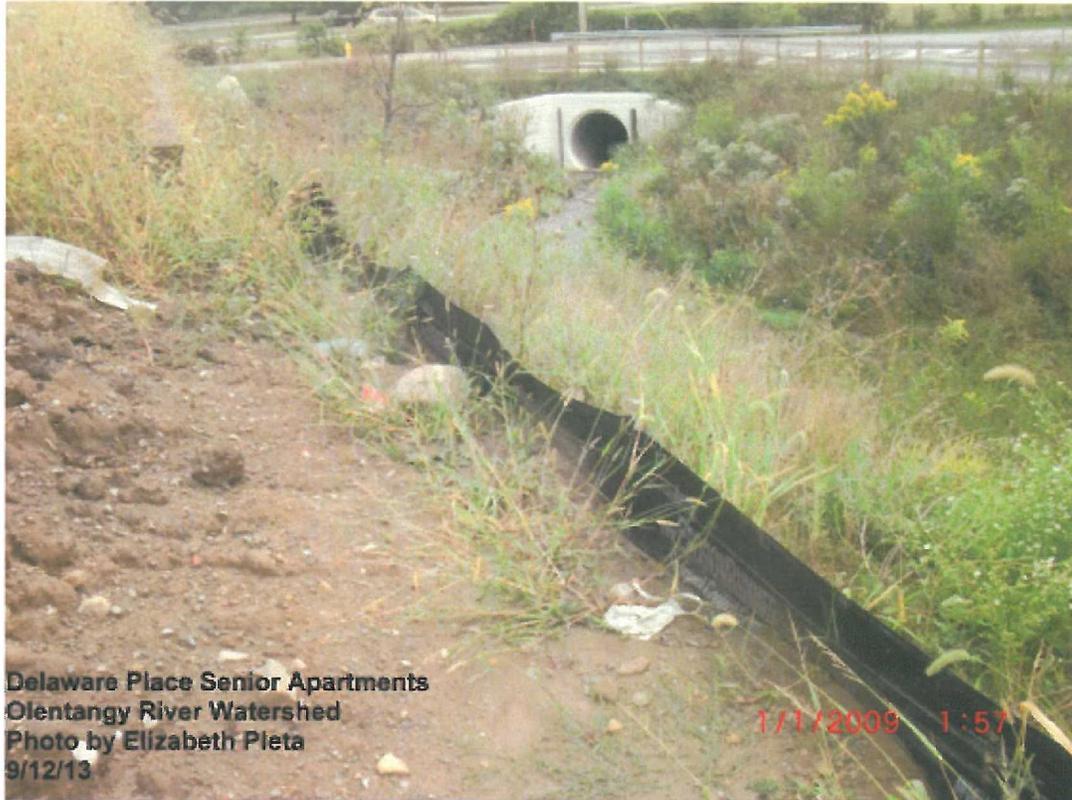
- Silt fencing on the southern portion of the site appeared to be overburdened (See Figure 1). The location of the silt fence, adjacent to a tributary stream in the Olentangy River Watershed, demands greater maintenance procedures than have been followed to date. Maintenance is required within three (3) days from receipt of this letter.
- A temporary riser or skimmer remained absent from the sediment basin on the east side of the site, as noted in a previous inspection (See Figure 2). Entrenching silt fence around the outlet structure, as noted, is **not an acceptable alternative**. If corrections are not made upon our next inspection, further compliance measures will be taken on behalf of the Ohio EPA.

Figure 1: Silt fence adjacent to the stream is overburdened and requires maintenance.

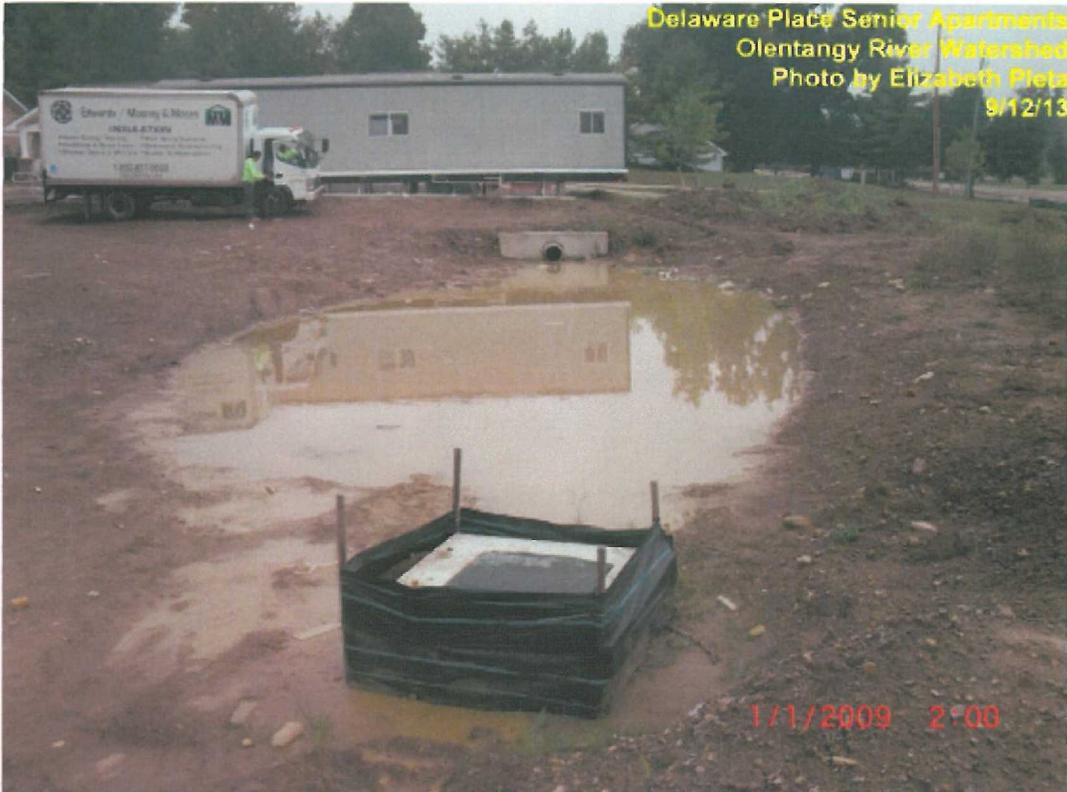
Figure 2: Installation of a temporary riser and/or skimmer is expected immediately.
