This letter is written regarding the storm water inspections I conducted at Blacklick Creek Stream Relocation and Stabilization Project, located adjacent to Fairfield Square Condominiums, on State Route 256, in Pickerington, Ohio. I understand this site is currently covered under our General Storm Water Permit associated with Construction Activities, and a Nationwide Permit issued by the Army Corps of Engineers. I conducted storm water inspections at this site on November 2, 9, 14 and 16, 2006 to ensure compliance with the General Permit.

Proposed Stream Bank Stabilization
Project
Blacklick Creek
at Fairfield Square Condos
Pickerington, Ohio

Blacklick Creek
Stream Relocation
Stream Bank Stabilization Project

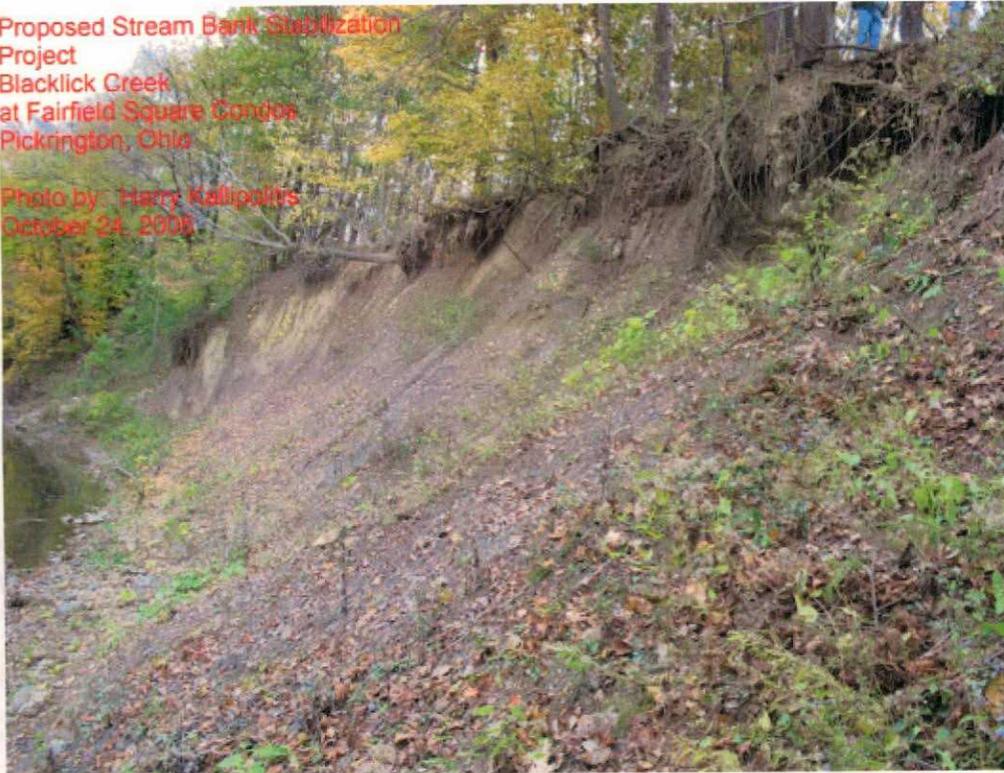
Figure 1: Eroding areas along Left Descending Bank of Blacklick Creek

The purpose of this project was to provide erosion protection to the highly eroding stream banks along the left descending bank of Blacklick Creek (see attached photo). The project design and construction included the placement of approximately 400 feet of rip rap along the left descending bank, in addition to shifting the bankfull stream channel to the west on average of 20 to 25 feet away from the eroding areas.

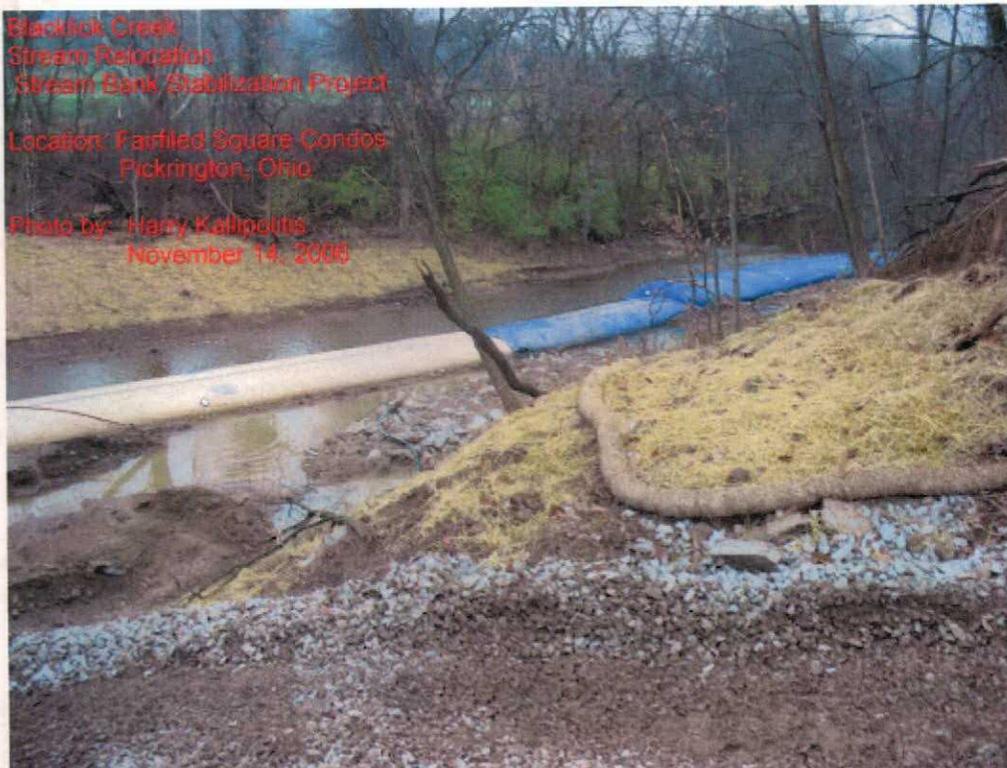
Figure 2: Large Aquabarriers to provide containment for construction activities.
Temporary Straw cover utilized as primary sediment control measure.

Large aquabarries were utilized to divert the stream flow around the area of construction and provide containment to minimize soil loss during this process (see attached photos). Temporary straw cover was utilized as the primary sediment control for this project with daily applications if necessary (see attached photos). The temporary equipment crossing of Blacklick Creek was constructed of a non-erodible fill as required in the Army Corps of Engineers Nationwide Permit.

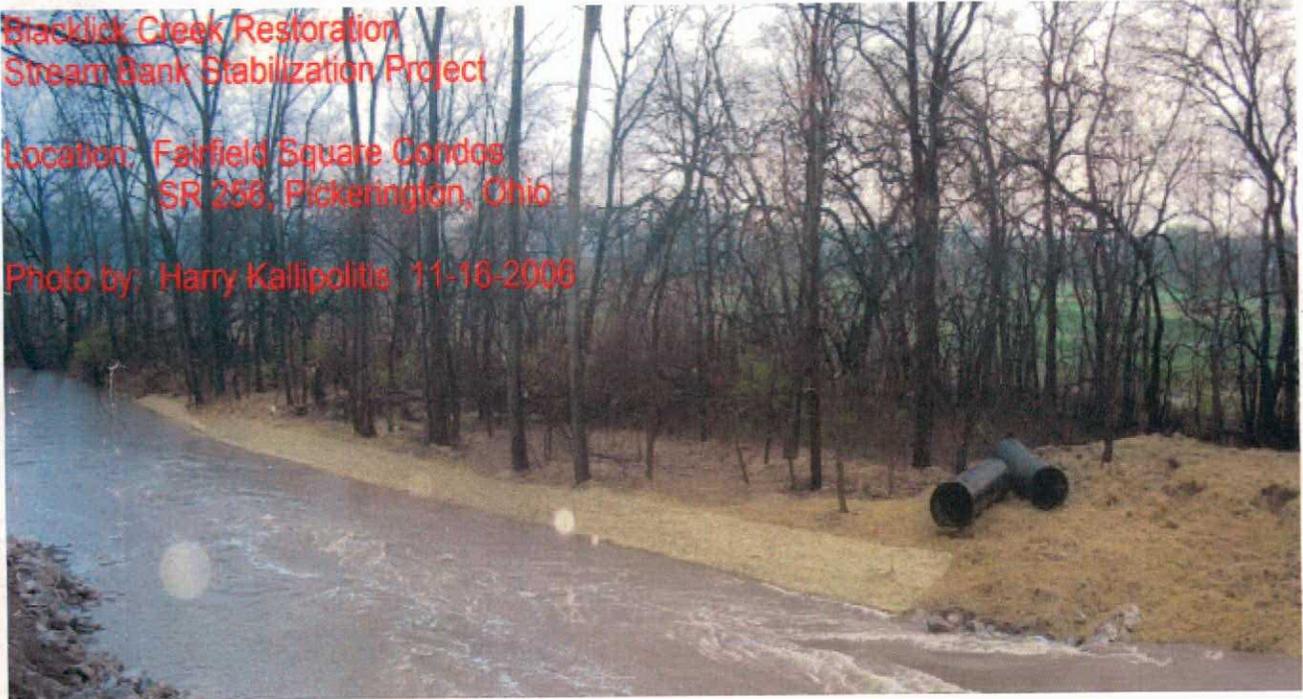
Figure 3: Erosion Control Matting will be expected given current weather conditions

In all, I was pleased regarding the level of effort the contractor implemented to ensure effective sediment and erosion control were installed and maintained on this project. I understand the contractor must install the final storm pipe which provides a discharge from the water quality pond associated with Fairfield Square Condominiums. Once this work is completed, final stabilization will be required. Given the time of year, erosion control matting will be expected for this area, as noted on the right descending banks of Blacklick Creek (see attached photos)
