April 17, 2007

Re: **Wilmington Sanitary Landfill
Notice of Violation**

On March 29, 2007, I, representing the Ohio Environmental Protection Agency (Ohio EPA), conducted an inspection of Wilmington Sanitary Landfill (Facility) located in Clinton County. During the inspection, I was accompanied by Don Maher, Superintendent of Sanitation for the City of Wilmington. This inspection was conducted to determine compliance with Ohio EPA's Solid Waste Regulations. The working face during this inspection was located in the central eastern portion of the west expansion area. The findings observed were also documented by photographs. Ohio EPA records show that construction and operation of the Facility is authorized by Permit-to-Install #05-3708 (PTI), issued January 17, 1995.

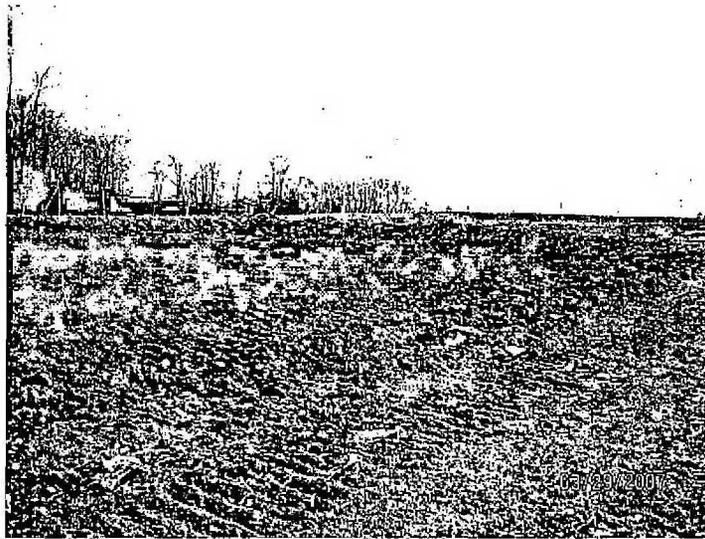
3. Blowing litter and flagging waste was observed along the northeast corner of the expansion area (see Figure 3). As indicated by the operator, this area is being regraded in an effort to correct the overfill violation. This violation was documented in a Notice of Violation, dated December 6, 2006. Therefore, despite efforts to return to compliance, **the current condition of the overfill area was in violation of OAC Rule 3745-27-19(F)** which states:

Figure 3: Exposed solid waste and soils from overflow correction operation, as well as flagging waste

"Daily cover shall be applied to all exposed solid waste by the end of the working day to control fire hazards, blowing litter, odors, vectors, and rodents. In no event shall solid waste be exposed for more than twenty-four hours after unloading."
