State of Ohio Environmental Protection Agency

May 15, 2009

RE: MATOUSEK LANDFILL
NOTICE OF VIOLATION

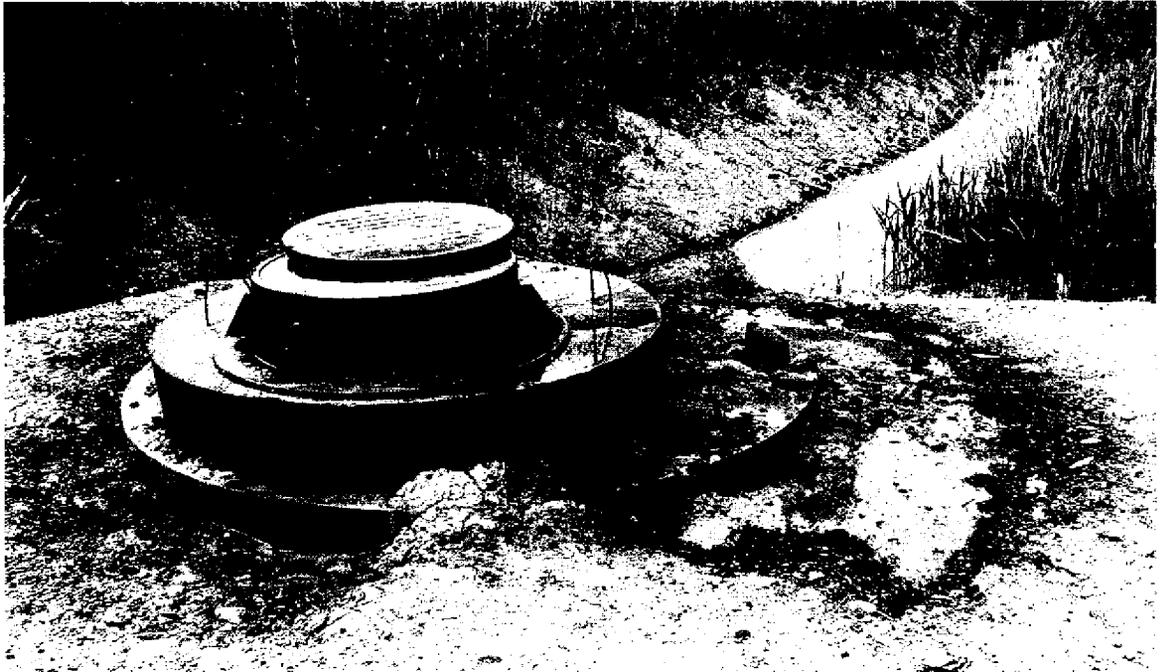
On May 13, 2009, I (Jarnal Singh) of the Ohio Environmental Protection Agency, Northeast District Office (Ohio EPA-NEDO), while conducting an inspection of the City View Center, observed leachate overflowing a manhole structure at the 'mouth' of the 42" storm sewer located at the south end of the undeveloped portion of the City View Center in Garfield Heights, Ohio. The manhole is located on property owned by Peter J. Limited. Leachate was observed discharging from the top of the manhole and entering a storm water ditch running south adjacent to a haul road on the Peter J. Limited portion of the Matousek Landfill (see attached photographs).

Picture of overflowing manhole structure. Looking south. Picture taken May 13, 2009, by J. Singh.

Leachate from this structure cannot be allowed to overflow. Leachate must be properly contained, characterized and then disposed of in accordance with ORC 6111. Please provide written notice to Ohio EPA, within seven days of your receipt of this letter, of the actions that have been taken to address and prevent the reoccurrence of the above noted violations. Failure to comply with the above mentioned requirements may result in escalated enforcement action being taken by this Agency.
