Re: Defiance County Landfill
Inspection Results

November 10, 2009

Defiance County Landfill 11-04-09 Inspectio..

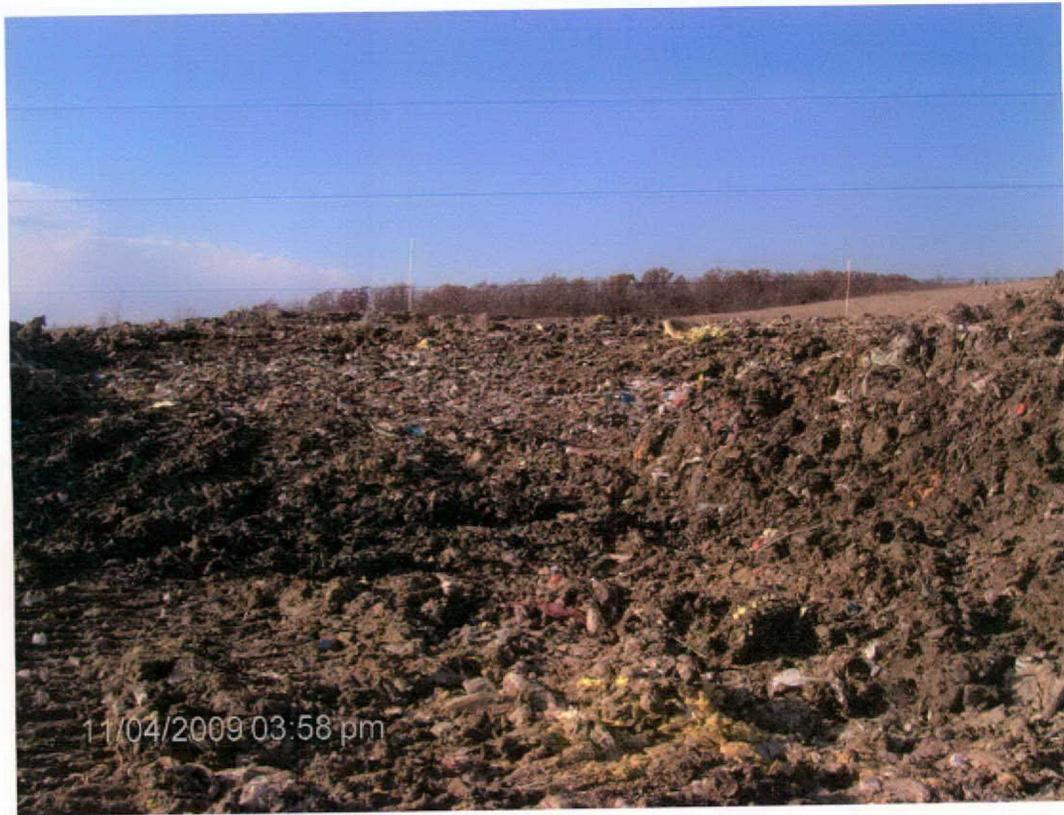
Significant flagging in the daily cover was observed in an area of daily cover in Phase 2A. Additionally, an area in the northwest corner of Phase 2A appeared to contain little to no cover and a large amount of blackbirds were observed concentrated in the area of exposed waste. Ms. Crosser agreed that the cover was not adequate and indicated that it was due to recent rainfall and associated soils being used for daily cover containing a large amount of moisture. Photos 1 and 2 depict areas of inadequate daily cover.

Photo 1- Area of inadequate daily cover, taken by Brent Goetz

The owner/operator must use a cover material that can be adequately spread and removed, while meeting the definition of OAC Rule 3745-27-19(F), in all weather conditions. Additionally, regardless of the weather conditions the owner/operator is responsible to ensure that all areas are covered at the end of the working day. The daily cover observed in Phase 2A was not adequate; therefore, the owner/operator is in violation of OAC Rule 3745-27-19(F).

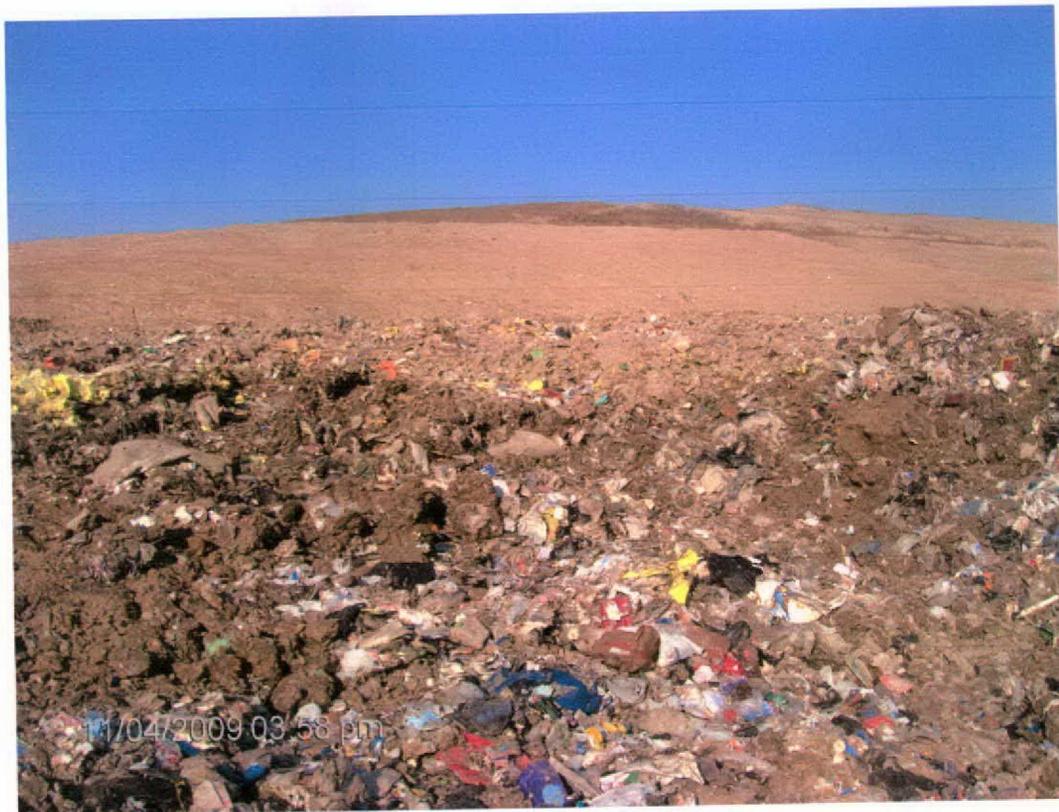
Photo 2- Area of inadequate daily cover, taken by Brent Goetz

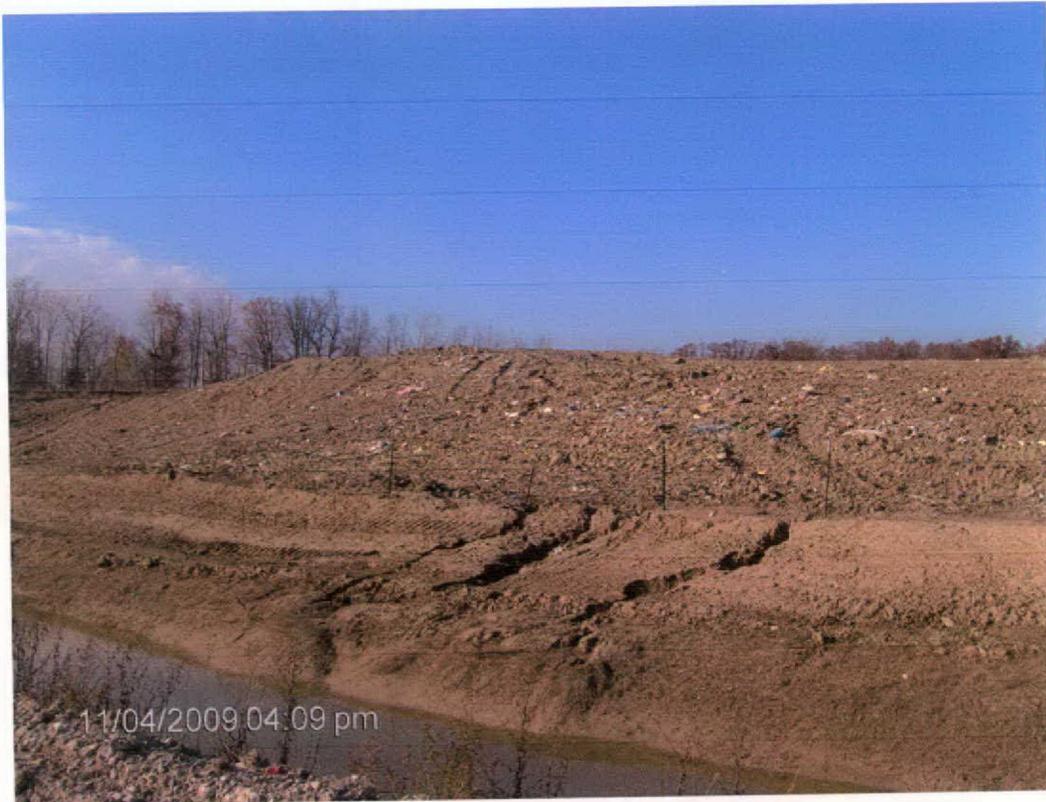
Flagging was noted in the intermediate cover on the west half of the "top" of Phase 1A and in Phase 1B. **Cover in these areas did not meet the specification of intermediate cover and should be immediately addressed to avoid any potential future violations.** Photo 3 depicts the area of inadequate intermediate cover.

Photo 3- Area of inadequate intermediate cover, taken by Brent Goetz

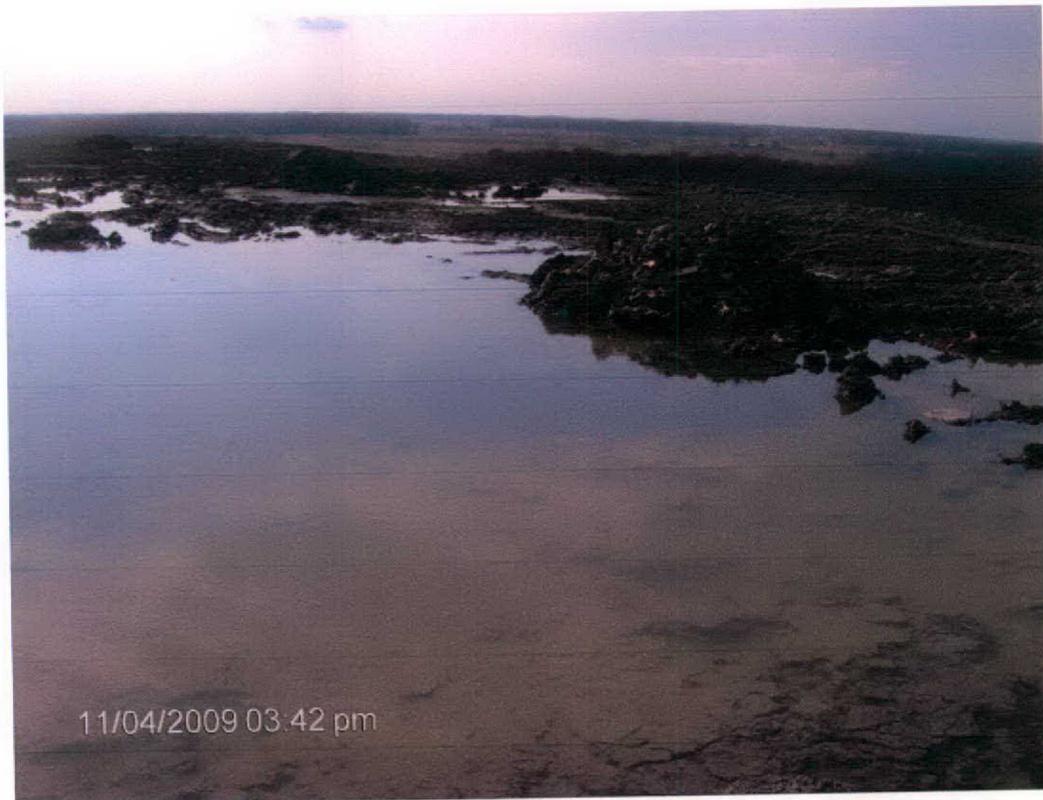
Waste disposal operations in Phase 4 remain on hold due to access issues caused by recent rainfall events, and the resulting effect on the access roads. Additionally, recent rainfall events caused areas of significant ponding in areas of Phase 4. An attempt was made to drain the ponded water into the landfill by excavating approximately 10-15 holes through the intermediate cover and allowing the water to drain into the waste. Photos 4 and 5 depict the areas of ponding and the holes excavated to drain the ponded water.

Excavating holes through the intermediate cover in Phase 4 and diverting water into areas where solid waste has been deposited is a violation of OAC Rule 3745-27-19(J)(1).

The lack of proper grading, to promote positive drainage is the cause of the ponding in Phase 4. Excavating holes through the intermediate cover in Phase 4 and diverting water into areas where solid waste has been deposited is not correcting the conditions causing the ponding. The owner/operator is therefore, in violation of OAC Rule 3745-27-19(J)(3). In order to correct this violation Phase 4 must be adequately graded to promote positive drainage. Please respond in writing within 14 days of receipt of this letter indicating how the owner/operator will address this violation.

Photo 4-Area of ponded water with excavated hole to drain water into waste, taken by Brent Goetz

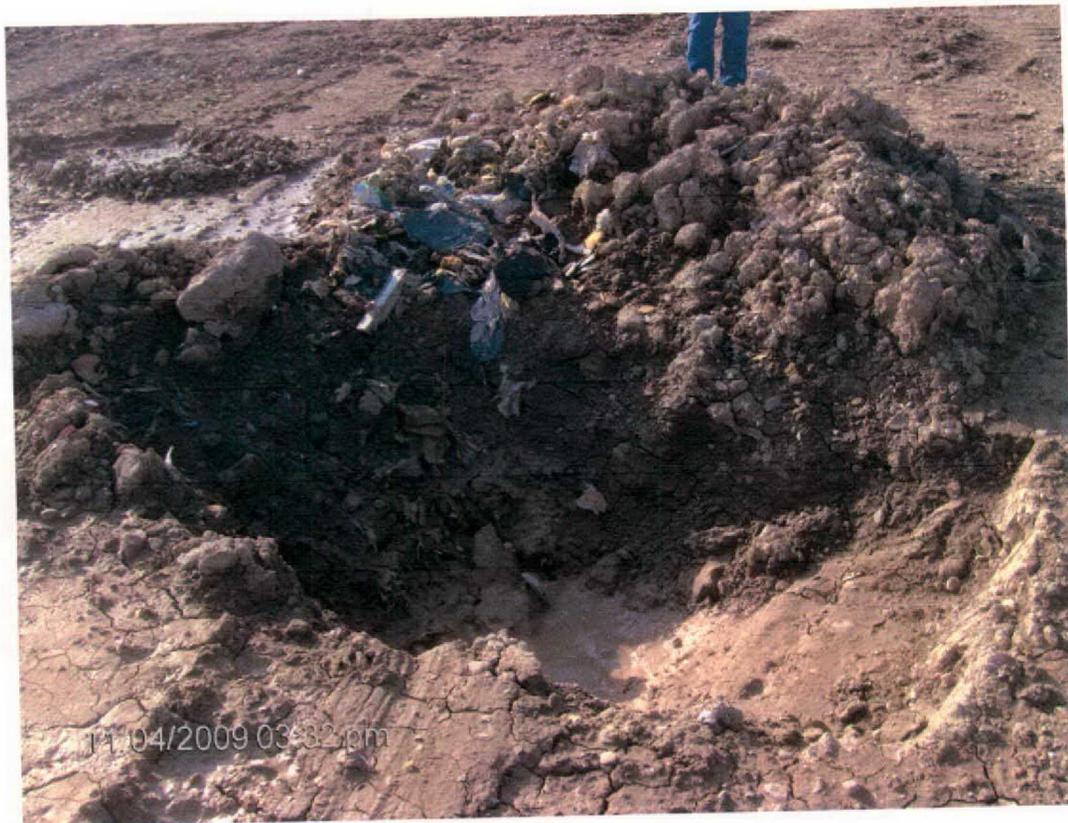
Photo 5- Excavated hole to drain water into waste, taken by Brent Goetz
